# Technical Service Bulletin

**97 Reduced power "Electrical system: fault" or "Drive system: fault" appears: P068500, P068A00, P1BEF00, B158131 P0C4700**  
97 23 97 2070566/1 June 6, 2023.

| Model(s) | Year | VIN Range | Vehicle-Specific Equipment |
|---|---|---|---|
| Q4 e-tron, and<br>Q4 e-tron<br>Sportback | 2024 | All | Not Applicable |

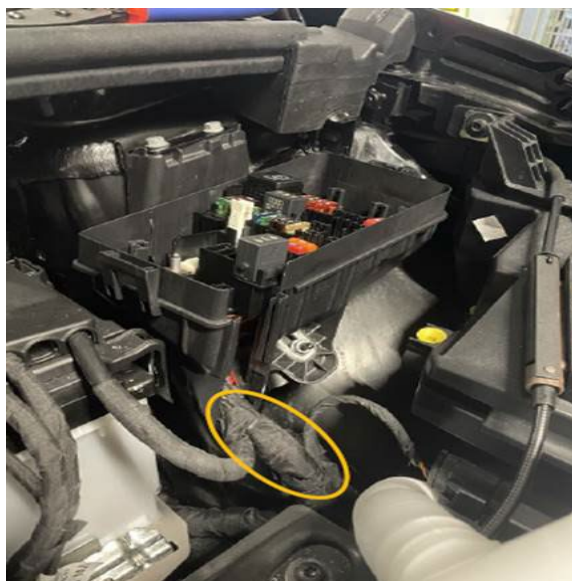
If the above DTC's are present, inspect splice point J1 within the main wiring harness indicated by the yellow circle (Figure 1).

**Figure 1:** J1 splice point location.

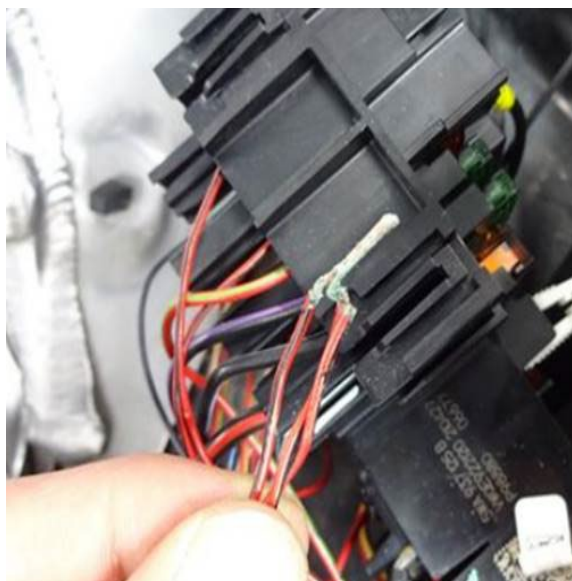
Insufficient sealing to splice point J1 "positive connection (30) in main wiring harness".

If splice point J1 is corroded as seen in Figure 2, repair the splice point using the following steps.

**Figure 2:** Corrosion found at splice point J1.

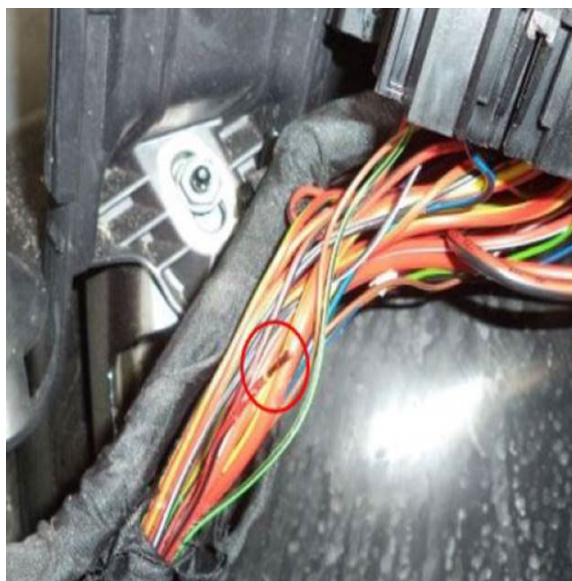
**Figure 5:** Clean wire stripped back at J1 splice point.

The corroded wire **MUST** be cut back until the wires are clean and shiny (Figure 5).

It may be necessary to lengthen or replace the corroded wire(s).

Connect the repair wiring kit **10A998110** to the harness. Use the crimp connector included in the repair kit. Shrink the crimp connector so that the connection is sealed.

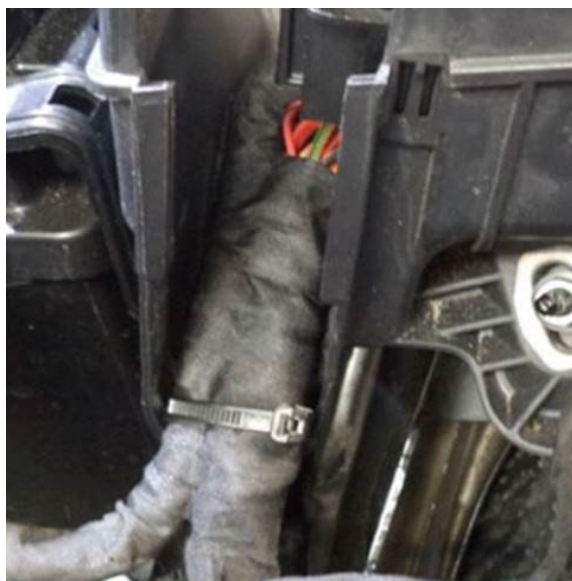
**Figure 6:** Completed repair.

Wrap fabric adhesive tape **N 10729001** around the wiring harness and secure the cable tie supplied (Figure 6).
