# Technical Service Bulletin

## 27 48V Vehicle electrical system warning, DTC P0CA700 and/or U046900 stored in the starter/generator control module/ECM

27 23 57 2058831/9 June 14, 2023. Supersedes Technical Service Bulletin Group 27 number 23-55 dated May 8, 2023, for reasons listed below.

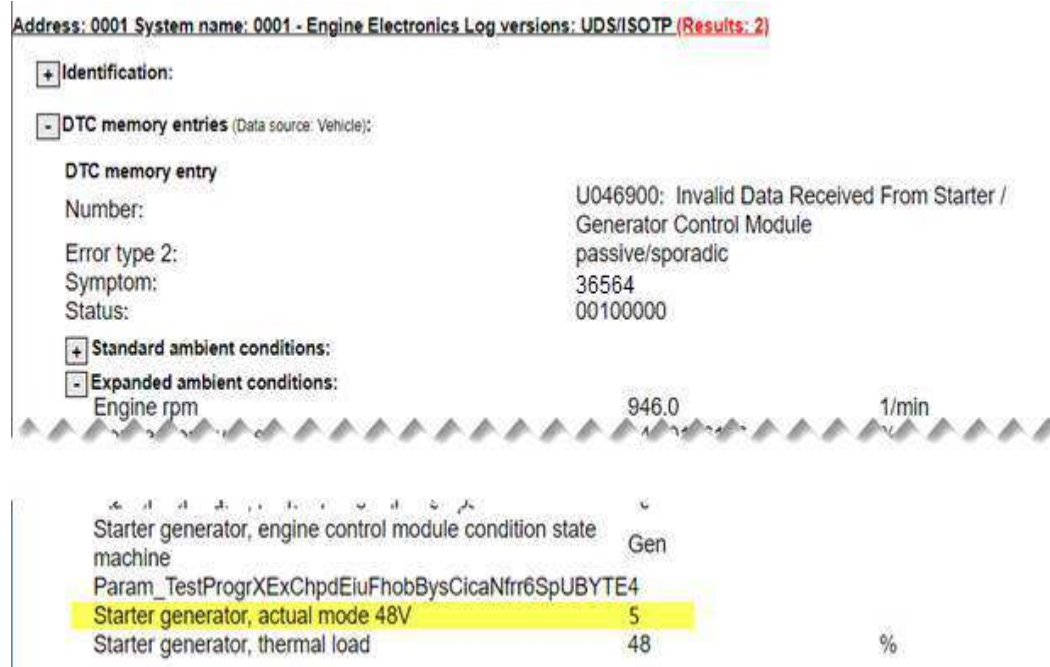
Figure 1: Extended ambient data in ODIS GFF log.

If the value displayed for *Starter generator, actual mode 48V* is not shown, or a value other than 5 is displayed (see Figure 1) please check the software version of the BSG (address word 00CC).

If the software is older than, but not including SW 0527, please update the BSG via the SVM update instructions at the end of this TSB, then follow up with the checks listed under Criterion 2.
