**HYUNDAI**  
**Technical Service Bulletin**

| GROUP<br><b>CAMPAIGN</b> | NUMBER<br><b>23-01-036H-1</b> |
| DATE<br><b>JUNE 2023</b> | MODEL(S)<br><b>ELANTRA (CN7A)<br/>SONATA (DN8A)<br/>SANTA FE (TMA)</b> |

**SUBJECT:** HECU MODULE DARK CURRENT MEASUREMENT AND REPLACEMENT (SERVICE CAMPAIGN 990)

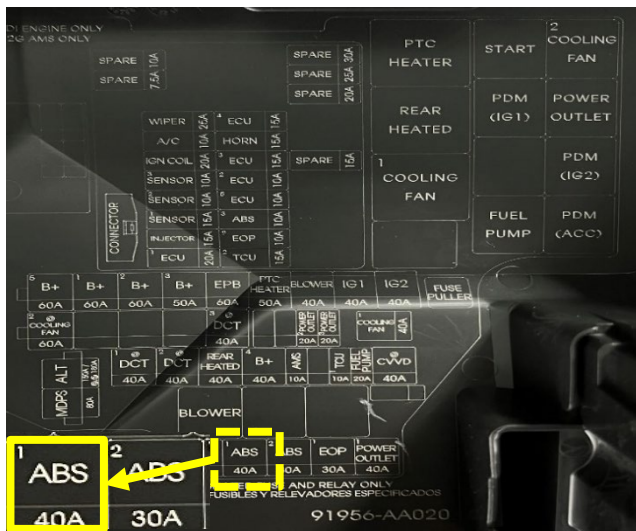
### Elantra (CN7A): 58910-AB800

| Model | Part Number | Part Name | Fuse Measurement Point | Maximum Dark Current Value |
|---|---|---|---|---|
| Elantra (CN7A) | 58910-AB800 | Hydraulic Unit Assy | 40A (ABS) | <b>95 <math>\mu</math>A</b> |

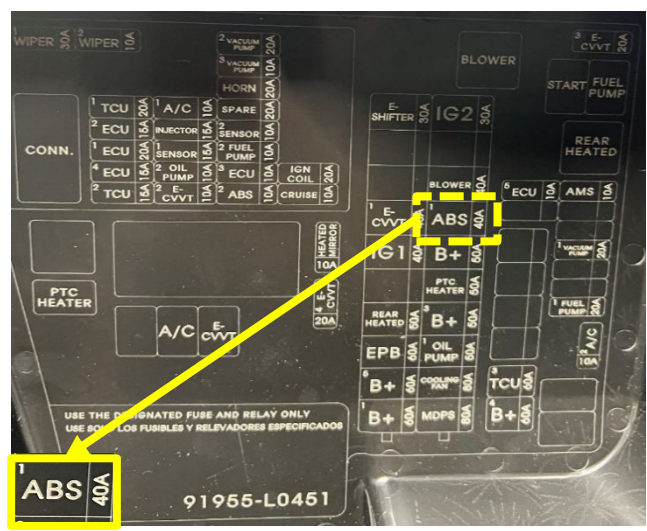
### Sonata (DN8A): 58910-L0100

| Model | Part Number | Part Name | Fuse Measurement Point | Maximum Dark Current Value |
|---|---|---|---|---|
| Sonata (DN8A) | 58910-L0100 | Hydraulic Unit Assy | 40A (ABS) | <b>95 <math>\mu</math>A</b> |

DN8A vehicles: The ABS fuse measurement location is under the right multi-fuse bar.

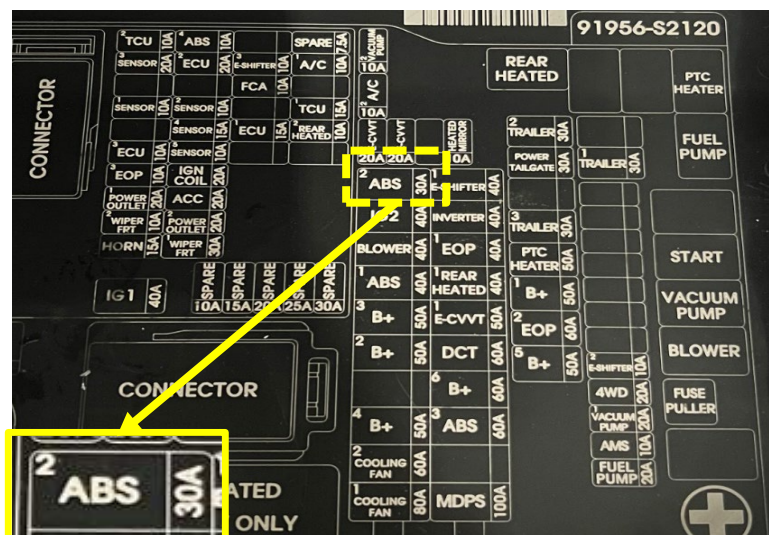
### Santa Fe (TMA): 58910-S2DA0 / 58910-S2GA0

| Model | Part Number | Part Name | Fuse Measurement Point | Maximum Dark Current Value |
|---|---|---|---|---|
| Santa Fe 2.5L (TMA) | 58910-S2DA0 | Hydraulic Unit Assy | 30A (ABS) | <b>95 <math>\mu</math>A</b> |
| Santa Fe 2.5T (TMA) | 58910-S2GA0 | Hydraulic Unit Assy | 30A (ABS) | <b>105 <math>\mu</math>A</b> |

TMA vehicles: The ABS fuse measurement location is under the left multi-fuse bar.

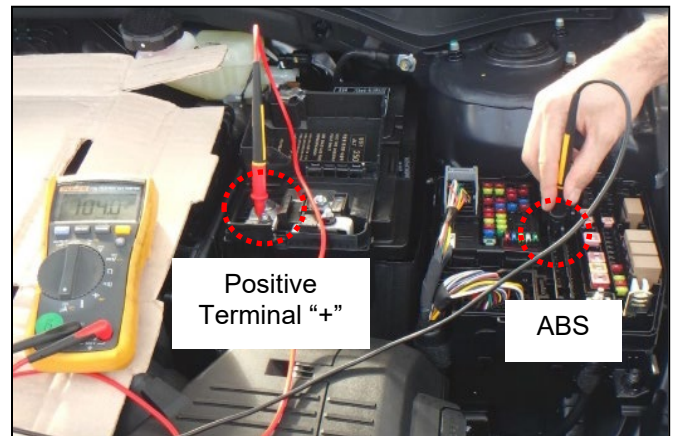
7. Measure the multimeter value/reading for at least 30 seconds. **The current draw value must stay consistent for a proper measurement.**

6. Contact the red lead to the positive (+) battery terminal.

Contact the black lead to the appropriate ABS fuse location (see the *Fuse Box Measurement Point Guide*).
