# TECHNICAL SERVICE BULLETIN

| DA22-001B | NTB22-038B | June 20, 2023 |

## RAB WARNING LIGHT ON IN INSTRUMENT PANEL AND/OR DTC B2724-23 STORED

**APPLIED VEHICLES:** 2019-2021 Altima (L34)  
2019-2022 Murano (Z52)  
2019-2021 Rogue Sport (J11)  
2019-2021 Versa (N18)

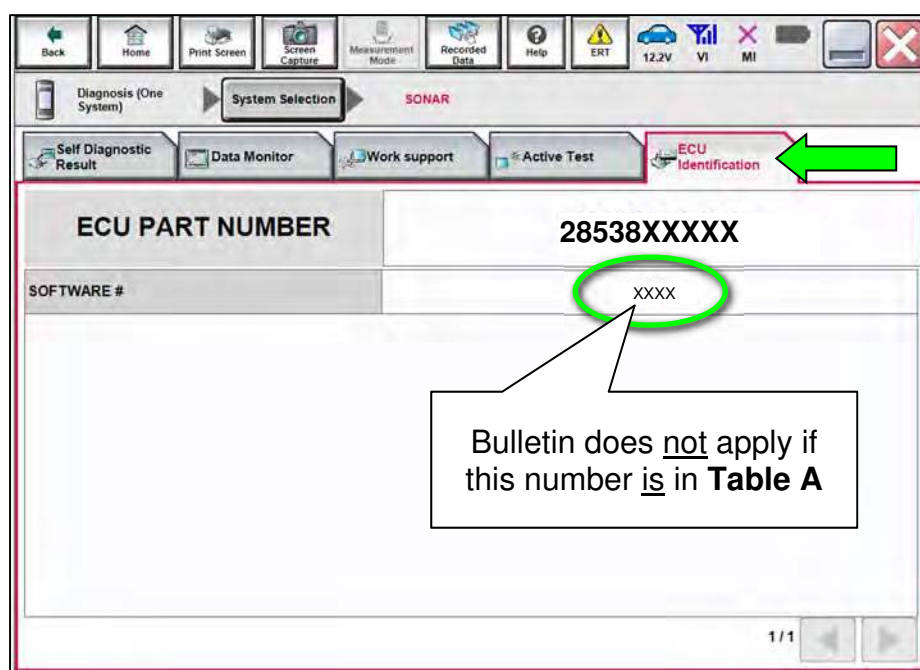
Figure 4

15. Select **ECU Identification**.
16. Confirm the current **SOFTWARE #** (Figure 4). See **Table A** (below) for model specific **SOFTWARE #**.
  - If the **SOFTWARE #** is in **Table A**, this bulletin does not apply. See the Electronic Service Manual (ESM) for further diagnostic information.
  - If the **SOFTWARE #** is not in **Table A**, proceed to step 17.

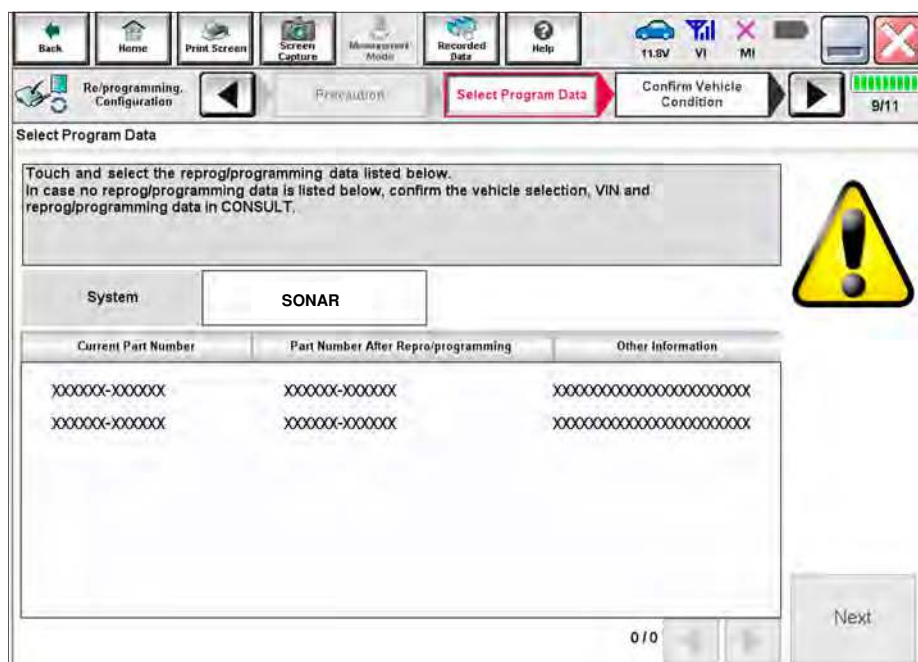
Figure 16

**HINT:** If you get the screen below and it is blank (no reprogramming listed), it means there is no reprogramming available for this vehicle. Close CONSULT and refer back to the ESM for further diagnosis.

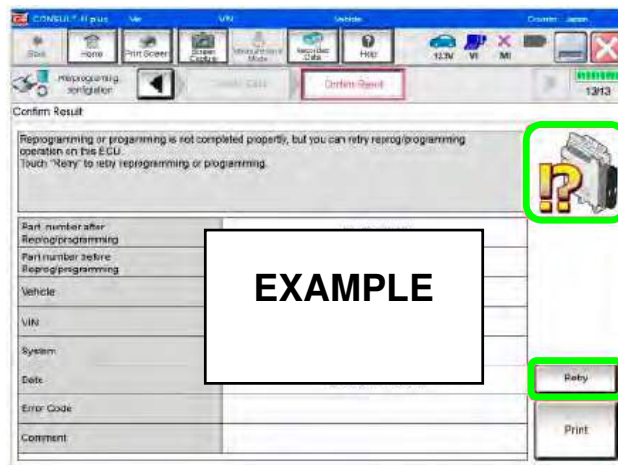
Figure 21

**If reprogramming does not complete and the “!?” icon displays, as shown in Figure 21:**

- Check battery voltage (12.0 - 15.5 V).
- Ignition is ON, engine OFF.
- External Bluetooth® devices are OFF.
- **All** electrical loads are OFF.
- **Select retry and follow the on screen instructions.**
- “Retry” may not go through on first attempt and can be selected more than once.

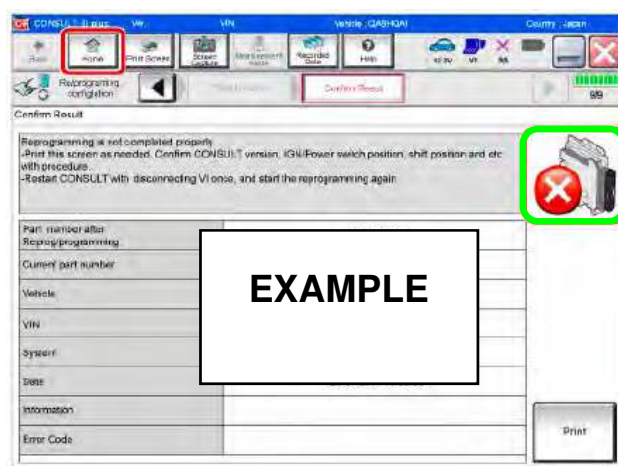
Figure 22

**If reprogramming does not complete and the “X” icon displays, as shown in Figure 22:**

- Check battery voltage (12.0 - 15.5 V).
- CONSULT A/C adapter is plugged in.
- Ignition is ON, engine OFF.
- Transmission is in Park.
- All CONSULT VI cables are securely connected.
- All C-III plus updates are installed.
- **Select Home, and restart the reprogram procedure from the beginning.**

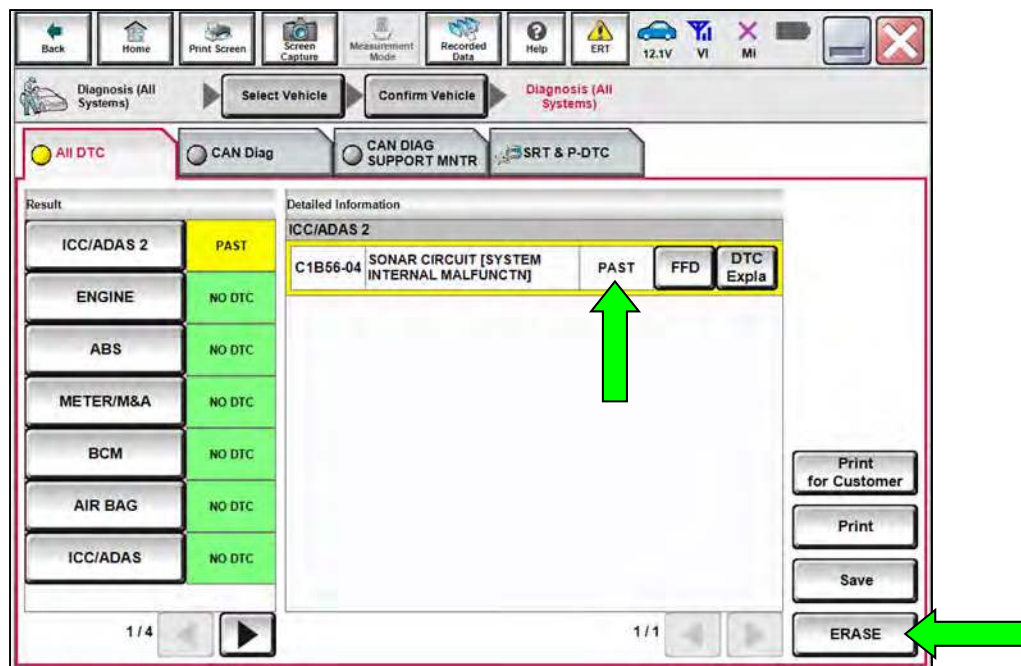
Figure 38

64. Select **Automatic Selection(VIN)**.
65. Select **Confirm**.
66. Select **Confirm** again.
67. Turn the ignition OFF, and then turn the ignition ON.
68. Confirm DTC C1B56-04 is displayed as **PAST** (not **CRNT**) (Figure 38).
69. Select **ERASE**.
