# Technical Service Bulletin

## 91 SOS Emergency call function deactivated message in the cluster, DTC U153E00 is stored in the telematics module

91 23 09 2055945/13 June 29, 2023. Supersedes Technical Service Bulletin Group 91 number 22-31 dated September 23, 2022, for reasons listed below.

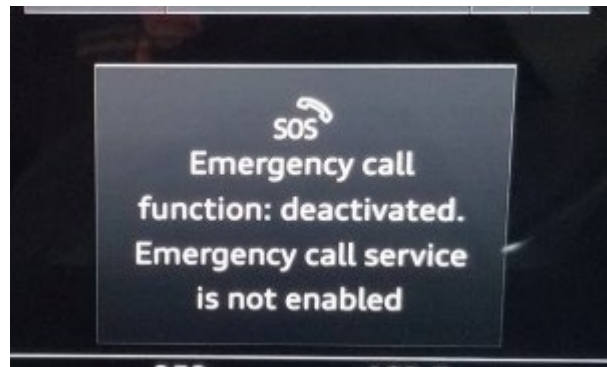
- The warning message “SOS Emergency call function deactivated” is seen in the instrument cluster (Figure 1 or 2).

**Figure 1.** SOS warning in the instrument cluster.

1. Follow all instructions in TSB 2011732: *00 Software Version Management (SVM), operating instructions*.
2. Update the telematics control module, J949 (address word 0075) using the SVM action code as listed in the table below, if necessary:

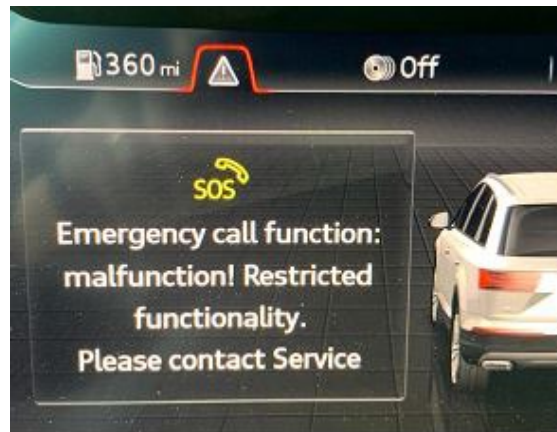
**Figure 2.** SOS warning in the instrument cluster.
