## SERVICE BULLETIN

**APPLICABILITY:** 2022MY WRX

**NUMBER:** 09-102-23

**SUBJECT:** Diagnosis Procedures for DTCs  
 P2404 & P2109

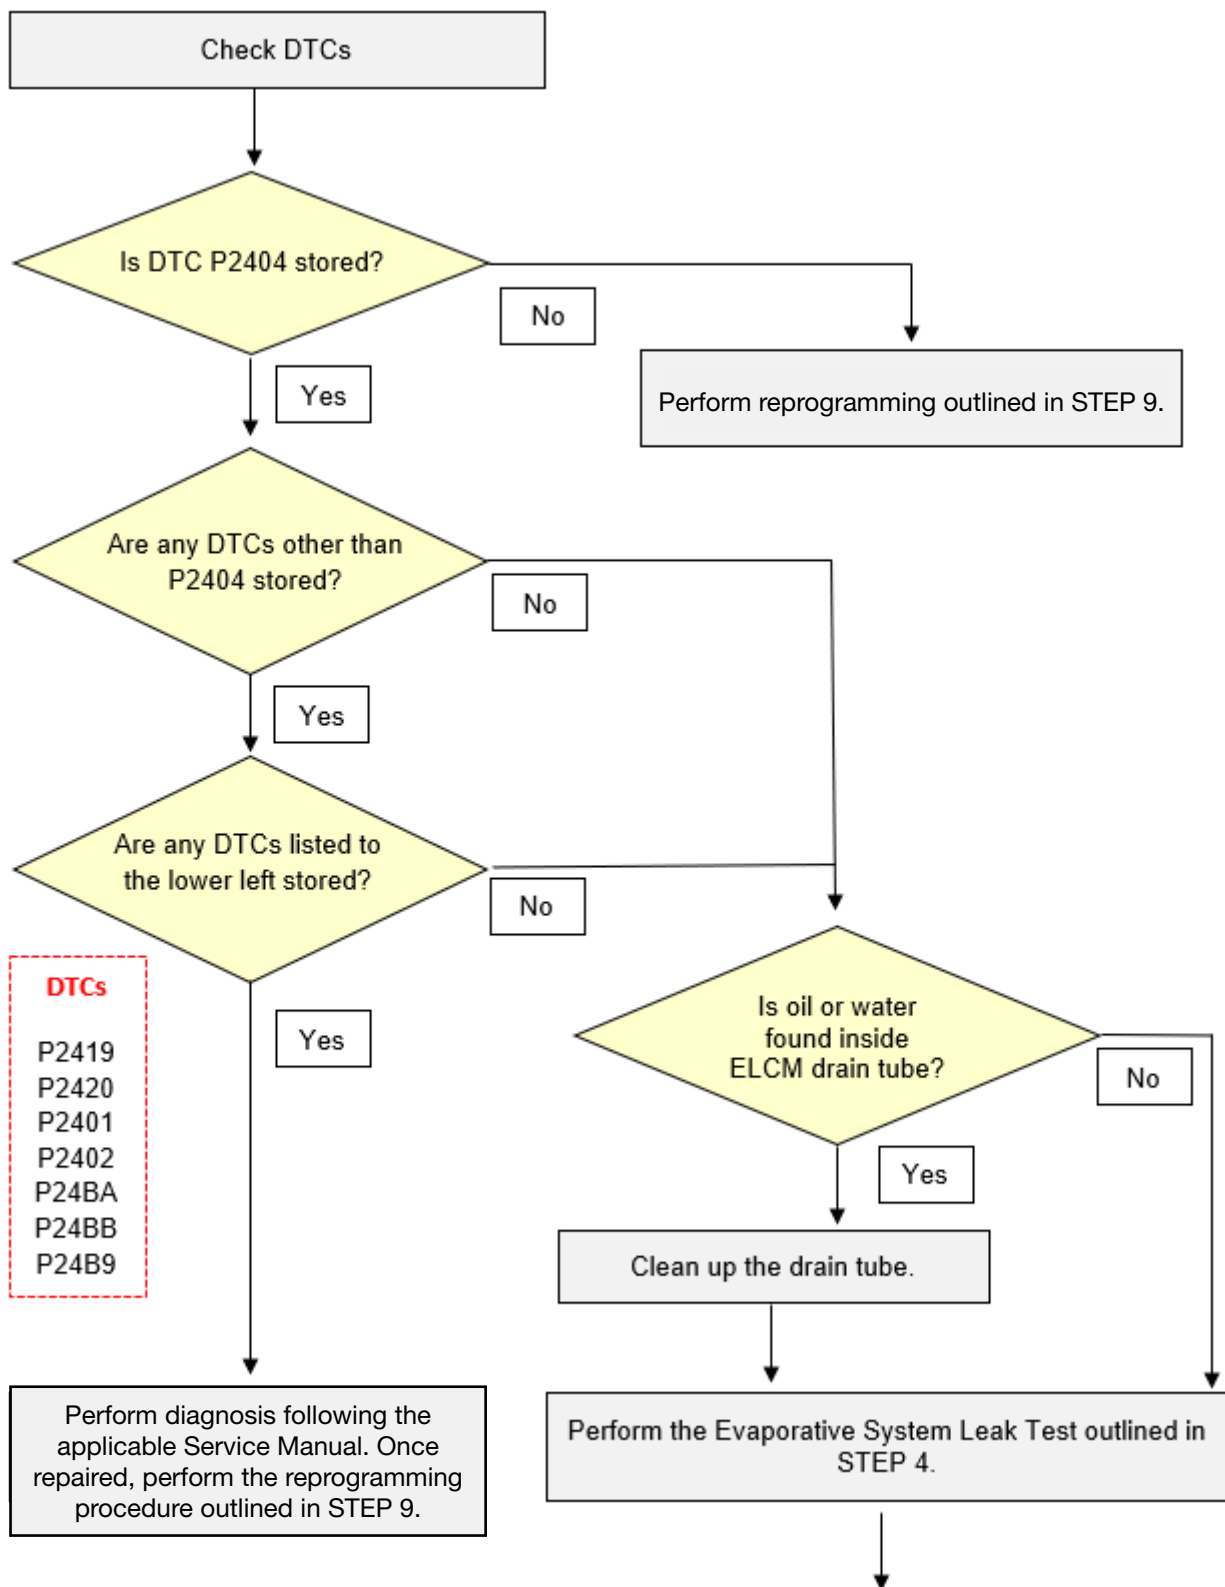
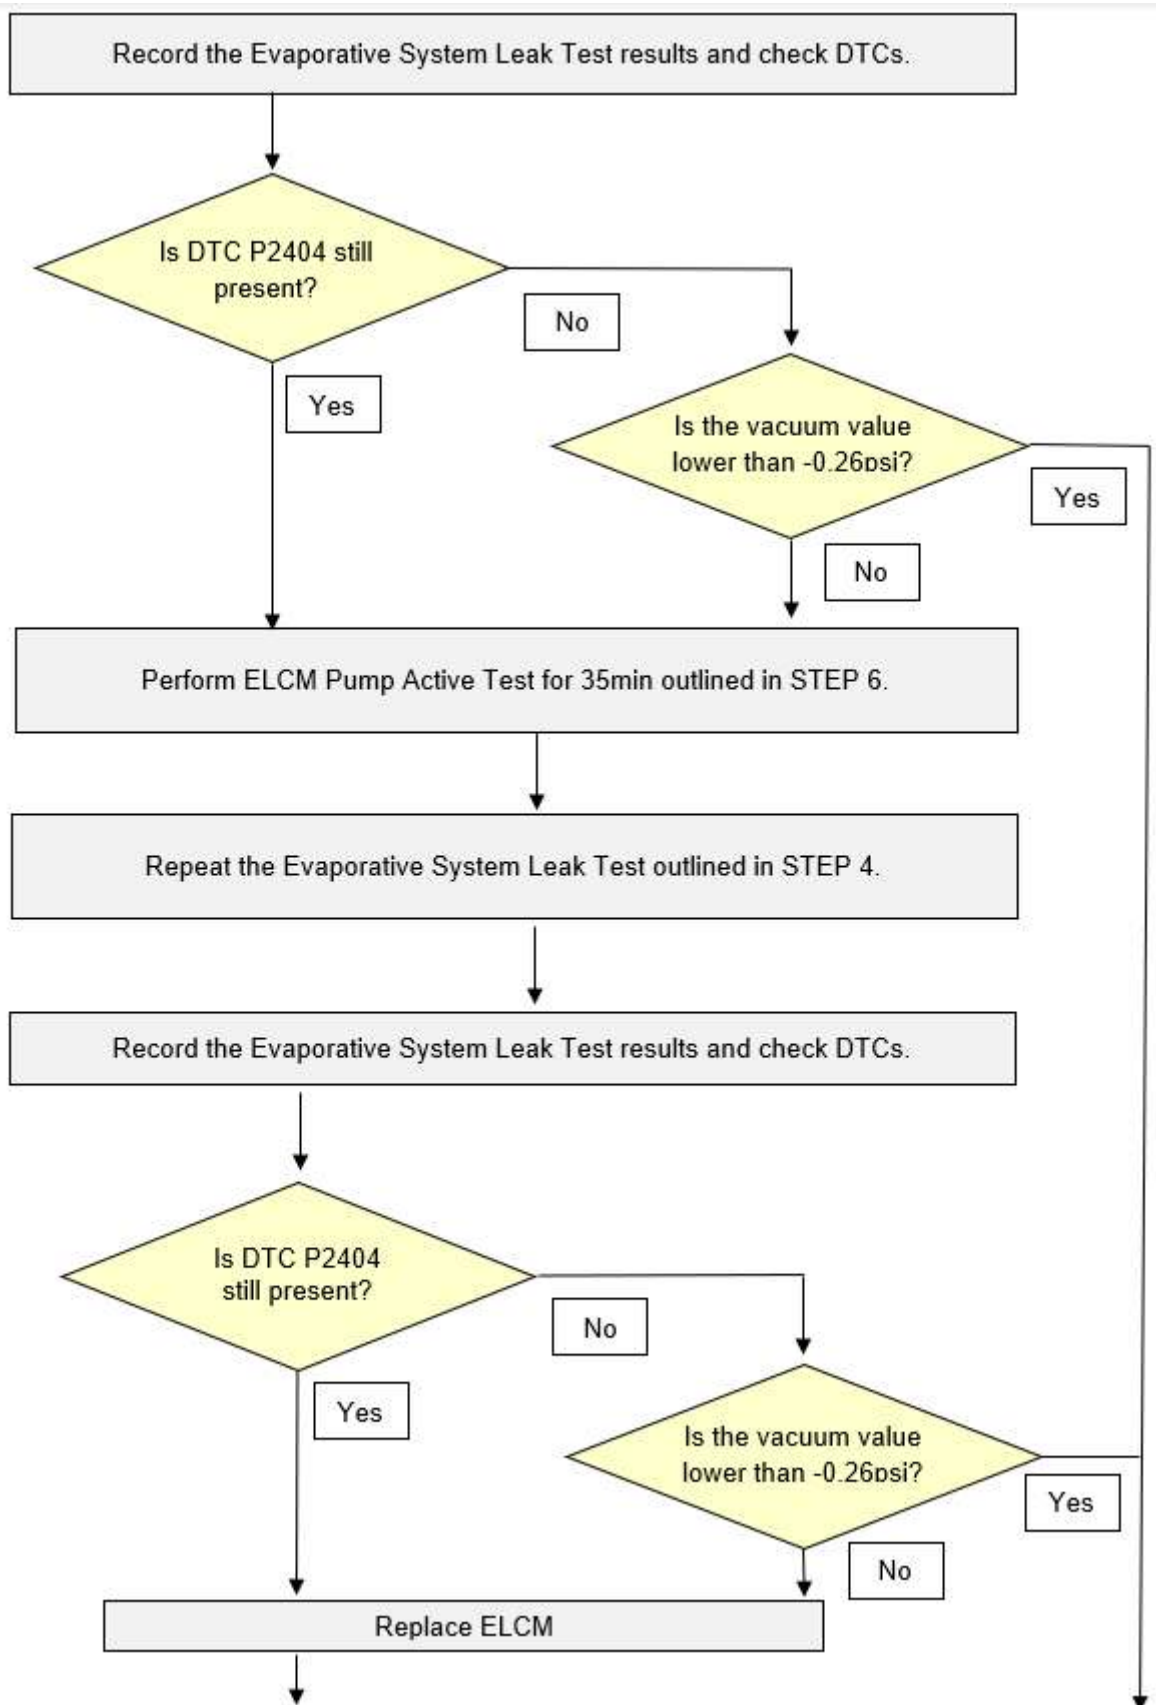
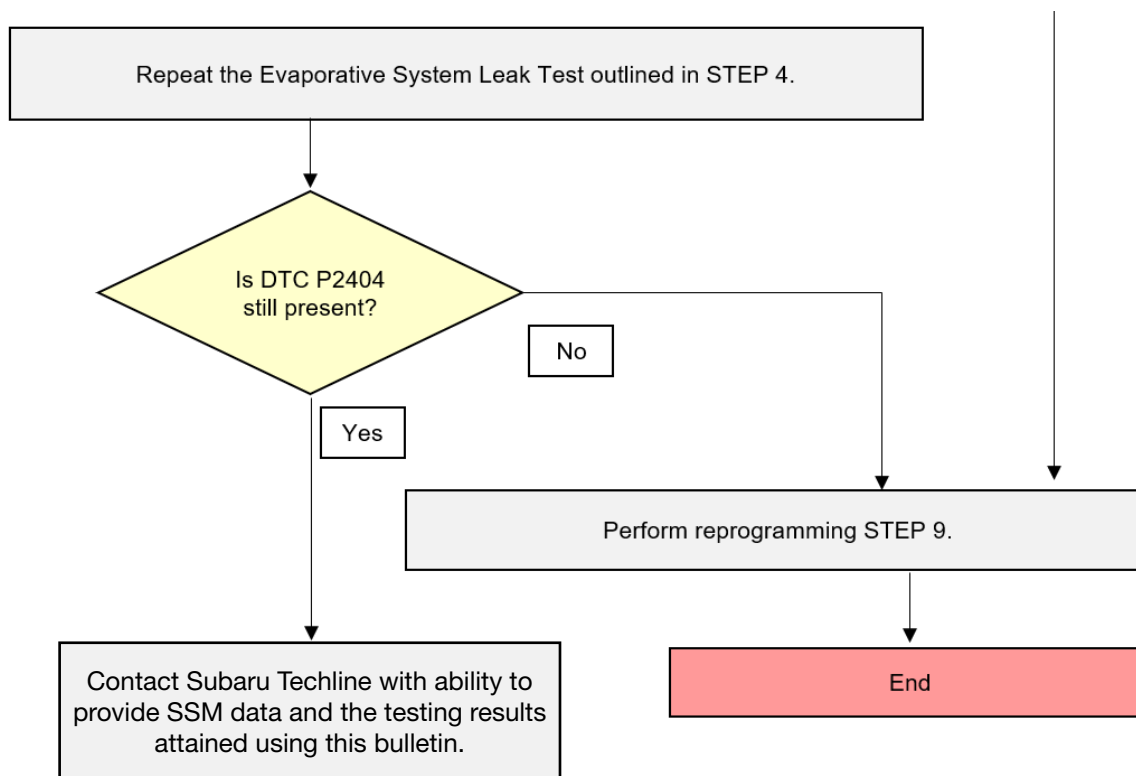
## SERVICE PROCEDURE FLOWCHART:

This bulletin announces the diagnostic procedures and availability of reprogramming files to rectify DTCs P2404 (Evap System Leak Detection Pump Sense Circuit Range/Performance) and P2109 (Throttle/Pedal Position Sensor “A” Minimum Stop Performance). P2404 is caused by the internal pump of the Evaporate Leak Check Module (ELCM) being temporarily stuck/seized. P2109 is caused by the throttle body becoming frozen in the closed position. If these DTCs are found stored within the ECM, follow the procedures outlined in this bulletin.

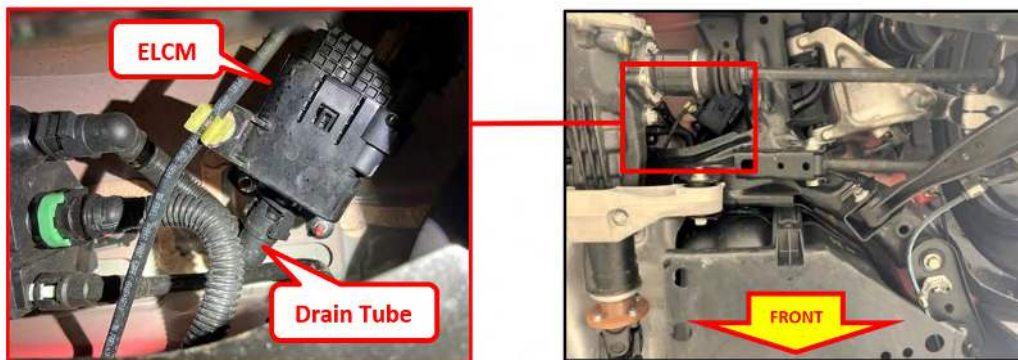
**STEP 3:** CAREFULLY disconnect the ELCM drain tube. Inspect for signs of water or oil.

Have signs of water or oil been detected within the ELCM drain tube?

**YES** – Clean and dry the drain tube using a non-alcohol base cleaner. Proceed to STEP 4.

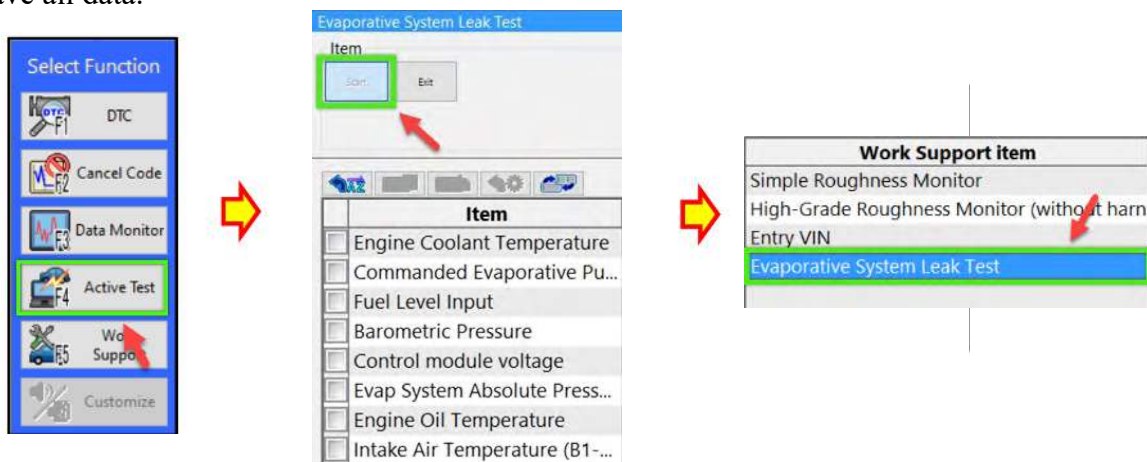
**STEP 4:** Connect the vehicle to a recommended power supply. See APPENDIX A for addition information regarding power supply. Using SSM, perform the Evaporative System Leak Test. Collect and save all data.

Once the evaporative system leak test is complete, check the DTCs and examine the vacuum value results. Record the value shown in the row labeled MID: \$3C, TID: \$C4, and Scaling ID: \$FE. This value should be lower than -0.26 PSI.

Value Must Be Lower Than -0.26 PSI

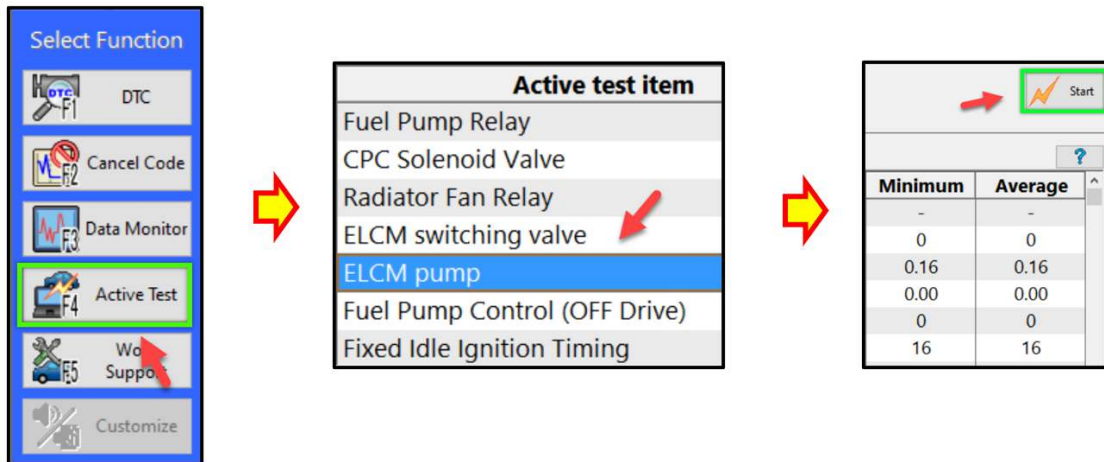
**STEP 6:** Using SSM, perform the ELCM Pump Active Test for a period of 35 minutes or more. See APPENDIX A for addition information regarding power supply.

Once the ELCM Pump Active Test has been performed for a period of 35 minutes or more, repeat the Evaporative System Leak Test outlined in STEP 4. Check the DTCs and the vacuum value results.

**STEP 8:** Replace the Evaporate Leak Check Module and repeat the Evaporative System Leak Test outlined in STEP 4. Check the DTCs and the vacuum value results.
