# Service Alert

IN-VEHICLE NETWORK MALFUNCTION AND MASTER WARNING  
LIGHT ON. DTC U3000:04 STORED (DOES NOT APPLY TO  
09-001/23)

Service Alert No.: SA-027/23

Last Issued : 06/13/2023

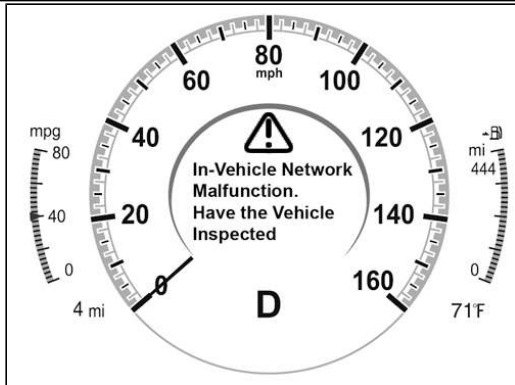
| In-Vehicle Network Malfunction error message | |
| Master Warning light ON. | |
| Connected Vehicle Reception Icon shows "X" | |

DTC U3000:04 (Telematics communication unit internal malfunction) stored.

5. Disconnect battery for 1 hour.

6. Connect battery.

8. Clear DTC.

9. Check TCU software version. Go to MGSS -> Infotainment/TCU -> [Telematics Control Unit \(TCU\) Updates](#). and update the [TCU software](#) if MGSS has a newer version available.
