## Technical product information

| <b>Topic</b> | DTC's B14BF01 and /or B14A854 evident in address 0009 - Steering column will not adjust |
| <b>Brand</b> | Bentley |
| <b>Transaction No.</b> | 2062095/3 |

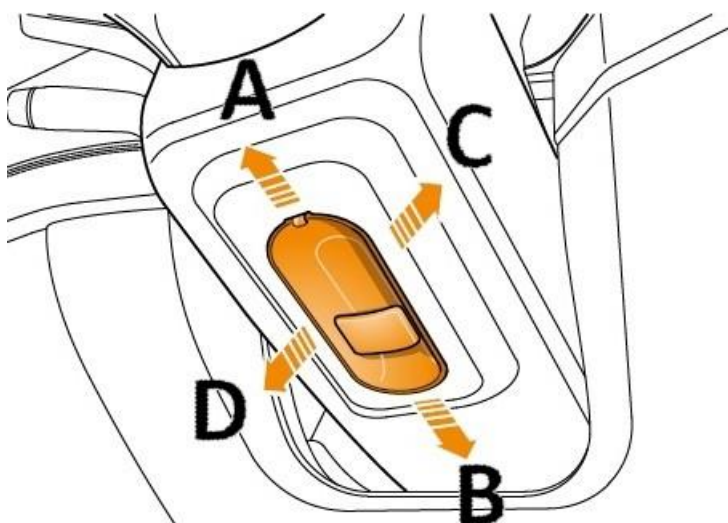
Steering column will not adjust in any direction

- B14BF01: Steering column vertical adjustment motor - Electrical
- B14A854: Power adjustable steering column control module - No basic setting

Referring to Figure 1 - Carry out the following switch tap sequence

- 3x Out (Point A)
- 1x In (Point B)
- 1x Out (Point A)
- 1x Up (Point C)
- 1x Down (Point D)

In the event that the afore mentioned process is not successful - Apply moderate force to dislodge the steering column from the actual position it is stuck in - For example:

- Column is stuck at it's highest position - Apply force downwards and press the 'Down' switch to attempt to release column from it's stuck position -
- Column is stuck at its lowest position – Apply force upwards
- Once complete - Check for steering column movement functions and clear all related DTC's
- Retest and monitor for the reoccurrence of DTC's
