| <b>Topic</b> | New Continental GT and GTC - Window drop glass |
| <b>Transaction No.</b> | 2070497/1 |

Retailer glass reset procedure for GT/GTC

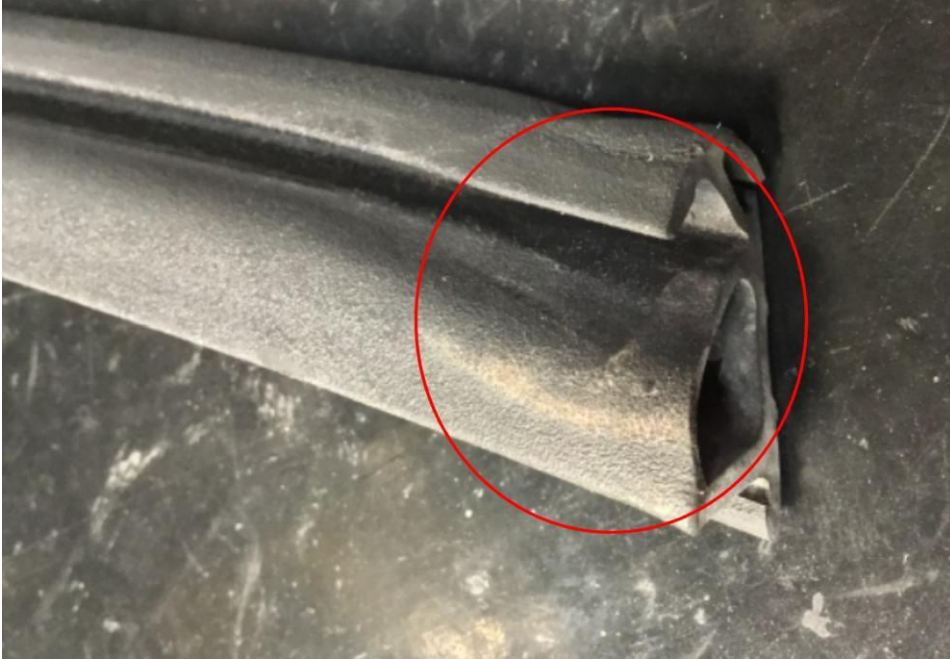
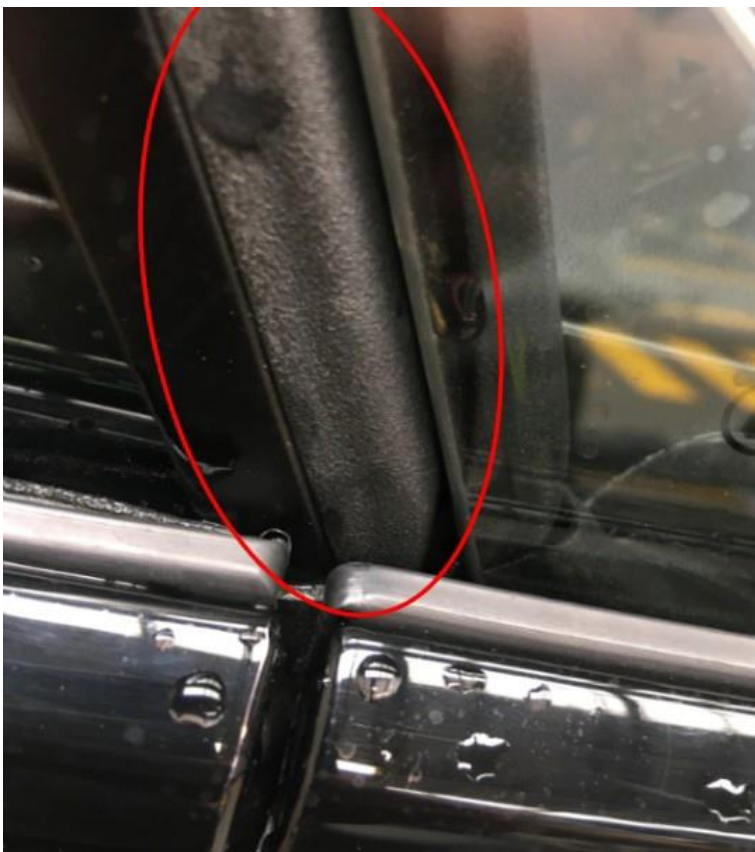
- Damage
- Splits
- Tears
- Misalignment
- Incorrectly fitted/located
- Drop glass seal deformation (see Figures 7 and 8 as examples)

NOTE: Any issues found with the window seals must be rectified before conducting the remaining steps
