# Service Bulletin

Bulletin No.: 23-NA-007

Subject: Black Radio Display Screen (Triangle and Camera with Slash Through it) with DTCs B1A62 82 and 86 Setting Current in Video Processing Module (VPM)

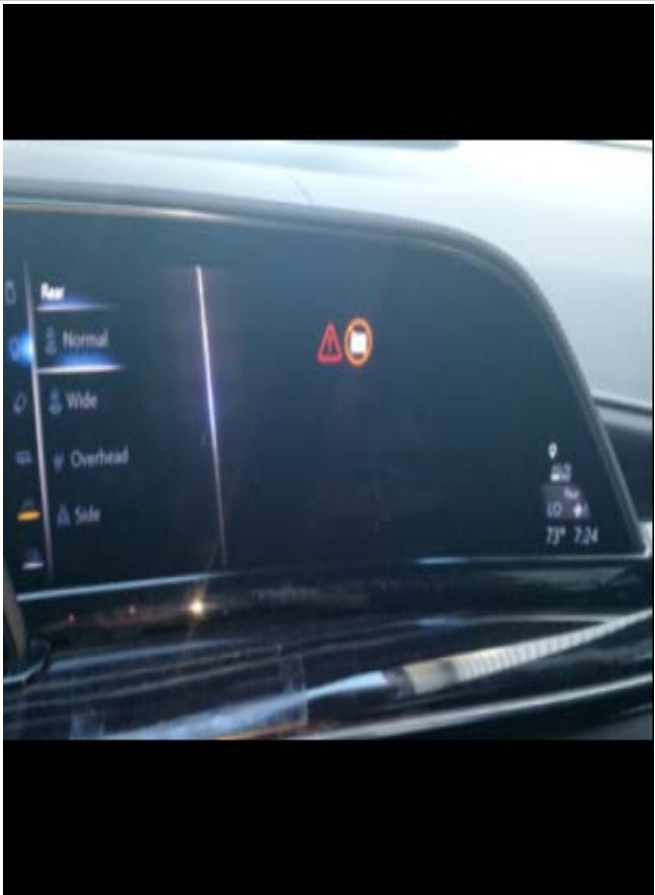
| Condition | Some customers may comment on a condition present on startup on the radio display where a black screen with a triangle and a camera with the slash through it is displayed. |

| <div>6259342</div> <p>Technicians may find two DTCs set current or in recent history:</p> <ul style="list-style-type: none"><li>" DTC B1A62 82</li><li>" DTC B1A62 86</li></ul> | |
| Cause | The cause of the condition may be software anomalies in the Video Processing Module (VPM). |

| Correction | Reprogram the VPM with the latest software released. |
