# Service Bulletin

Bulletin No.: 21-NA-005

**Subject:** Service Safety Restraint Message Displayed on the Driver Information Center (DIC), Airbag Malfunction Warning and Airbag Malfunction Indicator Lamp (MIL) Illuminated - DTC B0001-1B and/or B0002-1B Set or B0012-OD and/or B0013-OD Set

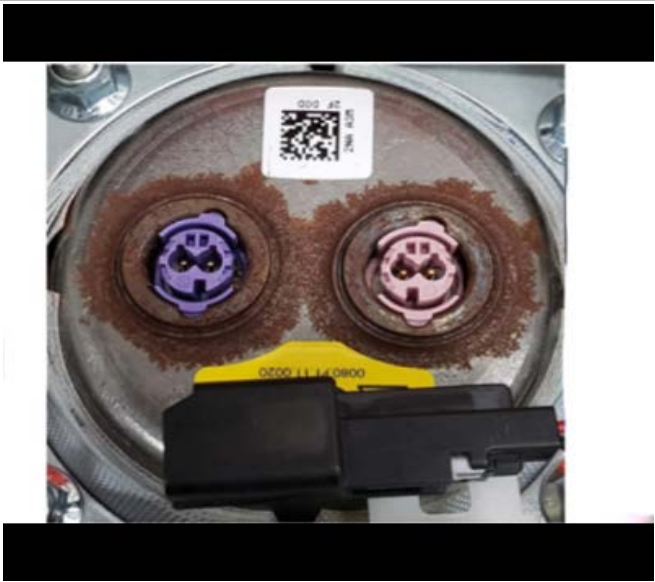
| Cause | <p style="text-align: right;">5704083</p> <p>Cause of condition may be rust particles, or other contaminants trapped within connection terminal interface causing excessive resistance seen in the airbag loops.</p> |

| Correction | In order to correct the condition, the following steps in the Service Procedure below must be followed to ensure proper root cause. |

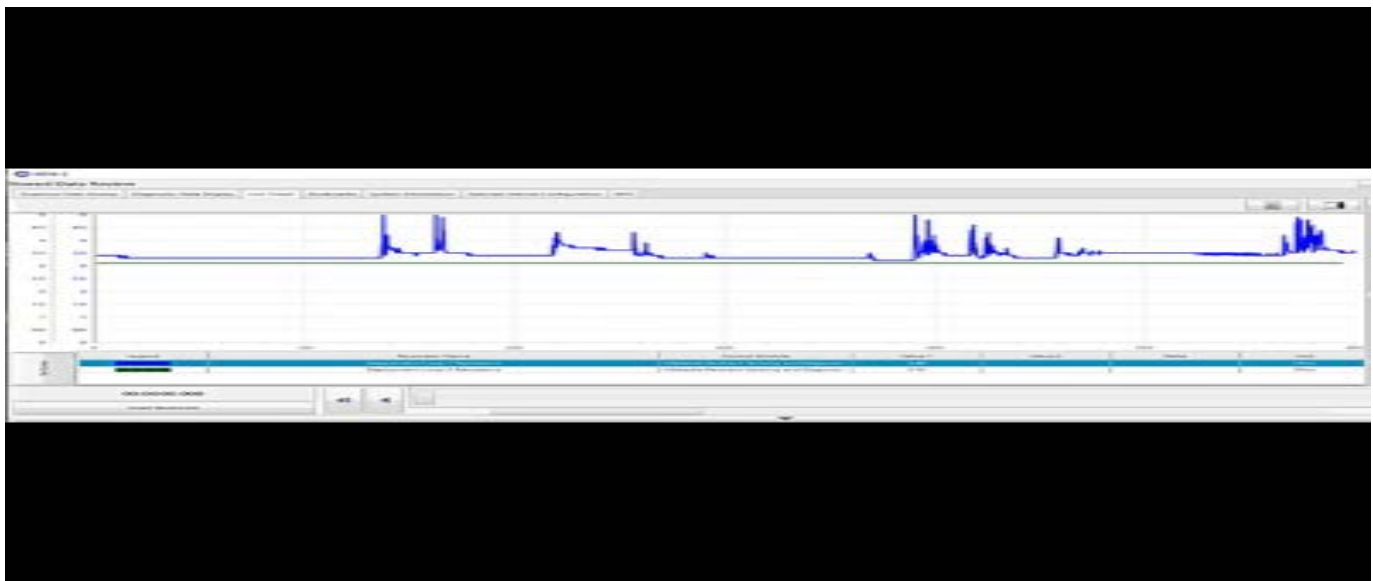
5972189

1. Use a MDI tool and plug it into the (ADL) to show a profile of the resistances.

2. Move the airbag cover both up and down, as well as left to right, to confirm if resistance spikes are observed:
  - If resistance spikes are seen. Replace the steering wheel airbag and steering wheel harness. Refer to Steering Wheel Airbag Replacement in SI.
