| <b>Topic</b> | Bentayga - Air suspension warning light within the DIP - DTC's P089200 - C104707 - C103B13 - Evident within Address 74 |
| <b>Transaction No.</b> | 2062261/5 |

Bentayga - Air suspension warning light within the DIP - DTC's P089200 - C104707 - C103B13 - Evident within Address 74

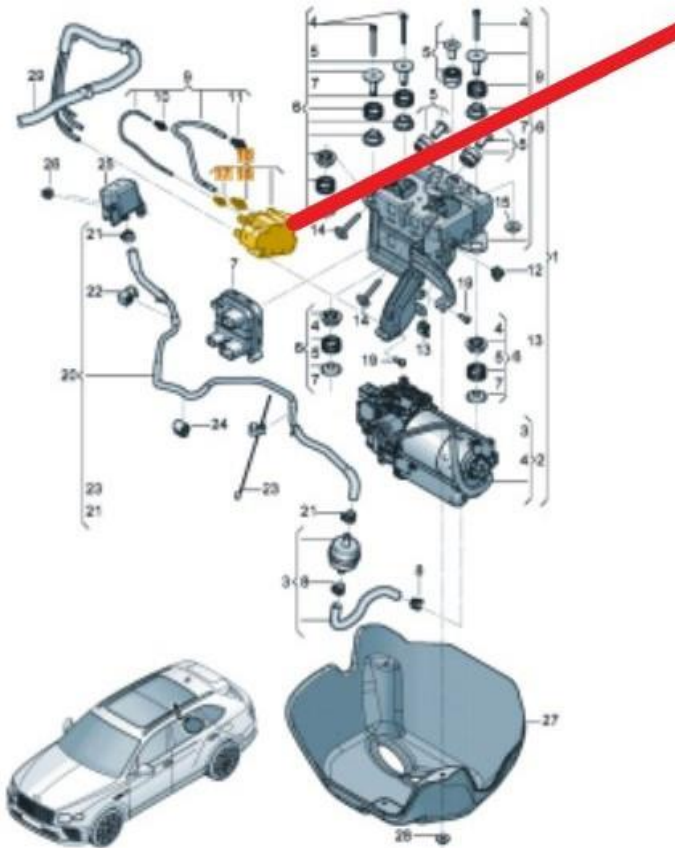
Figure 2

**Hint: The solenoid valve block can be replaced without the need to remove the air supply unit assembly from the vehicle**

- Check for water ingress within the air supply unit/valve block
- Check for water ingress within the air supply hoses
- Check the air filter is not blocked
- Should none of the afore mentioned issues be evident - Replace the solenoid valve block (Figure 2)
