# Technical product information

| Topic | Charging starts and stops when using a public charging unit |
| Brand | Bentley |
| Transaction No. | 2066502/2 |

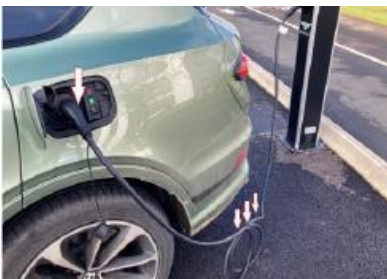
Referring to Figure 1 - Whilst charging the high voltage battery at a public charging unit and the vehicle is unlocked the charge socket locking pin retracts. The unsupported weight of the cable results in the cable relaxing within the charge socket, the charging issue is evident when the vehicle is locked, this is due to the locating pin being unable to lock into place resulting in the charging process being interrupted

If DTC logged is as shown within the Technical background section, the issue is likely to have occurred when the customer has used a public charging unit and cable. The issue can occur after the vehicle is unlocked, the weight of the public charging unit cable being used prevents a pin lock re-activation of the cable if the vehicle is then locked

5) Advise the customer that when using Public charging equipment, the charge cable should be supported until pin lock has been activated
