## Technical product information

| <b>Topic</b> | New Continental GT and GTC - Window drop glass |
| <b>Transaction No.</b> | 2070497/2 |

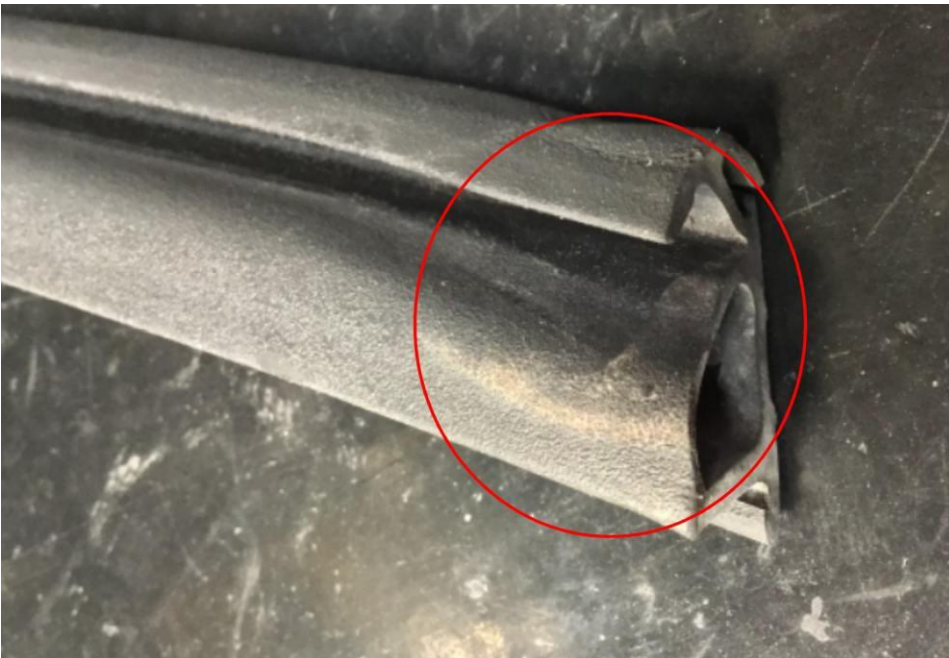
Figure 7

- Damage
- Splits
- Tears
- Misalignment
- Incorrectly fitted/located
- Drop glass seal deformation (see Figures 7 and 8 as examples)

NOTE: Any issues found with the window seals must be rectified before conducting the remaining steps

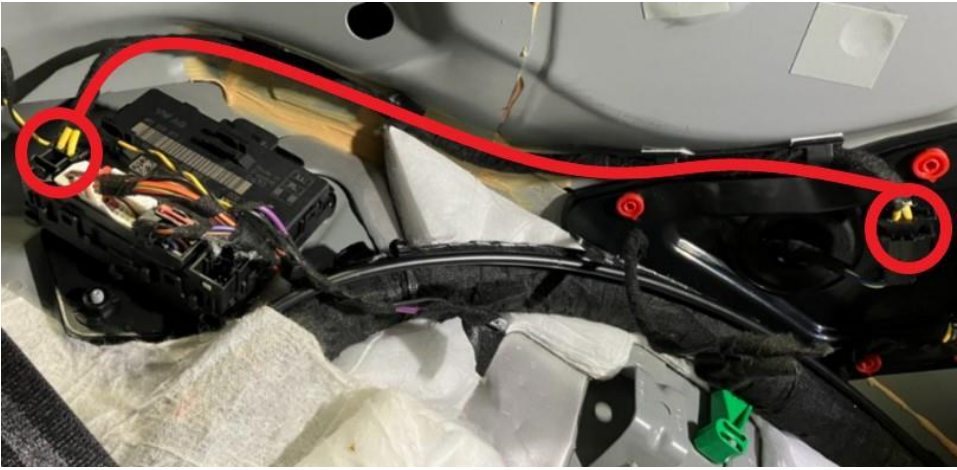
**B148729: Window regulator motor Range/Performance**

- Disconnect the original terminals from T6aq Pins 3 and 6 to T2jp Pins 1 and 2 respectively
- Once disconnected the terminals should be insulated with harness tape and suitably secured
- Referring to Figure 9 - Using 000 979 225E repair wires and (x2) 000 979 242E fit the new wires into T6aq Pins 3 and 6 to T2jp Pins 1 and 2 respectively
- Ensure the newly fitted wires are suitably insulated and secured away from the harness as shown in Figure 9
