# Technical Service Bulletin

## 01 MIL on, DTC P040100 is stored in the ECM - TDI

01 23 63 2064398/2 July 25, 2023. Supersedes Technical Service Bulletin Group 01 number 23-60 dated July 7, 2023 for reasons listed below.

| Model(s) | Year | VIN Range | Vehicle-Specific Equipment |
|---|---|---|---|
| A3 Sportback | 2010 - 2013 | Not Applicable | TDI |

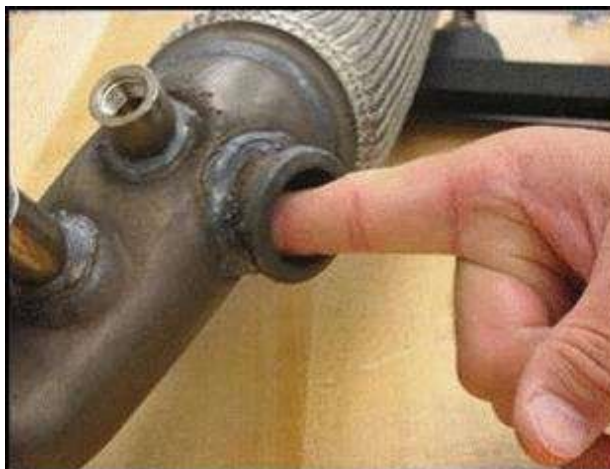
1. Remove the EGR filter from the Diesel Particulate Filter (DPF) and swipe the inside of the exhaust pipe at the EGR filter connection point using a clean cloth or your finger.

*Figure 1. Checking for carbon.*

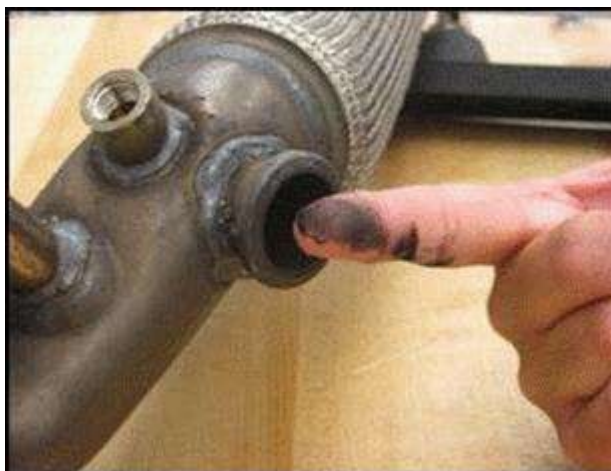
*Figure 2. Verifying that there is carbon.*

2. If your finger or the cloth comes out with black soot:
  - Replace the DPF & EGR filter together. **The engine must be running correctly with no faults stored to perform the next steps.**
  - Read out 01 ECM control module OBD Basic Settings block 67 with engine at idle and at operating temperature. Select activate and monitor field 3 when EGR is in OFF position.
  - If the MAF actual value is equal to or greater than 540 mg/h, proceed to smoke testing below (there is likely a leak within the intake system).
  - If the value is less than 540 mg/h, proceed to the inspection of the snow flap and air filter (TSB attachment). There is no need to smoke test.
  - Smoke test the charge air system for leaks if MAF value is 540 or great (see procedure below).

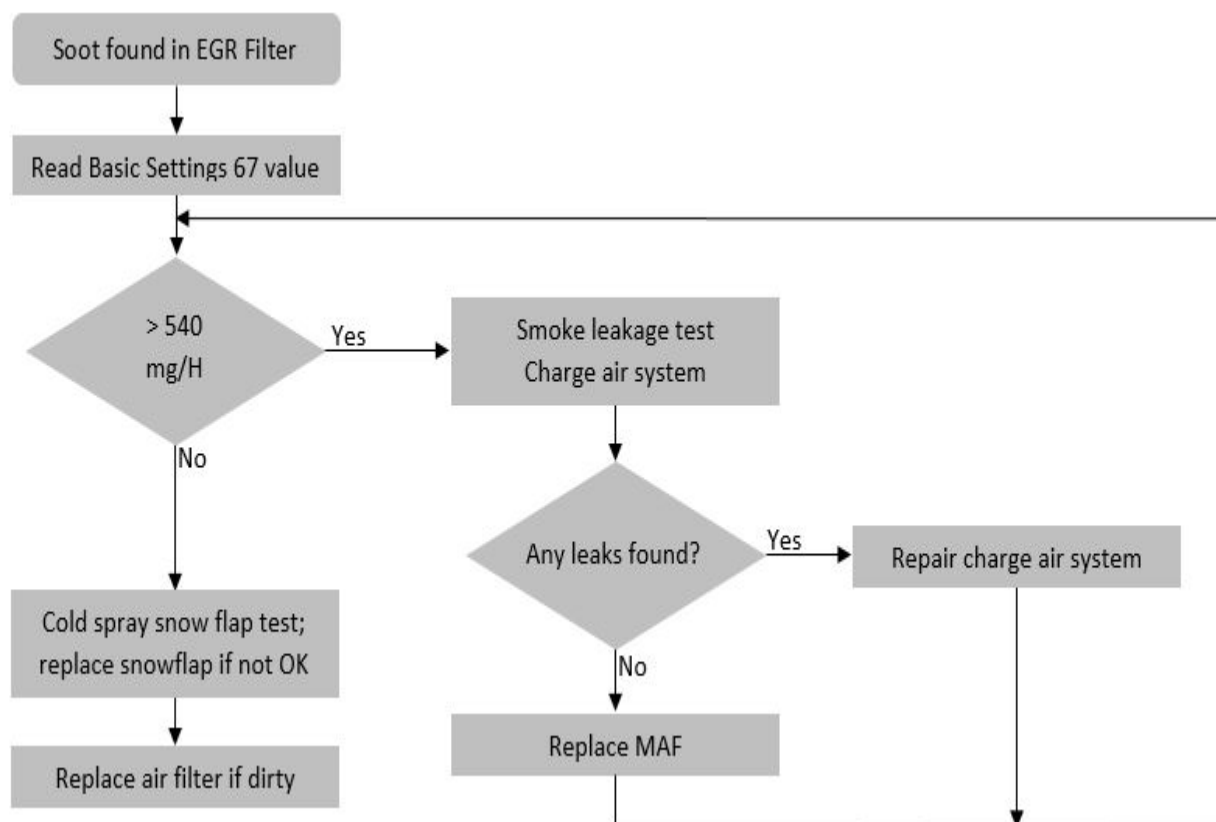
**Tip:** Proper intake airflow is essential for the longevity of the DPF. If a vehicle is found to have a damaged DPF, it is advised to inspect the condition of the intake air filter and verify resting position of the warm air valve (after the vehicle has cooled, see attachment). If the air filter is dirty, advise replacement.
