## Technical product information

| <b>Topic</b> | Bentley dynamic ride system warning displayed - DTC P0B2500: Hybrid/EV Battery "A" Voltage low' stored (48 volt system) |
| <b>Transaction No.</b> | 2068946/3 |

Bentley dynamic ride system warning displayed - DTC P0B2500: Hybrid/EV Battery "A" Voltage low' stored (48 volt system)

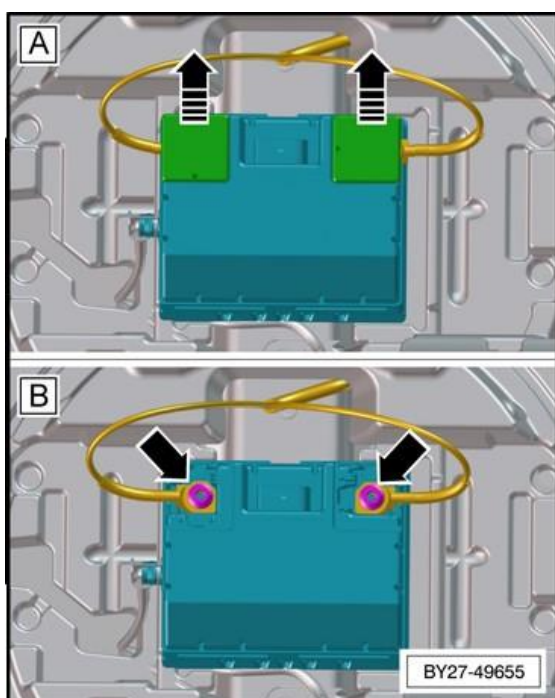
Figure 1

Possible internal fault with super capacitor

- Referring to Rep.Gr 27 - Deactivate the 48 volt system - Refer to 48 volt system - To activate and deactivate
- Referring to Rep.Gr 27 - Check the security of the super capacitor positive and negative terminals (Figure 1) as follows:
  - Remove the caps (A) from the terminals
  - Check the security of the positive and negative terminals
