| | Voluntary Emissions Service Campaign | 2023MY Sportage (NQ5a) |
| | SC268 | July 2023 |
| SUBJECT: FUEL FILLER NECK VENT COLLAR INSPECTION & REPLACEMENT (SC268) | | |

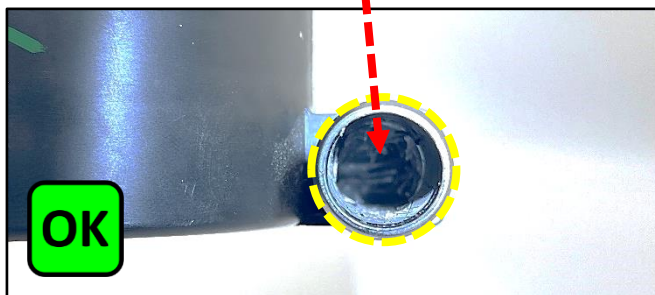
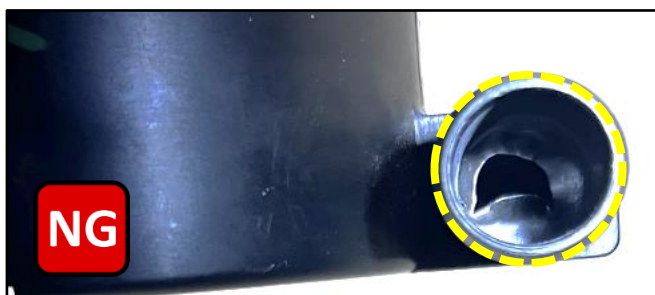
7. Using a flashlight, inspect the vent collar (F) vent port and confirm the following conditions:

- Vent collar port is not blocked (OK), then reinstall all removed parts in the reverse order of removal to complete this service action.
- Vent collar port is partially blocked (NG), then proceed the 'Repair Procedure' on page 4 to replace the vent collar.
