## Technical Service Bulletin (TSB)

### Flash: Powertrain Control Module (PCM) Updates

| REFERENCE: | TSB: 18-066-23<br>GROUP 18 - Vehicle Performance | Date: | May 24, 2023 | REVISION: | 18-101-22 REV. A |
| VEHICLES AFFECTED: | 2019 (DJ) RAM 2500 Pickup<br>2019 (D2) RAM 3500 Pickup<br>This bulletin applies to vehicles equipped with a 6.7L I6 Cummins Turbo Diesel Engine (Sales Code ETL) or a 6.7L I6 Cummins HO Turbo Diesel Engine (Sales Code ETM). | | | MARKET APPLICABILITY:<br><input checked="" type="checkbox"/> NA<br><input type="checkbox"/> SA<br><input type="checkbox"/> EE<br><input type="checkbox"/> MEA<br><input type="checkbox"/> IAP<br><input type="checkbox"/> CH | |

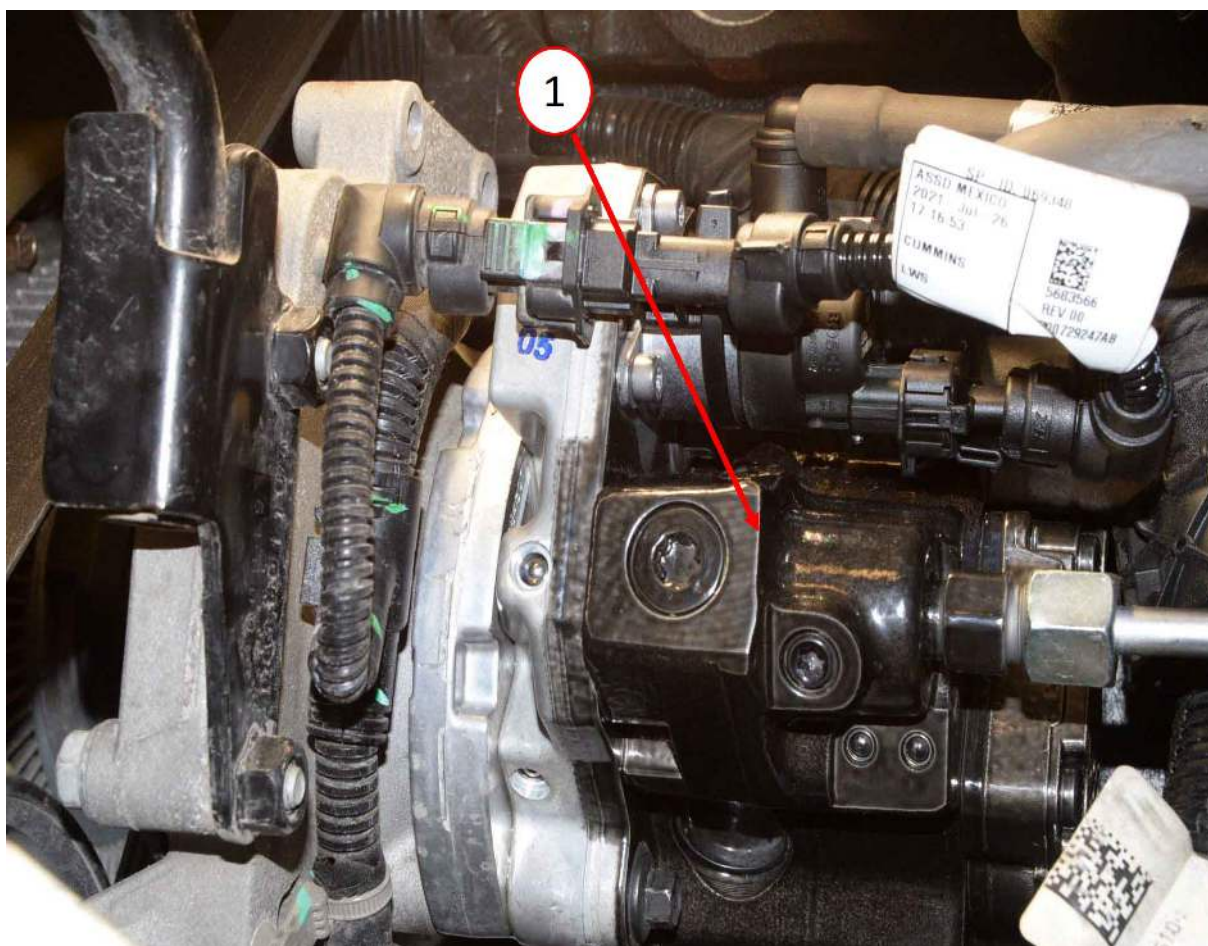
**Fig. 1**  
**CP3.3 Design Pump**

**NOTE:** The only calibration available will be for the updated CP3.3 design High-Pressure Fuel Injection Pump (Fig. 1) . Please ensure that recall Y78 has been completed first before proceeding with this update.

1. Inspect the High-Pressure Fuel Injection Pump to see which pump is currently installed on the vehicle (Fig. 1) . Also review the vehicle VIP report to see if campaign Y78 has been performed.

1 - CP3.3 Design Pump From Top View.

2. Does the VIP report indicate that Y78 has been performed, and is the vehicle equipped with the new design fuel injection pump released under the campaign?
  - YES>>> Proceed to [Step 1](#).
  - NO>>> Perform the Y78 campaign first. Once the campaign is performed, new pump installed and PCM updated, the PCM will have all of the updates listed in this document. This Bulletin does not apply.
