## STAR ONLINE PUBLICATION

**Case Number:** S2323000021 Rev. A

**Symptom/Vehicle Issue:** Clunk Noise From Front End Driving Between 15 And 35 MPH And When Decelerating. C0604- Active Air Dam Control Performance

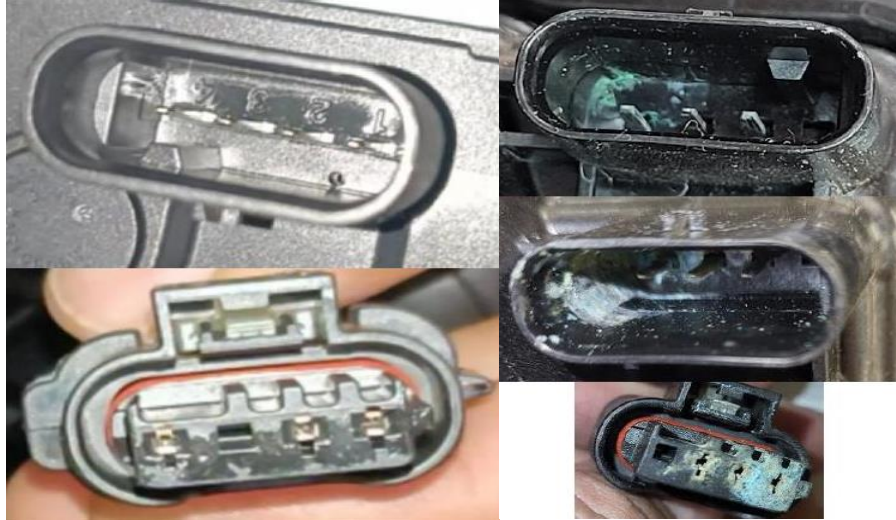
Dielectric grease or a wetness that could be described as an oily appearance in the active air dam connector is normal and should not cause a C0604 diagnostic trouble code (DTC). To verify whether the connector is contaminated with water from a damaged or rolled connector seal, use an UV black light to illuminate inside the connector. Dielectric grease will glow in appearance under a UV light (Fig 2). Water will not. Corrosion such as green or white oxidation material on the pins or inside the connectors will require connector and component replacement before continuing diagnosis (Fig 1).

Fig 1.  
Normal condition left. Corrosion on right.

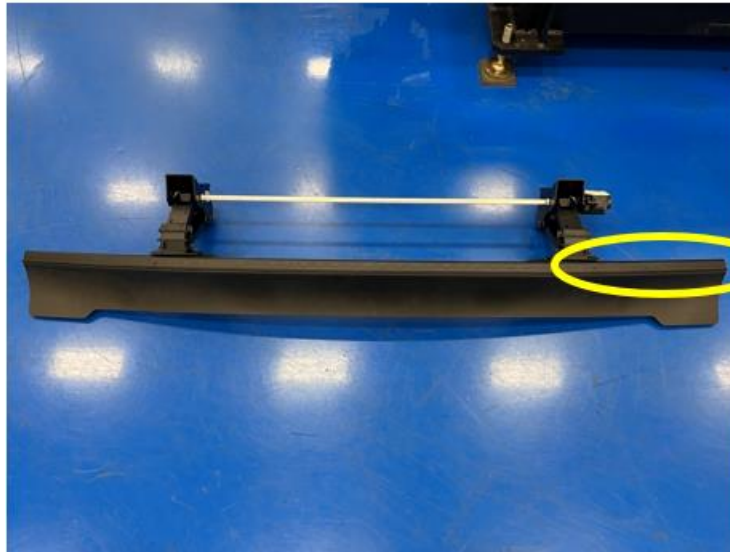
2. Clunk noise diagnosis. Check the active air dam blade front seal lip for witness marks (Fig 3) at the driver side fascia clip locations noted (Fig 4).

Fig 3  
Area to inspect for contact marks.

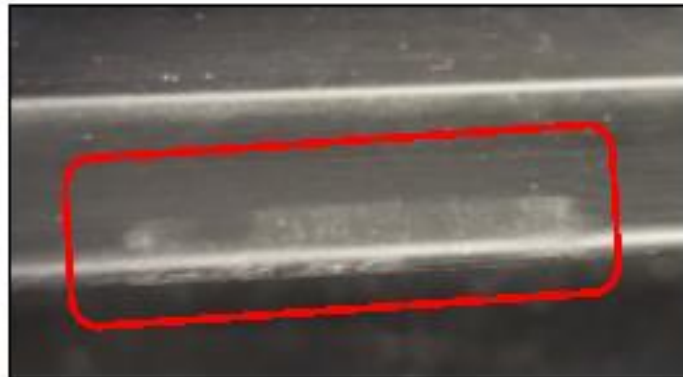
Fig 4  
Example of contact witness mark on the active air dam.

If the witness marks exist on the active air dam follow the below steps to trim the lip.
