## Technical Service Bulletin

| <b>CAMPAIGN</b> | <b>23-01-060H</b> |
| <b>JULY 2023</b> | <b>IONIQ 5 (NE1)</b><br><b>IONIQ 6 (CE1)</b> |

**SUBJECT:** DTC P1A9096 CHECK FOR ICCU & FUSE REPLACEMENT  
AND ICCU SOFTWARE UPDATE (SERVICE CAMPAIGN 997)

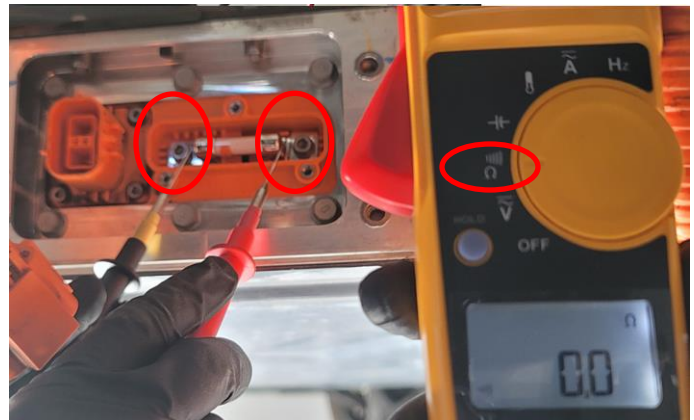
E6. Using a commonly available multimeter. Set at the ohmmeter measuring mode and inspect the fuse condition by checking the fuse's resistance value:

- **Fuse is Good:** Less than 1.0 ohm.

**DO NOT REPLACE THE FUSE.**  
**Do not follow the remaining steps to replace the fuse.**

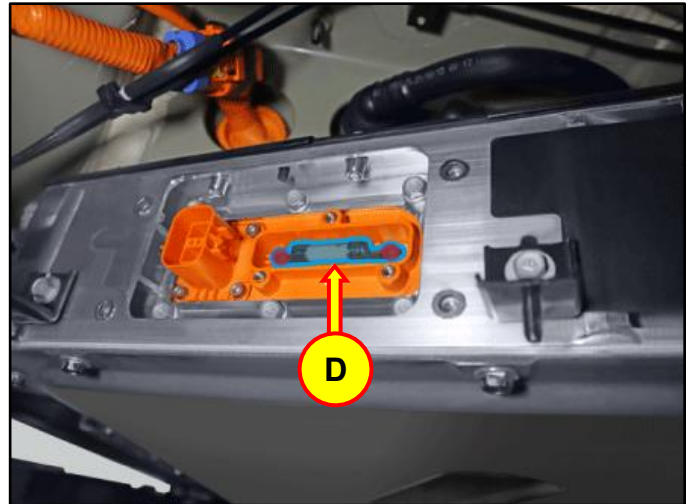
E7. Remove the ICCU fuse (D).

**There can be difficulty removing the fuse, which may include the nuts of the at the back of the fuse holder falling back into the battery.**

**Avoid using power driver to remove and install the bolts. Use a hand tool only.**

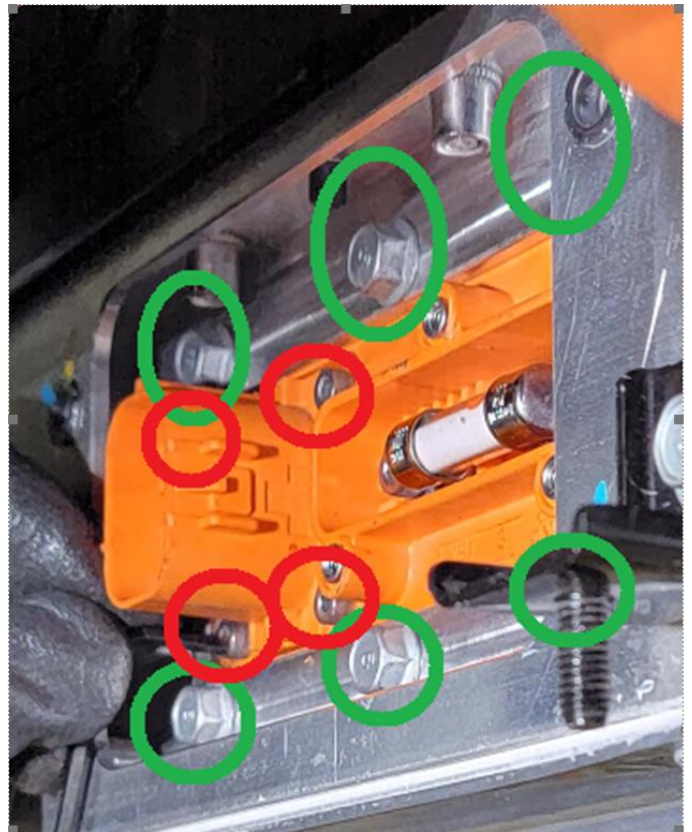
**SPECIAL INSTRUCTION: Only applies when ICCU Fuse rear nut(s) falls back into the battery.**

1. Remove:
  - 6 qty. 10mm bolts (Green marked),
  - 4 qty. bolts by Allen wrench (Red marked).
2. Push in bottom area. Pull out top area.
3. Reach in and grab the nut behind the plate on the bottom surface.
4. Hold the nut at the back side.
5. Install the fuse bolt at the place that the nut had dropped.
6. Install all the other bolts in reverse order of removal.
7. Install the rest of the fuse bolts.

**NOTE:** Contact Techline if the above procedure did not resolve a dropped nut problem.
