## SERVICE BULLETIN

**APPLICABILITY:** 2015MY Legacy & Outback

**NUMBER:** 09-103-23

**SUBJECT:** DTC P2404 / Reprogramming Files

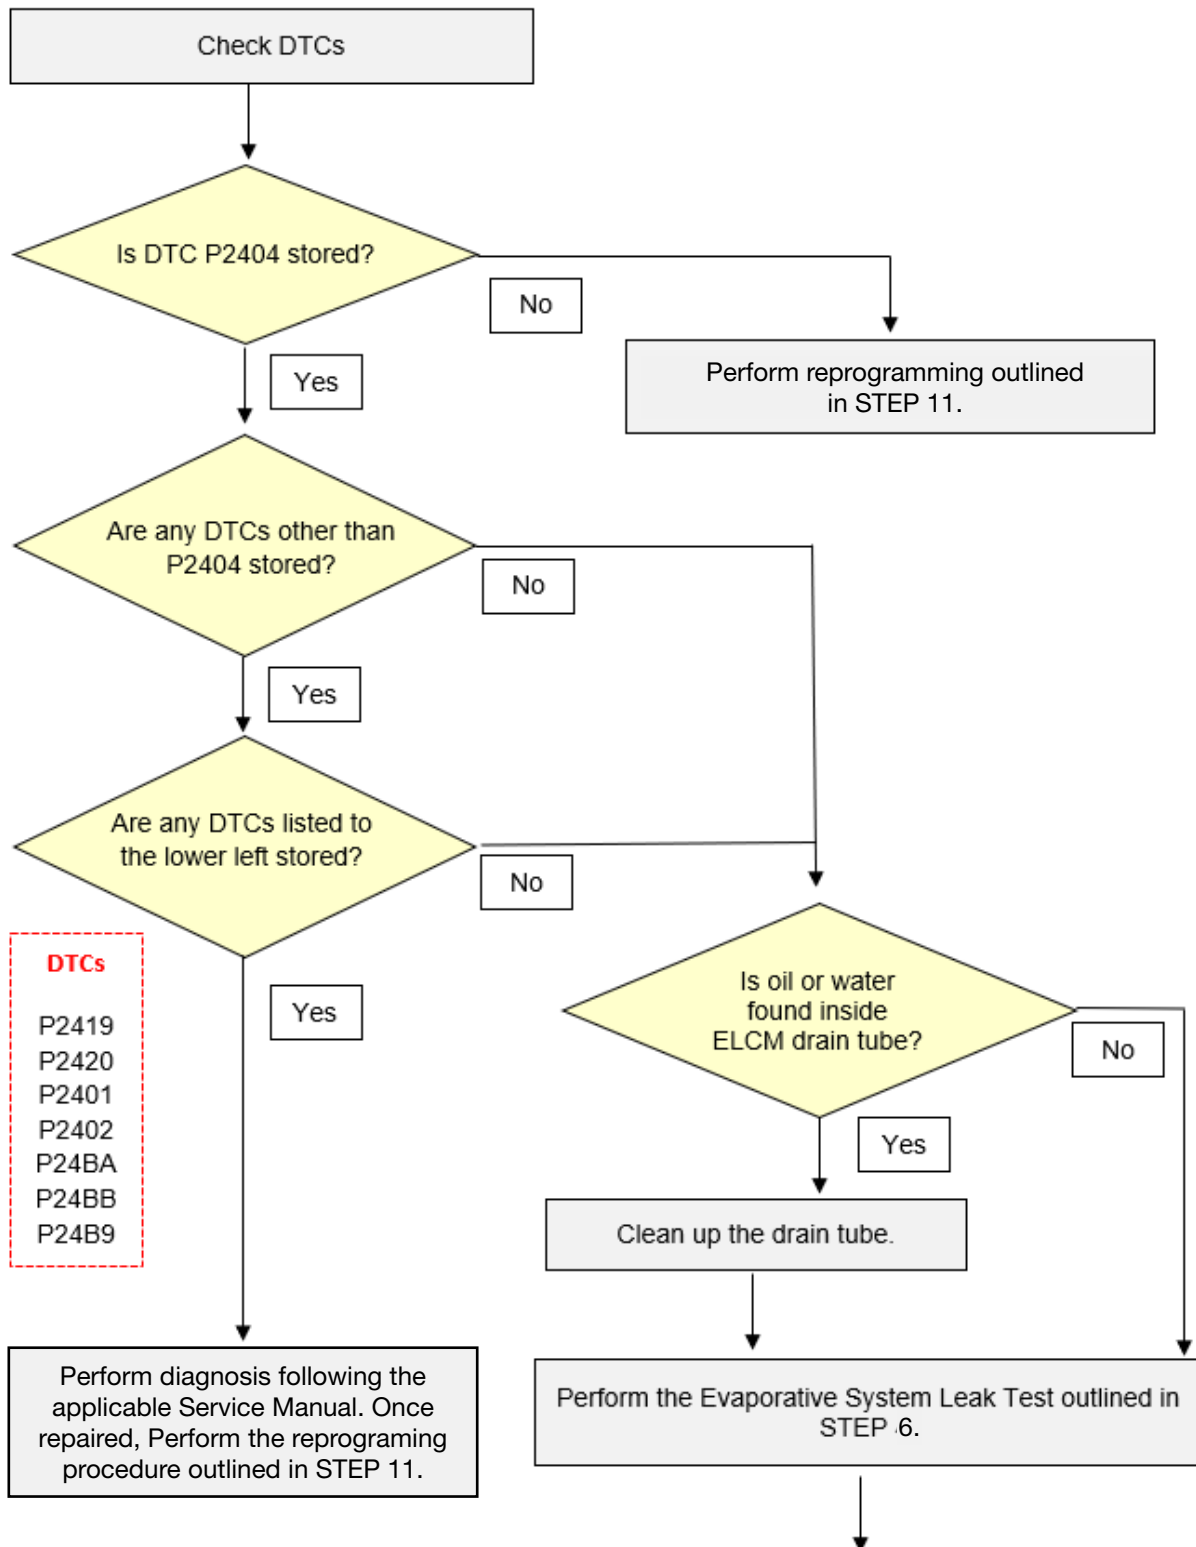
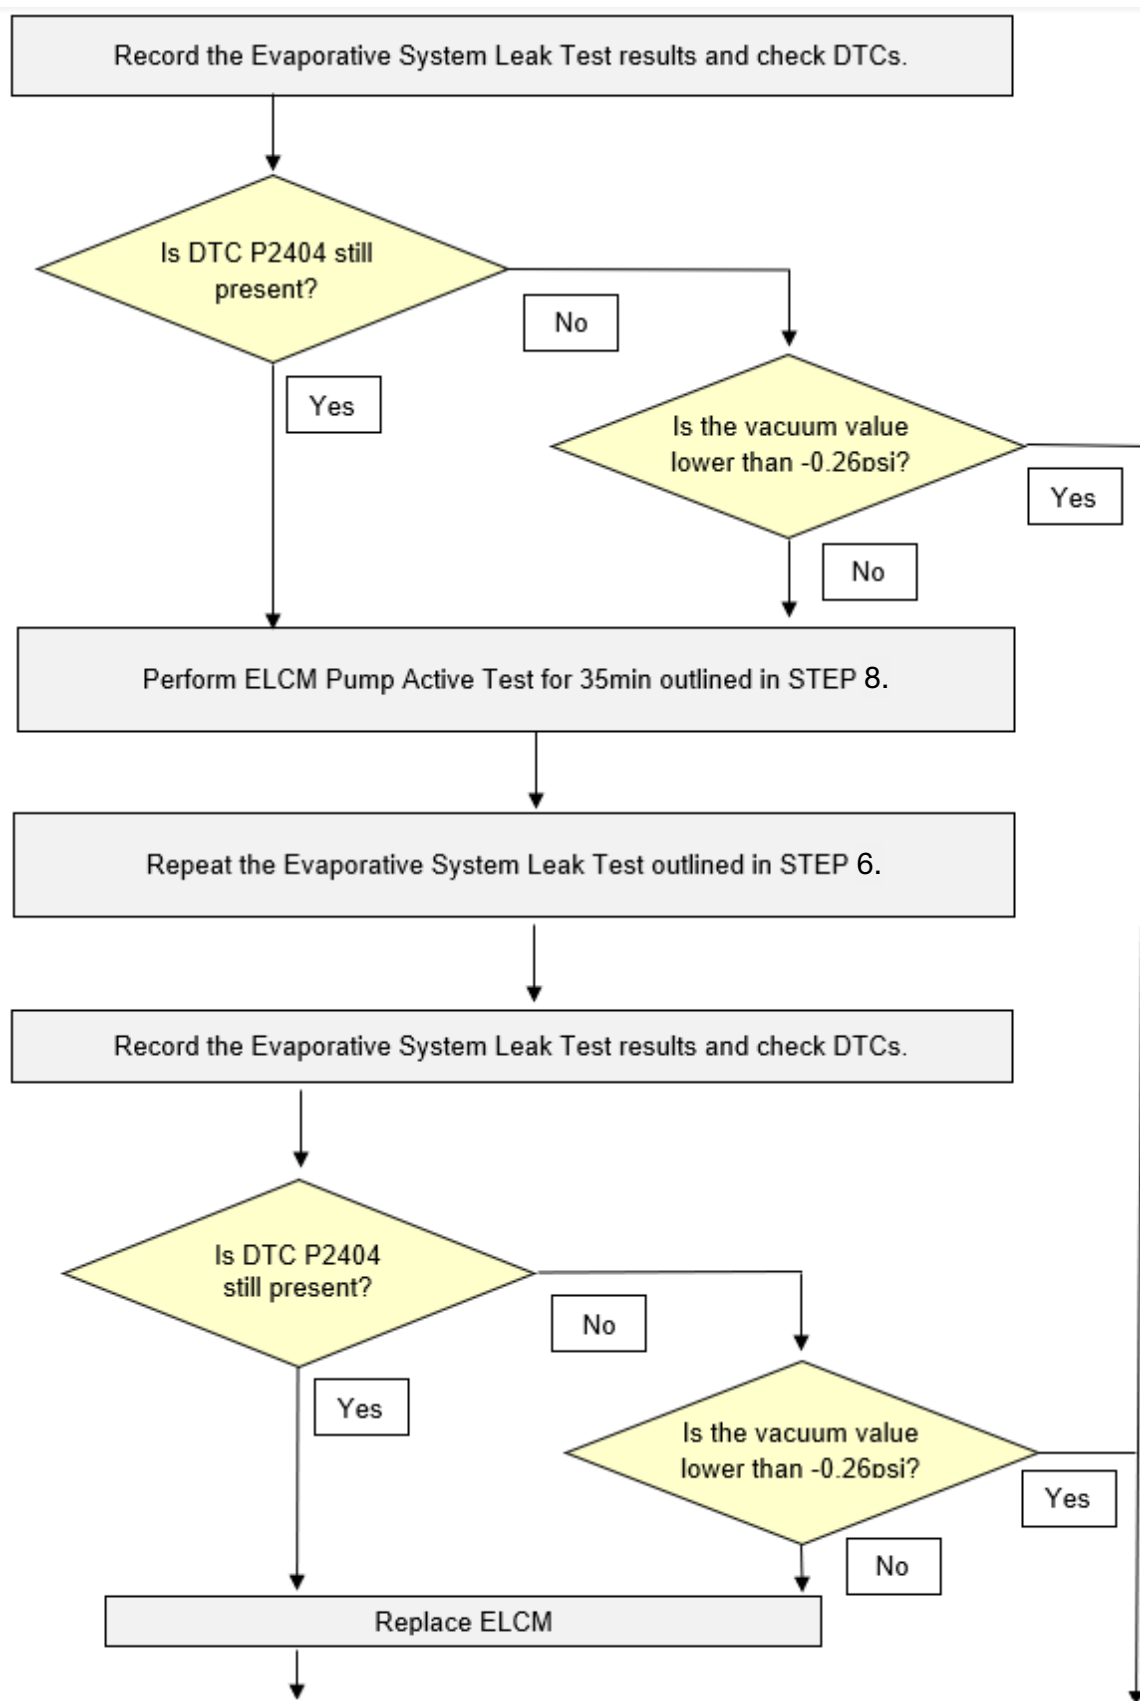
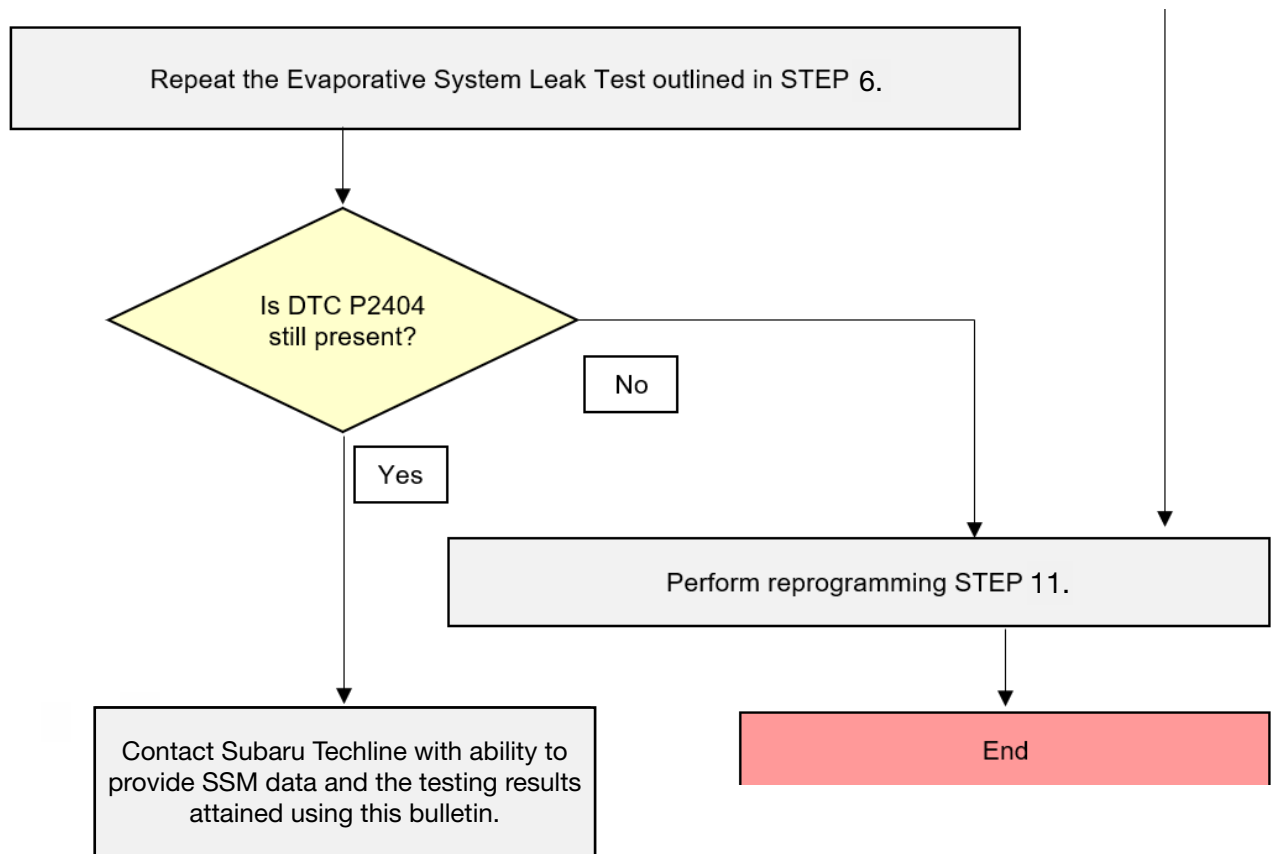
## SERVICE PROCEDURE FLOWCHART:

This bulletin announces diagnostic procedures and availability of new Engine Control Module (ECM) reprogramming files to address DTC P2404 (Evap System Leak Detection Pump Sensor Circuit Range/Performance) detection. In rare cases, the internal pump for the Evaporative Leak Check Module (ELCM) system can seize temporarily. The new files contain enhanced logic to prevent the ELCM pump from seizing temporarily. If P2404 is found stored in the fault memory, follow the procedures outlined below.

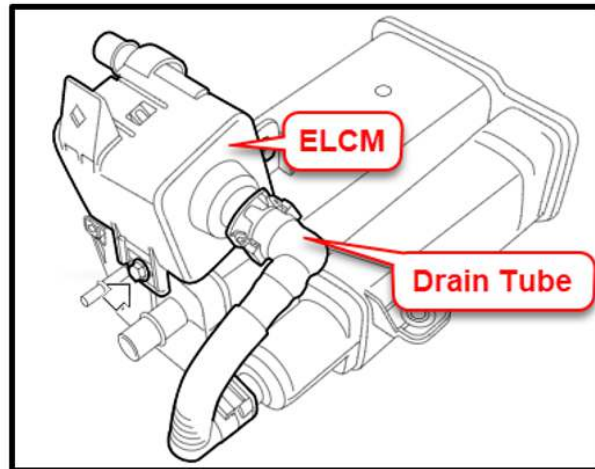
**STEP 5:** **CAREFULLY** disconnect the ELCM drain tube. Inspect for signs of water or oil.

Have signs of water or oil been detected withing the ELCM drain tube?

**YES** – Clean and dry the drain tube using a non-alcohol base cleaner. Proceed to STEP 6.

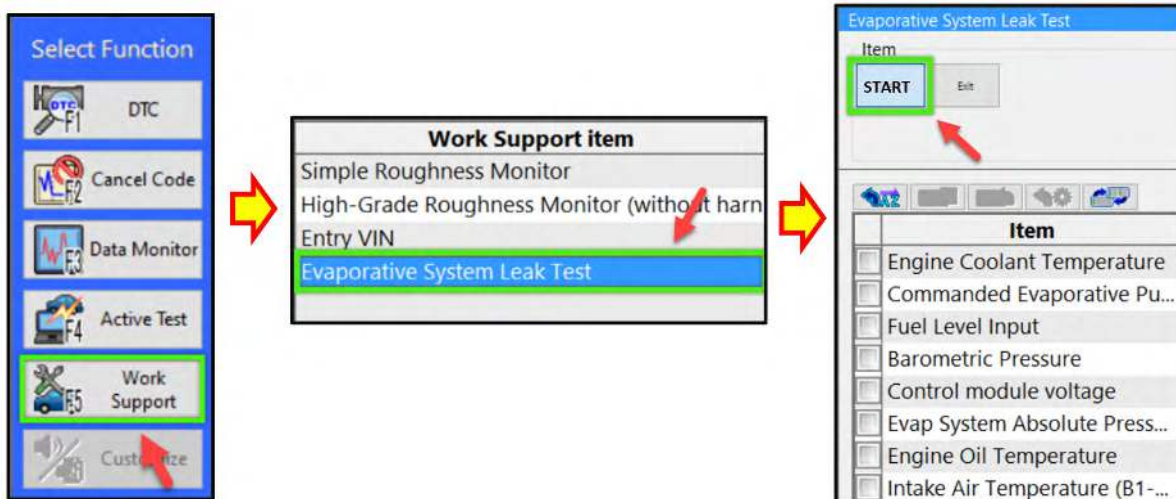
**STEP 6:** Connect the vehicle to a recommended power supply. See **APPENDIX A** for addition information regarding power supply. Using SSM, perform the Evaporative System Leak Test. Collect and save all data.

Once the evaporative system leak test is complete, check the DTCs and examine the vacuum value results. Record the value shown in the row labeled MID: \$3C, TID: \$C4, and Scaling ID: \$FE. This value should be lower than -0.26 PSI.

Value Must Be Lower  
Than -0.26 PSI

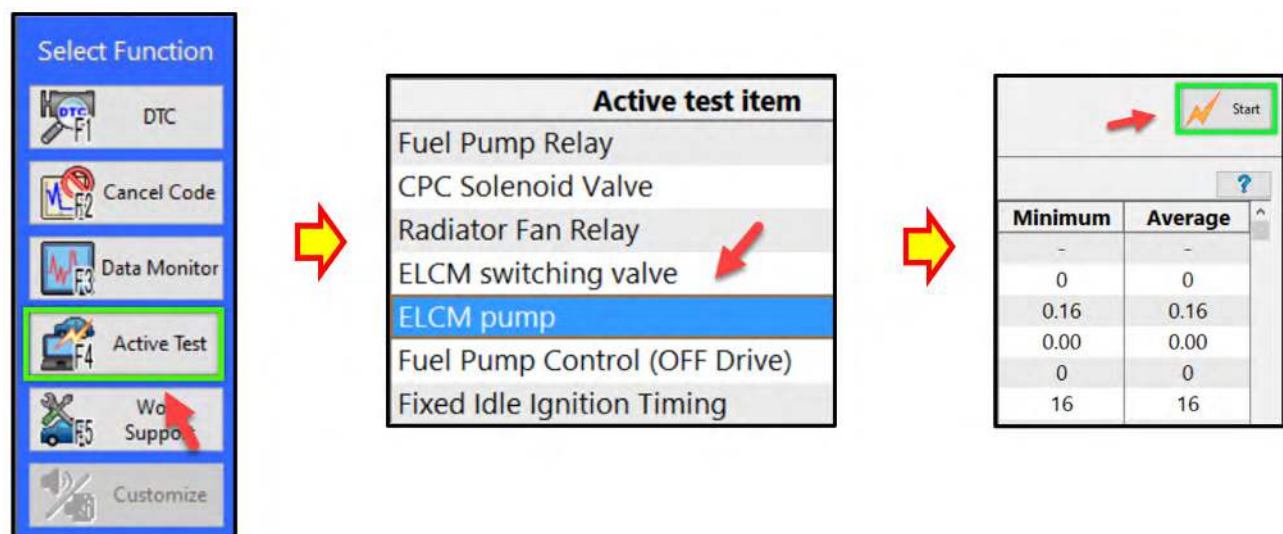
**STEP 8:** Using SSM, perform the ELCM Pump Active Test for a period of 35 minutes or more. See **APPENDIX A** for addition information regarding power supply.

Once the ELCM Pump Active Test has been performed for a period of 35 minutes or more, repeat the Evaporative System Leak Test outlined in STEP 6. Check the DTCs and the vacuum value results.

**STEP 10:** Replace the Evaporate Leak Check Module and repeat the Evaporative System Leak Test outlined in STEP 6. Check the DTCs and the vacuum value results.
