## SERVICE BULLETIN

**APPLICABILITY:** 2016-19MY Legacy & Outback

**NUMBER:** 09-109-23

**SUBJECT:** DTC P2404 / Reprogramming Files

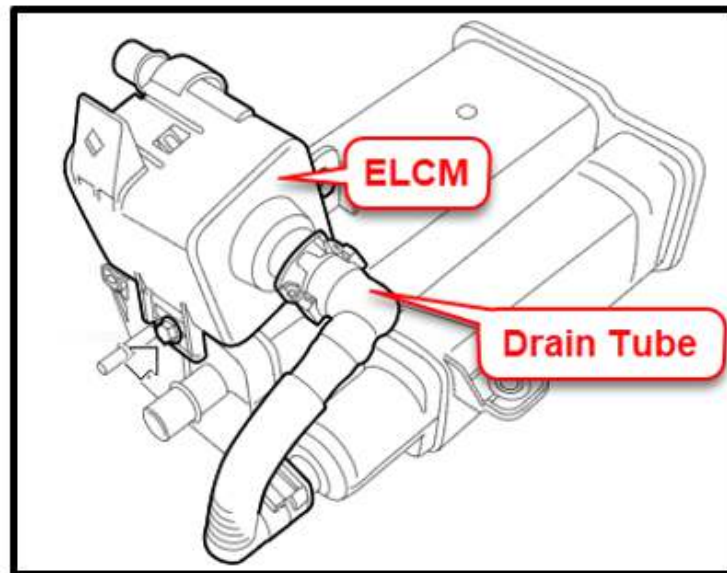
**STEP 5:** CAREFULLY disconnect the ELCM drain tube. Inspect for signs of water or oil.

Have signs of water or oil been detected withing the ELCM drain tube?

**YES** – Clean and dry the drain tube using a non-alcohol base cleaner. Proceed to STEP 6.

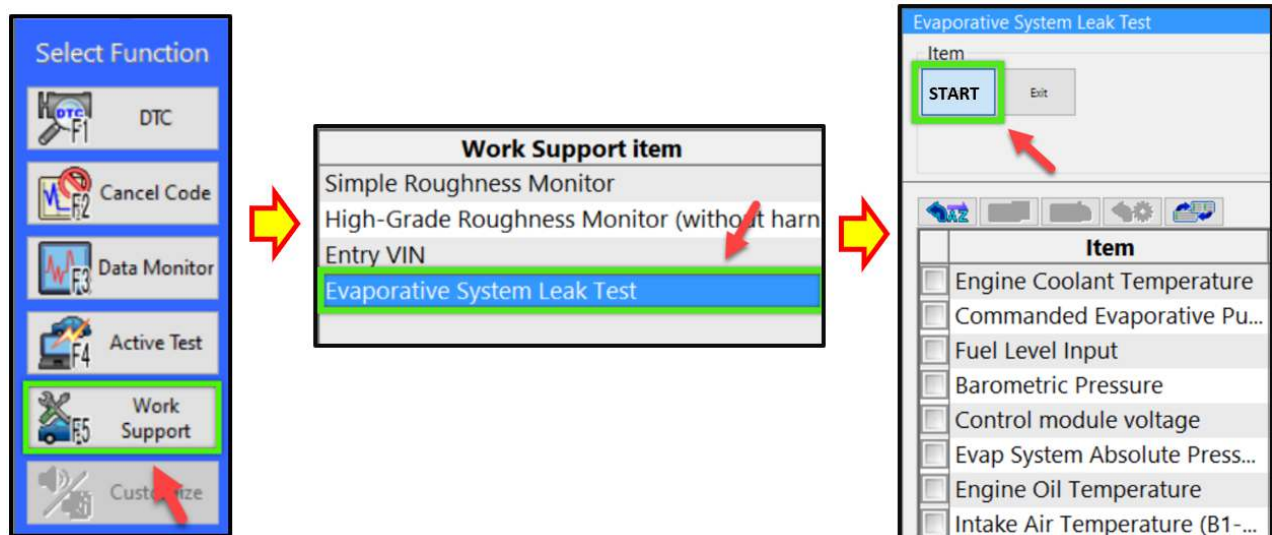
**STEP 6:** Connect the vehicle to a recommended power supply. See **APPENDIX A** for addition information regarding power supply. Using SSM, perform the Evaporative System Leak Test. Collect and save all data.

Once the evaporative system leak test is complete, check the DTCs and examine the vacuum value results. Record the value shown in the row labeled MID: \$3C, TID: \$C4, and Scaling ID: \$FE. This value should be lower than -0.26 PSI.

Value Must Be Lower  
Than -0.26 PSI

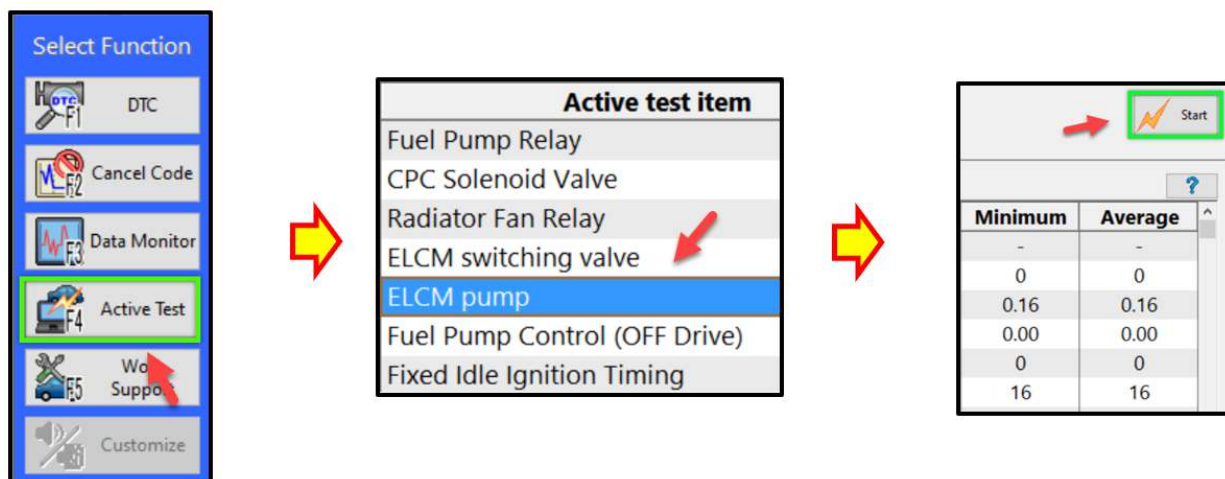
**STEP 8:** Using SSM, perform the ELCM Pump Active Test for a period of 35 minutes or more. See **APPENDIX A** for addition information regarding power supply.

Once the ELCM Pump Active Test has been performed for a period of 35 minutes or more, repeat the Evaporative System Leak Test outlined in STEP 6. Check the DTCs and the vacuum value results.
