# Technical Service Bulletin

## 91 No diagnostics communication to the telematics control module (ConBox); DTC U142100

91 23 15 2070942/1 July 19, 2023.

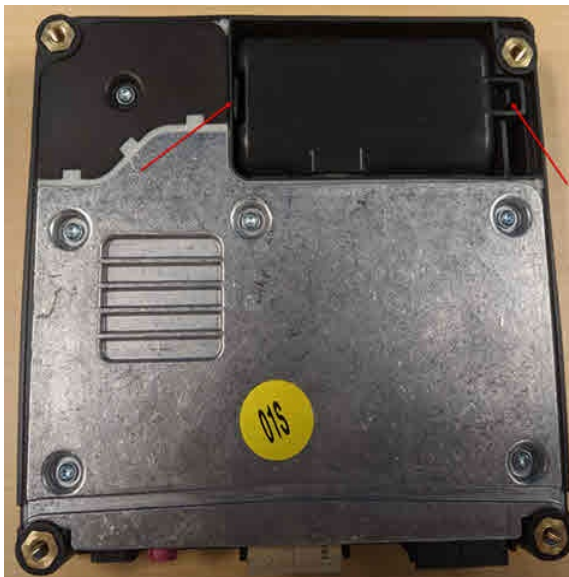
**Figure 2.** Backup battery compartment location.

2. Open the battery compartment of the control module for the emergency call module and communication unit, J949 (address word 0075), and disconnect the backup battery (Figures 2 - 3).

5. Wait approximately one minute, then reinstall the backup battery back into the control module for the emergency call module and communication unit, -J949- (address word 0075).
6. Reinstall the control module for the emergency call module and communication unit, -J949- (address word 0075) back into the vehicle.
7. If ODIS **still cannot** connect to the control module for the emergency call module and communication unit, - J949- (address word 0075), then follow the ODIS test plan and replace the control module for the emergency call module and communication unit with the part specified in ETKA.

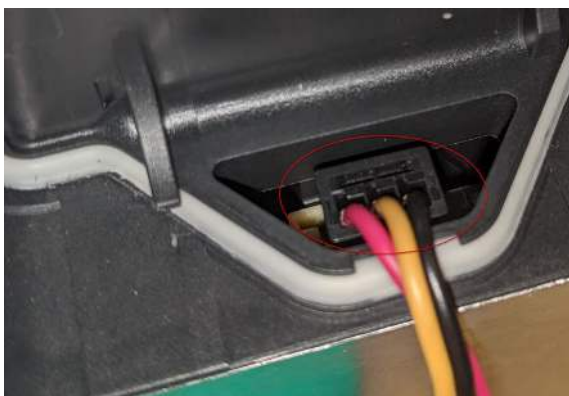
**Figure 3.** Backup battery connector (no release mechanism).
