## Technical product information

| <b>Topic</b> | HVAC not working – No air flow - DTC B10AE31 High Pressure sensor - No signal DTC logged within address 08 |
| <b>Brand</b> | Bentley |
| <b>Transaction No.</b> | 2067429/3 |

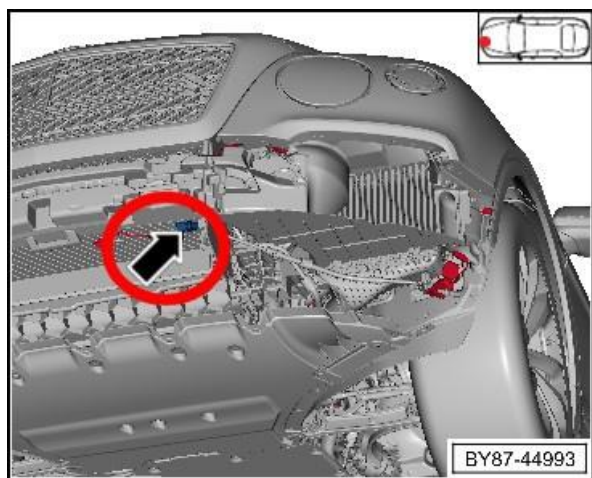
Figure 1

- HVAC not working to specification (No air flow)
- DTC B10AE31 High Pressure sensor - No signal DTC logged within address 08

- Gain access to High pressure sensor G65 (Figure 1)

- Replace G65 and associated parts (See parts information section)
- Refit all previously removed components
- Referring to Rep.Gr 87 - Charge the refrigeration system
