## Technical Service Bulletin (TSB)

### Transmission Harness Wiring Rubbing Against PCM Sharp Edge

| REFERENCE: | TSB: 08-141-23<br>GROUP 08 - Electrical | Date: | June 10, 2023 | REVISION: | – |
| VEHICLES AFFECTED: | 2023 (MP) Jeep Compass<br>This bulletin applies to vehicles built on and after January 12, 2023 (MDH 0112XX) and on and before April 10, 2023 (MDH 0410XX) equipped with the 2.0L I4 DOHC DI Turbo Engine W/ESS (Sales Code EC1) and Eight Speed Automatic 8F30 Transmission (Sales Code DGD). | | | MARKET APPLICABILITY:<br><div><input checked="" type="checkbox"/> NA<input type="checkbox"/> CH</div> <div><input type="checkbox"/> EE<input type="checkbox"/> IAP</div> <div><input type="checkbox"/> SA<input type="checkbox"/> MEA</div> | |

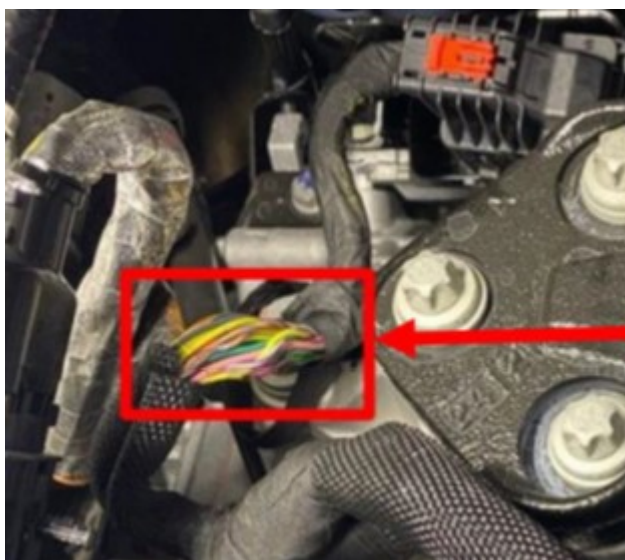
**Fig. 1**  
**TCM Harness**

| CAUSE: | Transmission harness possible damaged and/or wiring severed at the Powertrain Control Module (PCM). | | | | |

3. Are there any damaged or severed wires in the harness (Fig. 1) ?
  - YES>>> Proceed to [Step 1](#) of the Repair Procedure.
  - NO>>> Proceed to [Step 4](#) of the Inspection Procedure.

1. Repair the TCM wiring harness. Refer to the detailed service procedures listed in DealerCONNECT>Service Library under: 28 - DTC-Based Diagnostics / Circuit Testing Procedures / Standard Procedure/Wire Splicing.
2. Install two pieces of foil backed sealing tape onto the edge of the PCM where the harness crosses over (Fig. 2) .
3. Install the PCM. Refer to the detailed service procedures listed in DealerCONNECT under: 08 - Electrical / 8E - Electronic Control Modules / Module, Powertrain Control (PCM) / Installation.
