## Technical Service Bulletin (TSB) Diagnostic Trouble Code (DTC) P1CEA

| REFERENCE: | TSB: 25-002-23<br>GROUP 25 - Emissions Control | Date: | June 15, 2023 | REVISION: | – |
| VEHICLES AFFECTED: | 2022 - 2023 (WL) Jeep Grand Cherokee<br>This bulletin applies to vehicles built on or before January 31, 2023 (MDH 0131XX) equipped with 2.0L I4 DOHC DI Turbo PHEV Engine (Sales Code ECX). | | | MARKET APPLICABILITY:<br><div><input checked="" type="checkbox"/> NA<input checked="" type="checkbox"/> IAP<br/><input type="checkbox"/> EE<input type="checkbox"/> MEA<br/><input type="checkbox"/> SA<input type="checkbox"/> CH</div> | |

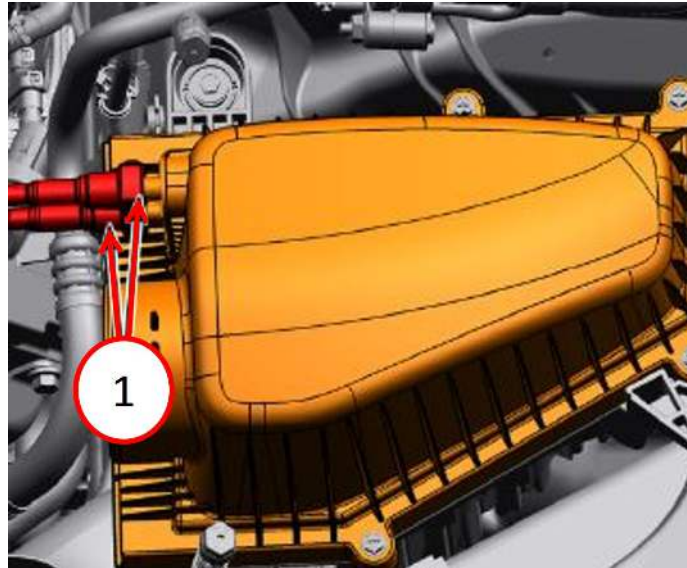
**Fig. 1****Two EVAP Line Quick Connects At The Air Cleaner Cover**

| CAUSE: | EVAP vacuum lines not fully secured. | | | | |

1 - Two EVAP Line Quick Connects

1. Open the hood.
2. Inspect the two EVAP line quick connects at the air cleaner cover (Fig. 1) by pressing the white connector lock (Fig. 2) and with a push-pull-push test, ensure both quick connect locks are locked (Fig. 2) .

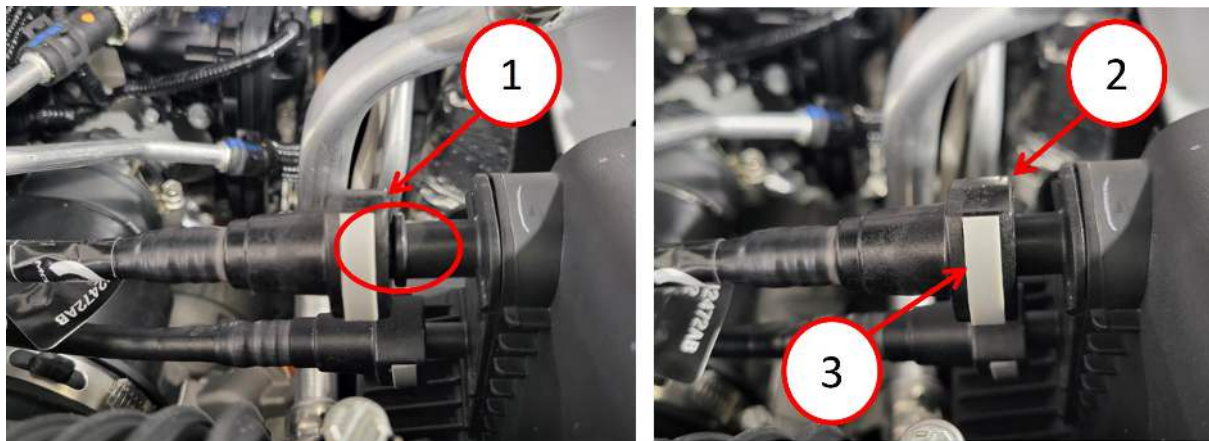
**Fig. 2****Unlocked And Locked EVAP Quick Connects**

- 1 - EVAP Quick Connector **NOT** Locked (Lock Ring Is Visible)
  - 2 - EVAP Quick Connector Seated And Locked
  - 3 - White Connector Lock
-
