## Technical Service Bulletin (TSB)

### Flash: Electric Power Steering (EPS) Module Updates

| REFERENCE: | TSB: 08-148-23<br>GROUP 08 - Electrical | Date: | June 17, 2023 | REVISION: | – |
| VEHICLES AFFECTED: | 2023 (GG) Dodge Hornet<br>This bulletin applies to vehicles built on or before May 30, 2023 (MDH 0530XX). | | | MARKET APPLICABILITY:<br><input checked="" type="checkbox"/> NA <input type="checkbox"/> MEA<br><input type="checkbox"/> SA <input type="checkbox"/> IAP<br><input type="checkbox"/> EE <input type="checkbox"/> CH | |

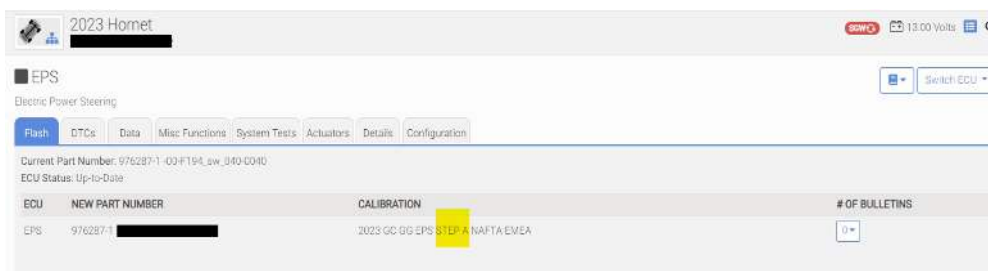
**Fig. 1**  
**Example of wiTECH Step Flashes**

**CAUTION! Multiple step flashes up to three may be necessary and are required to completely update this EPS these must be performed in order starting with STEP C, be sure to follow wiTECH accordingly (Fig. 1) .**

3. **Select the appropriate software per wiTECH (Step C, B or A) either Step C or B must be done first in order and end with Step A when finished.**
4. Reprogram the EPS module with the latest software. Detailed instructions for flashing control modules using the wiTECH Diagnostic Application are available by selecting the application's "HELP" tab.
5. Wait 2 minutes after the EPS flash has been completed.
6. To perform an EPS reset with wiTECH - Go to the Guided Diagnostics menu --> Select Reset ECU --> Select "EPS" from the list of modules --> Click "Continue" at the bottom of the page then follow the wiTECH prompts.
