## Technical Service Bulletin (TSB)

### Flash: Electric Power Steering (EPS) Module Updates

| REFERENCE: | TSB: 08-149-23<br>GROUP 08 - Electrical | Date: | June 17, 2023 | REVISION: | – |
| VEHICLES AFFECTED: | 2023 (GC) Alfa Romeo Tonale<br>This bulletin applies to vehicles built on or before May 30, 2023 (MDH 0530XX). | | | MARKET APPLICABILITY:<br><input checked="" type="checkbox"/> NA <input type="checkbox"/> MEA<br><input type="checkbox"/> SA <input type="checkbox"/> IAP<br><input type="checkbox"/> EE <input type="checkbox"/> CH | |

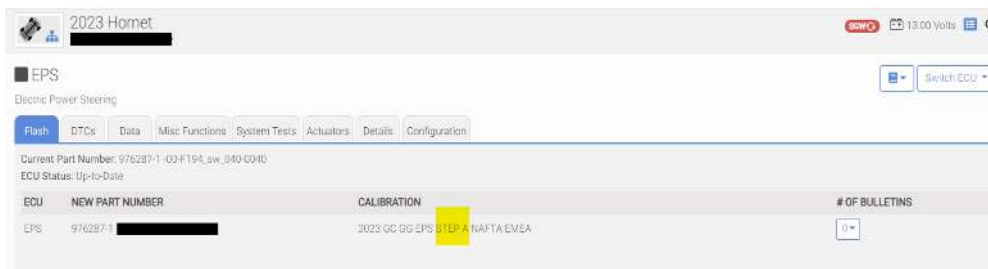
**Fig. 1**  
**Example of wiTECH Step Flashes**

**CAUTION! Multiple step flashes up to three may be necessary and are required to completely update this EPS these must be performed in order starting with STEP C, be sure to follow wiTECH accordingly (Fig. 1) .**

3. **Select the appropriate software per wiTECH (Step C, B or A) either Step C or B must be done first in order and end with Step A when finished.**
4. Reprogram the EPS module with the latest software. Detailed instructions for flashing control modules using the wiTECH Diagnostic Application are available by selecting the application's "HELP" tab.
5. Wait 2 minutes after the EPS flash has been completed.
6. To perform an EPS reset with wiTECH - Go to the Guided Diagnostics menu --> Select Reset ECU --> Select "EPS" from the list of modules --> Click "Continue" at the bottom of the page then follow the wiTECH prompts.
