## Technical Service Bulletin (TSB)

### Flash: Electric Power Steering (EPS) Module Updates

| REFERENCE: | TSB: 08-148-23 REV. A<br>GROUP 08 - Electrical | Date: | June 23, 2023 | REVISION: | 08-148-23 |
| VEHICLES AFFECTED: | 2023 (GG) Dodge Hornet<br>This bulletin applies to vehicles built on or before May 30, 2023 (MDH 0530XX). | | | MARKET APPLICABILITY:<br><input checked="" type="checkbox"/> NA <input type="checkbox"/> MEA<br><input type="checkbox"/> SA <input type="checkbox"/> IAP<br><input type="checkbox"/> EE <input type="checkbox"/> CH | |

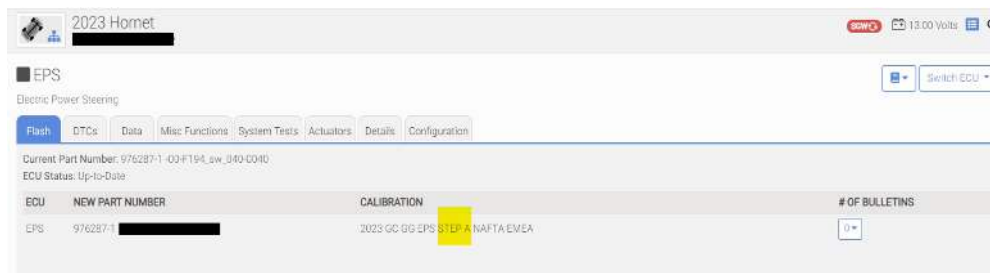
**Fig. 1**  
**Example of wiTECH Step Flashes**

**CAUTION! \*\*Multiple step flashes up to three may be necessary and are required to completely update this EPS these must be performed in order starting with STEP A or B and ending with Step C, be sure to follow wiTECH accordingly (Fig. 1) .\*\***

3. **\*\*Select the appropriate software per wiTECH (Step A, B or C) either Step A or B must be done first in order and end with Step C when finished.\*\***
4. Reprogram the EPS module with the latest software. Detailed instructions for flashing control modules using the wiTECH Diagnostic Application are available by selecting the application's "HELP" tab.
5. Wait 2 minutes after the EPS flash has been completed.
6. To perform an EPS reset with wiTECH - Go to the Guided Diagnostics menu --> Select Reset ECU --> Select "EPS" from the list of modules --> Click "Continue" at the bottom of the page then follow the wiTECH prompts.
