# Technical Service Bulletin

## 01 MIL on P045600 Very Small Leak Detected - NVLD

01 23 66 2071199/1 August 9, 2023.

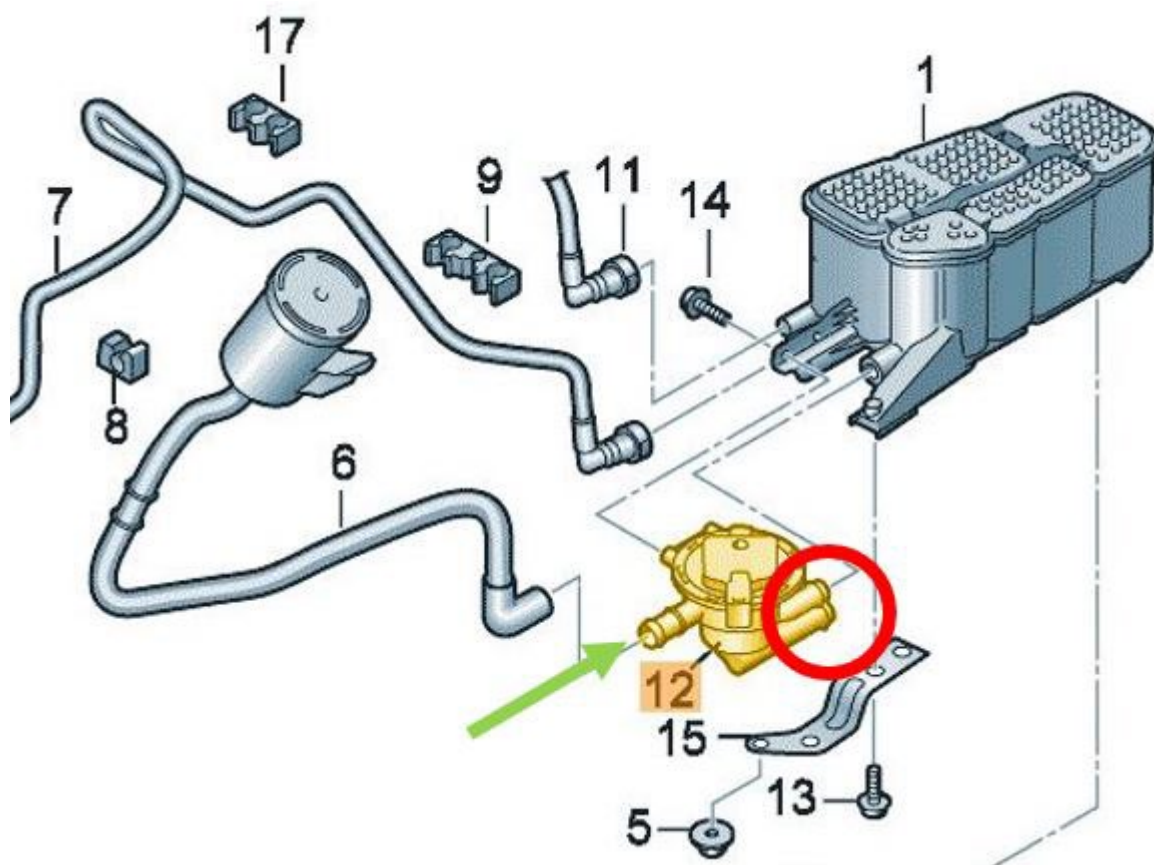
The smallest contamination may be sufficient to cause an internal leak in fuel tank pressure sender G400 (NVLD); this can lead to the DTC “P045600 – Very Small Leak Detected” being set.

**Figure 1:** Fuel tank pressure sender G400 (NVLD).

- Using a compressed air gun, please blow through the NVLD (item 12 in illustration) with several brief pressure applications of approx. 5 bar. To do so, use the opening on the NVLD marked in the illustration by a green arrow (figure 1).

The opening marked with a red circle (figure 1) must not be closed or exposed to compressed air, as this may cause irreparable damage to the NVLD. In addition, this ensures that possible contamination can be blown out of the NVLD.

While blowing through the component as described, please hold it in your hand -> the component must not be clamped or secured in a vice (risk of damage).

Reinstall the fuel tank pressure sender G400 (NVLD), and recheck the system for leaks.
