# Technical Service Bulletin

## 01 MIL on, DTC P040100 is stored in the ECM - TDI

01 23 68 2064398/3 August 11, 2023. Supersedes Technical Service Bulletin Group 01 number 23-63 dated July 25, 2023 for reasons listed below.

| Model(s) | Year | VIN Range | Vehicle-Specific Equipment |
|---|---|---|---|
| A3 TDI | 2010 – 2013 | All | Not Applicable |

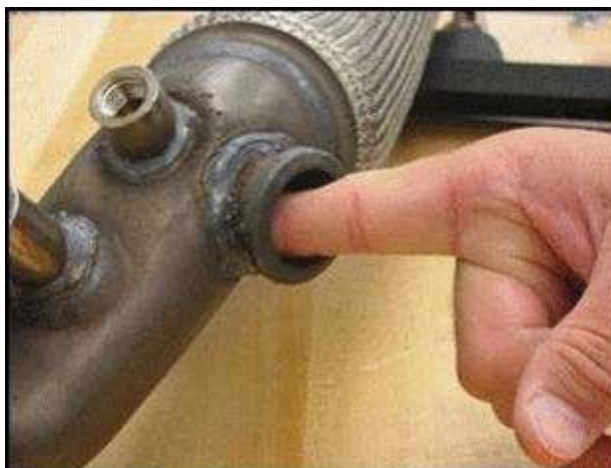
1. Remove the EGR filter from the Diesel Particulate Filter (DPF) and swipe the inside of the exhaust pipe at the EGR filter connection point using a clean cloth or your finger.

*Figure 1. Checking for carbon.*

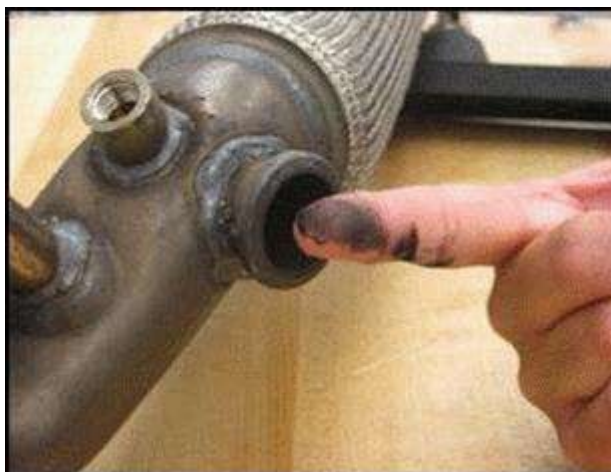
*Figure 2. Verifying that there is carbon.*

2. If your finger or the cloth comes out with black soot:
  - Replace the DPF & EGR filter together. **The engine must be running correctly with no faults stored to perform the next steps.**
  - Read out 01 ECM control module OBD Basic Settings block 67 with engine at idle and at operating temperature. Select activate and monitor field 3 when EGR is in OFF position.
  - If the MAF actual value is equal to or greater than 540 mg/h, proceed to smoke testing below (there is likely a leak within the intake system).
  - If the value is less than 540 mg/h, proceed to the inspection of the snow flap and air filter (TSB attachment). There is no need to smoke test.
  - Smoke test the charge air system for leaks if MAF value is 540 or great (see procedure below).
