# Technical Service Bulletin

## 01 - MIL on, Whistling noise, leaking air Bank 2 - DTC P2ADF00, Engine Crankcase breather

01 23 72 2071318/1 August 23, 2023.

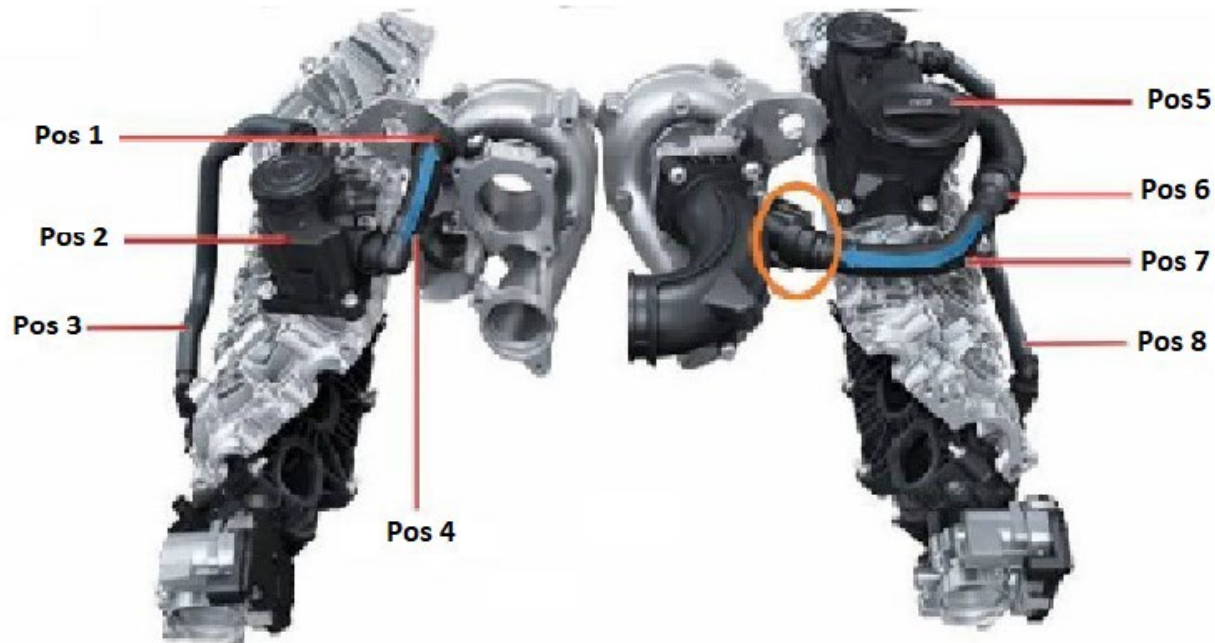
- Item 1: Non-return valve
- Item 2: Oil separator for bank 1
- Item 3 Part load breather line for bank 1
- Item 4: Full load breather line for bank 1
- Item 5: Oil separator for bank 2
- Item 6: Non-return valve
- **Item 7: Full load breather line for bank 2**
- Item 8: Part load breather line

In this case, replace the full load breather line for cylinder bank 2.

1. Do not replace the oil separator for bank 1 or bank 2 or the part load breather lines.
  - a. Please refer to image of the crankcase from the Self Study Program 920493 as a guide.
