# Technical Service Bulletin

**87 Air conditioning does not cool, DTC B16A284 is stored in the thermal management control module**  
87 23 53 2061660/2 August 24, 2023. Supersedes Technical Service Bulletin Group 87 number 20-12 dated December 15, 2020 for reasons listed below.

| Model(s) | Year | VIN Range | Vehicle-Specific Equipment |
|---|---|---|---|
| A8, A8 e quattro, and S8 | 2020 – 2021 | All | Not Applicable |

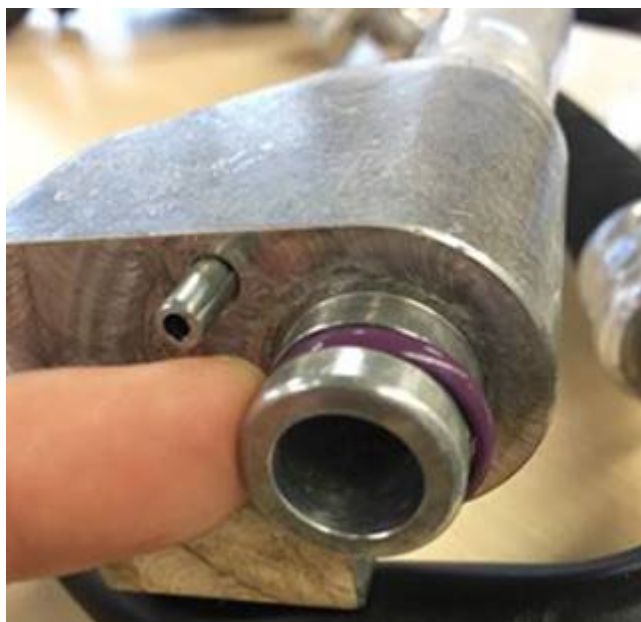
A refrigerant leak test reveals a leak at the bolted connections of the refrigerant line with inner heat exchanger that connects the main circuit to the rear evaporator. When the line is removed an incorrect and/or damaged O-ring seal is found (Figure 1).

**Figure 1.** Damaged refrigerant line O-ring seal.

1. Perform an air conditioning circuit leak test diagnosis using either contrast dye or by pressurizing the circuit with compressed nitrogen and investigating the leak location with a soapy water solution at each end of this refrigerant line. Provided no damage to the mating sections of the line are found replace the O-ring seals on either end of the line. If a leak is not found at either end of this refrigerant line, continue with the leak diagnosis and repair.
2. Please take photos of the customer concern and upload them into DOC-IT with the repair order. Photos should:
  - Have a date stamp and VIN reference.
  - Be taken in focus and with sufficient light.
  - Where it is appropriate, mark the affected place for a reference to the concern for analysis.
