# Technical Service Bulletin

## 48 Electric steering column adjustment is not working, DTC B14BF01 is stored in the BCM 1

48 23 54 2062288/4 August 23, 2023. Supersedes Technical Service Bulletin Group 48 number 21-01 dated May 14, 2021 for reasons listed below.

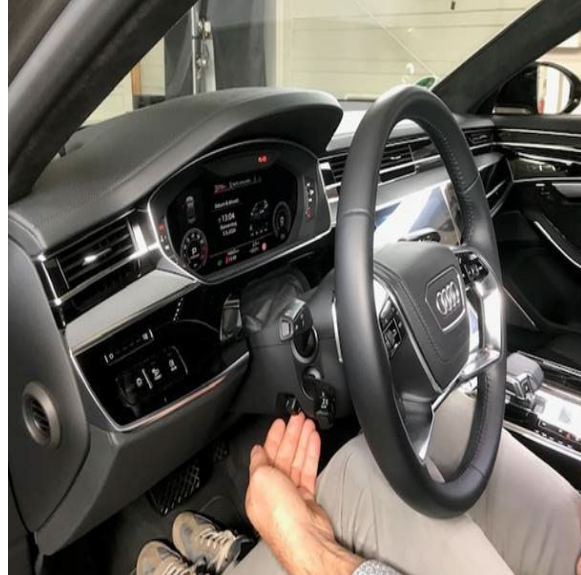
**Figure 1.** 40 kg force pushing steering wheel upward.

- Get into the vehicle and use your knees to push the steering wheel upward (a force of approx. 40 kg or 88 lbs is required), at the same time press the steering column adjustment switch upwards in the vertical adjustment direction (Figure 1).
- This will restore the function of the electric steering column adjustment.

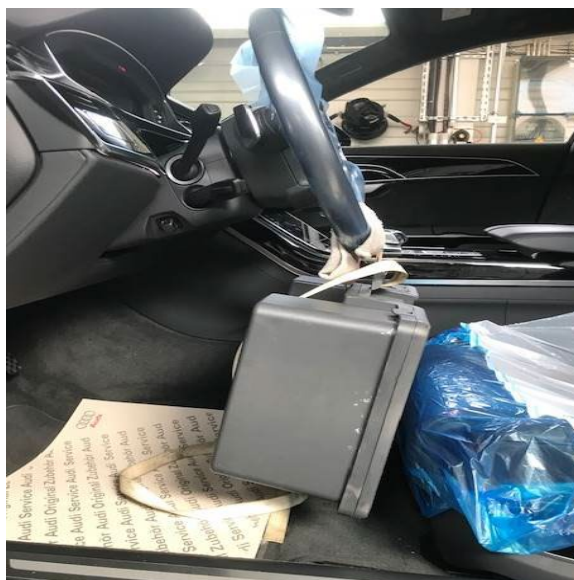
**Figure 2.** Weight necessary for steering adjustment.

6. Attach the tool kit to the steering wheel using a small securing strap (Figure 2). Take care not to damage the steering wheel.

We recommend placing a cleaning cloth underneath, as shown in Figure 2.

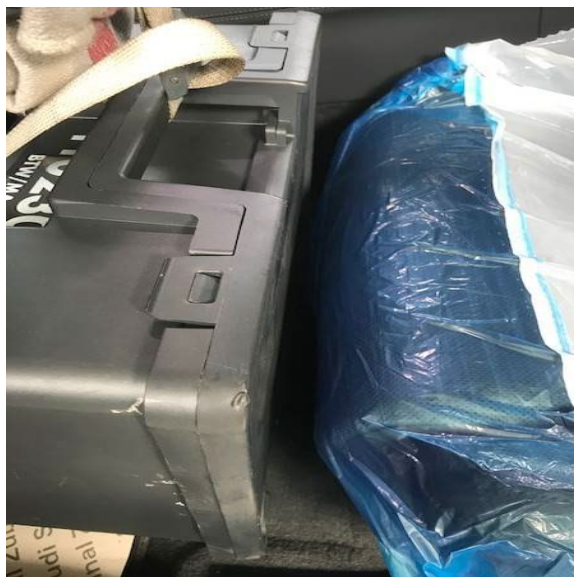
**Figure 3.** Plastic foil protection for the seat.

7. Apply plastic foil to make sure the tool kit cannot scrape against the seat (Figure 3).
