# Technical Service Bulletin

## 87 Air conditioning does not cool - P053000, P251500 stored in C5

87 23 50 2068460/4 August 10, 2023. Supersedes Technical Service Bulletin Group 87 number 23-40 dated April 10, 2023, for reasons listed below.

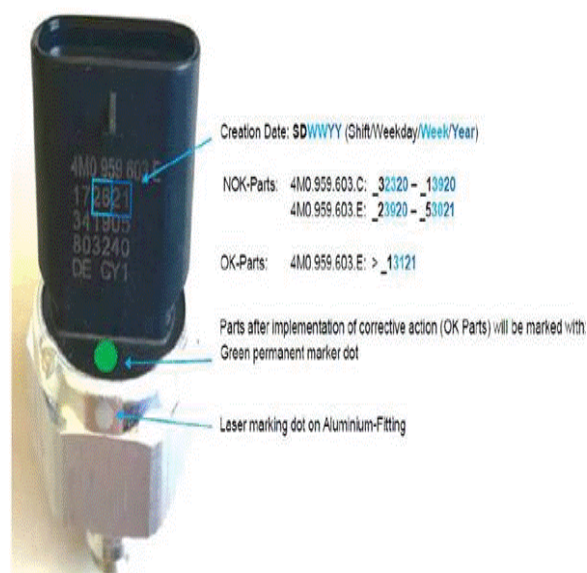
**Figure 1.** Pressure and temperature sensor markings and build date.

A failure of the sensor electronics causes a loss of pressure evaluation. The sensor with base part number 4M0959603 and a build date before the date Calendar Week 31, 2021 is at issue (G395 / G827).

2. Inspect the markings on the sensor to determine if the sensor has been previously replaced with an improved sensor produced after Calendar Week 31, 2021. Figure 1 shows the locations of the markings and their interpretation. In this example, while the sensor is an 'E' index sensor, contains a green dot on the connector housing and a laser marking on the aluminum housing the build date of the sensor is *before* Calendar Week 31, 2021, and would require replacement.

The presence of the green dot on the sensor is not the sole, conclusive evidence of the sensor being of the improved type. The green dot was applied in production as an immediate identification of an improved sensor but the green dot was not applied indefinitely. Always check the sensor date as this is the confirmation of the sensor status.

1. Should the vehicle present with the symptom profile described in this TSB inspect and/or replace all of the pressure sensors in the refrigerant circuit that are of the base part number 4M0959603 and have a build date before Calendar Week 31, 2021. Each model for which this TSB appears will have between 1 and 3 of this type of sensor installed at various positions in the refrigerant circuit, either on the low or high pressure sides of the circuit (G395 / G827).

3. A sensor with index 'E', produced after Calendar Week 31, 2021, has a laser marking on the aluminum housing and may or may not contain a green dot on the connector housing is of the improved type and need not be replaced.
