# Technical Service Bulletin

## 87 Air conditioning does not cool; B10AE21

87 23 52 2063575/3 August 18, 2023. Supersedes Technical Service Bulletin Group 87 number 22-28 dated July 12, 2022, for reasons listed below.

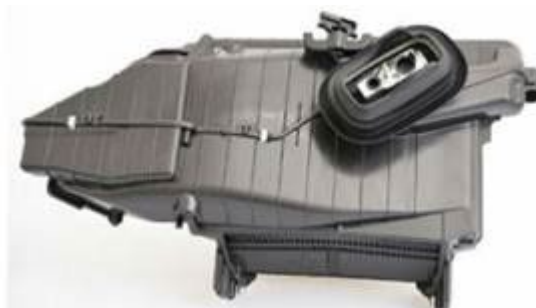
The refrigerant circuit head pressures are checked, found to be insufficient and after recovering the refrigerant volume the diagnostic finding is determined that the refrigerant volume in the circuit is very low or empty. DTC B10AE21 (High-pressure sensor Lower limit not reached) may be stored in the Heating/Air Conditioning Electronics control module, E87 (address word 0008). Leak identification dye is added to the refrigerant circuit along with a full charge of the refrigerant and the vehicle is test driven. Correct cabin cooling is restored. A visual inspection of the refrigerant circuit is conducted and no obvious leak can be seen under UV lighting. When using an electronic refrigerant leak detector at the central vents and condensate drain it alerts that the evaporator core may be the source of the leak.

**Figure 1.** HVAC evaporator and housing.

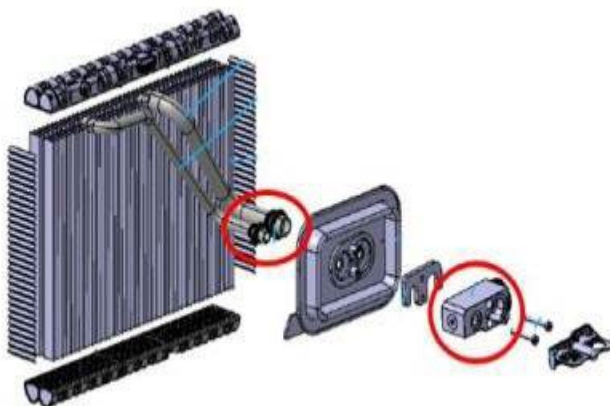
If, after checking for refrigerant leaks at each component and connection in the refrigerant circuit and systematically excluded as a cause, your diagnostic conclusion is that the evaporator core is the only refrigerant leak in the entire circuit apply a high level of scrutiny to the connection junction at the evaporator core /expansion valve/refrigerant lines for a possibly overlooked leak in these areas (figures 2 - 3).

**Figure 2.** Refrigerant connections in need of closer observation.

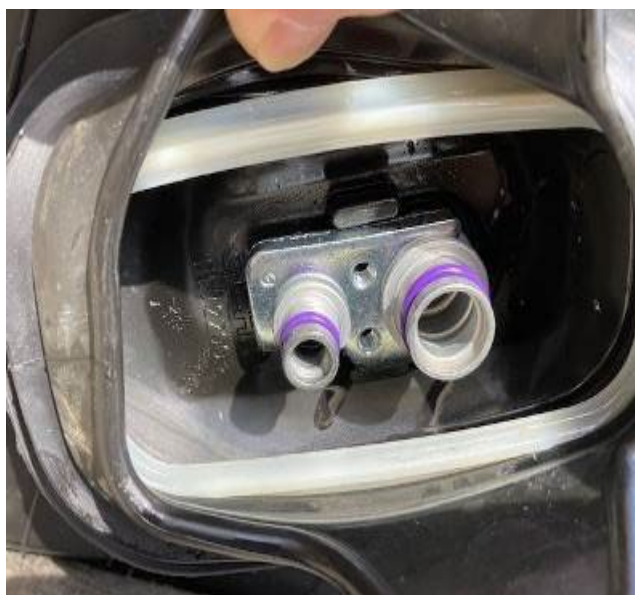
**Figure 3.** Refrigerant connections to the expansion valve.

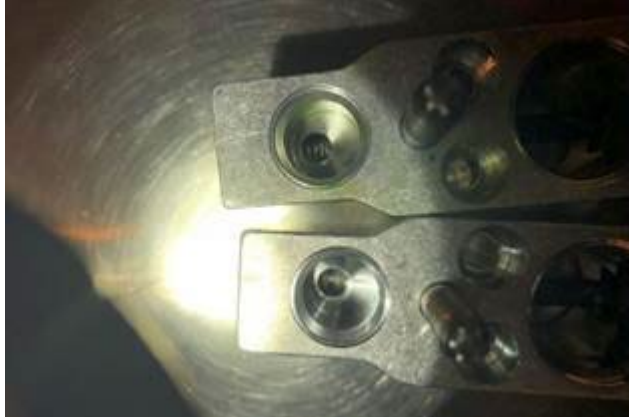
**Figure 4.** Leak at expansion valve connection evidenced by residue from the contrast agent.

If a refrigerant leak is detected from the evaporator core/expansion and valve/refrigerant line junction, take a short video showing the diagnostic confirmation of a leak in this area and post it to Doc-IT. Then, replace the expansion valve and all four O-rings without replacing the evaporator (figure 4). Re-test to ensure that the refrigerant leak is solved without the replacement of the evaporator core. Photograph any damage to the expansion valve ports, damaged o-rings, or refrigerant line connections and post these to Doc-IT as well.
