# Technical Service Bulletin

## 91 No diagnostics communication to the telematics control module; DTC U142100

91 23 19 2056076/19 August 8, 2023. Supersedes Technical Service Bulletin Group 91 number 23-08 dated June 29, 2023, for reasons listed below.

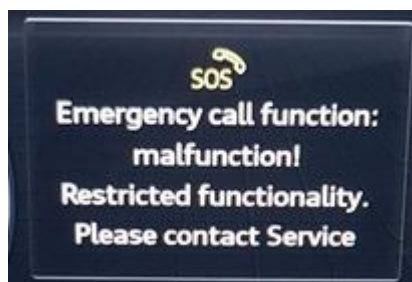
- An SOS Warning might be displayed in the instrument cluster (Figure 1).

**Figure 1.** Emergency call malfunction warning.

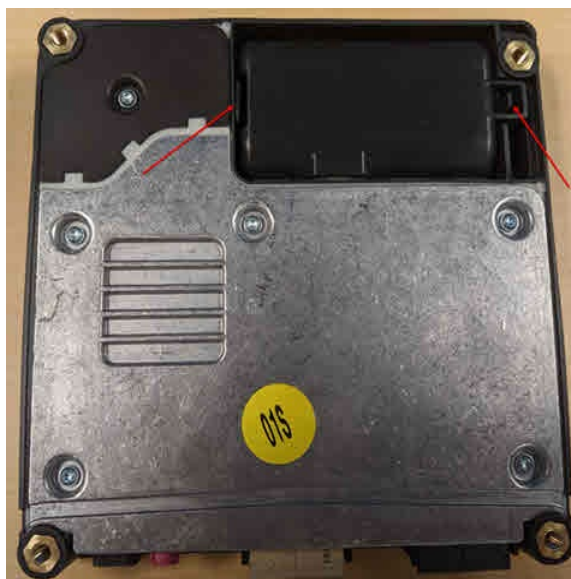
*Figure 2. Backup battery compartment location.*

1. Remove and unplug the telematics control module, -J949- (address word 0075) according to the Elsa Repair Manual.
2. Open the battery compartment of the telematics control module, -J949- (address word 0075), and disconnect the backup battery (Figures 2 - 3).

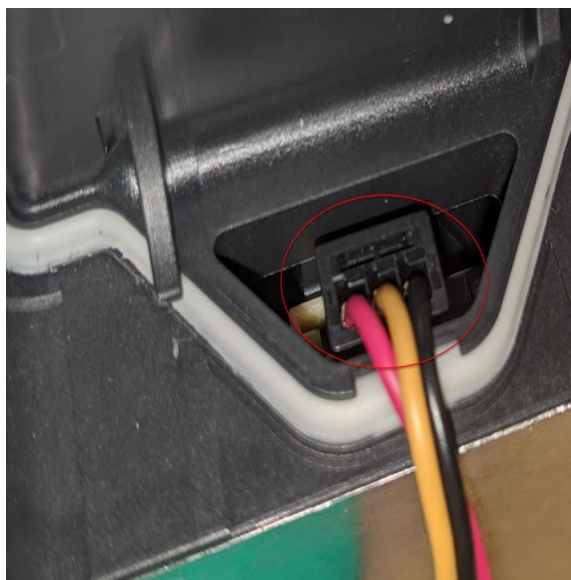
**Figure 3.** Backup battery connector (no release mechanism).
