69-23-01TT – DTC B101C07

Release date: 8/31/2023

| Model(s) | Year | Eng. Code | Trans. Code | VIN Range From | VIN Range To |
|---|---|---|---|---|---|
| Atlas, Atlas Cross Sport | 2024 | All | All | All | All |

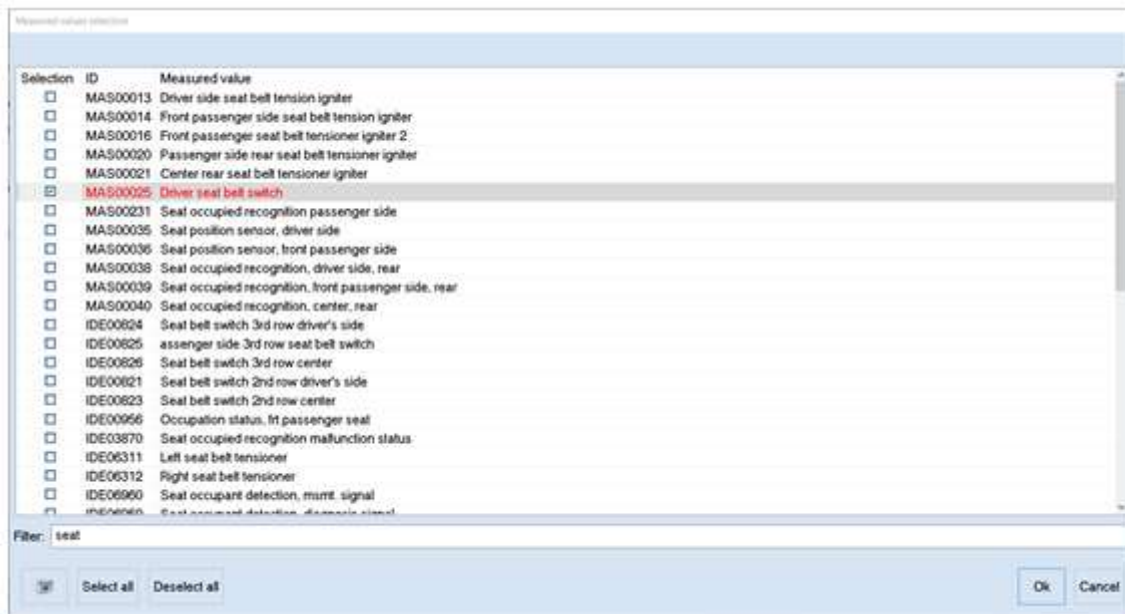
Figure 1

For Airbag Control Unit (diagnostic address 0015), read MVB “MAS00025 - Driver Seat Belt Switch” (figure 1). You should see the status change between “connected” (figure 2) and “not connected” (figure 3) when fastening & unfastening the seat belt.

Do not perform any repair unless the safety belt switch status will NOT change state.
