| <b>Topic</b> | New Continental GT and GTC - Window drop glass operation |
| <b>Transaction No.</b> | 2070497/3 |

Retailer glass reset procedure for GT/GTC

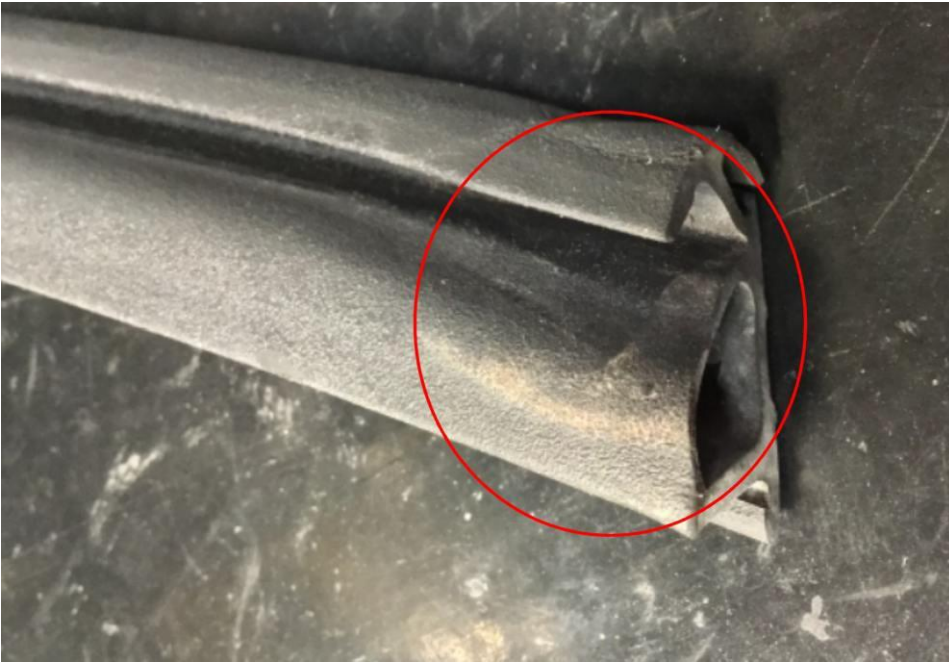
Figure 9

- Damage
- Splits
- Tears
- Misalignment
- Incorrectly fitted/located
- Drop glass seal deformation (see Figures 9 and 10 as examples)

NOTE: Any issues found with the window seals must be rectified before conducting the remaining steps

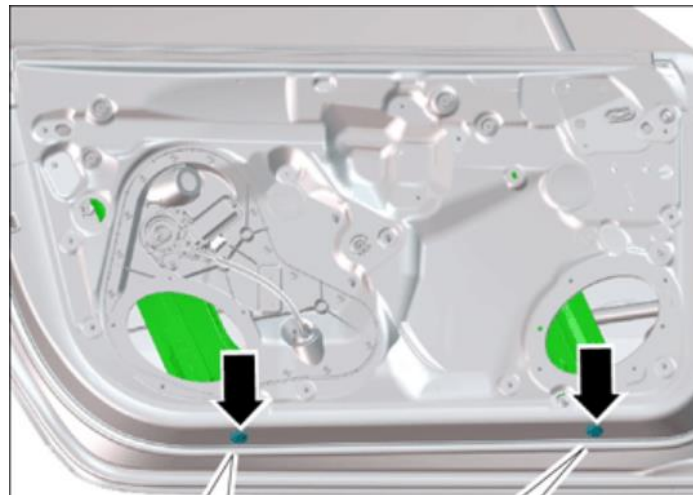
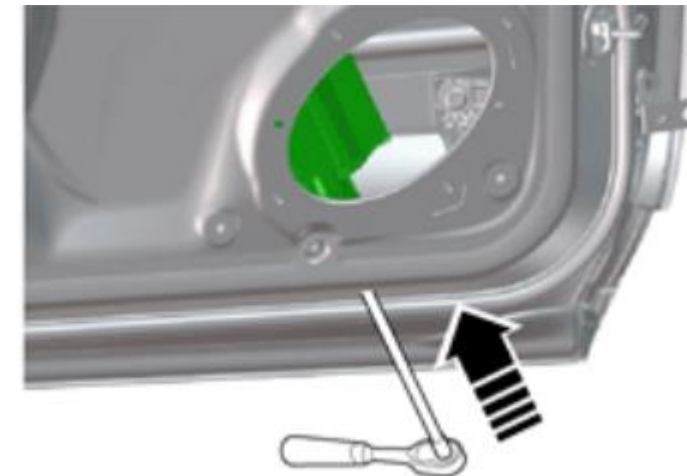
Example: Front drop glass Z axis not adjusted correctly. Bottom of tape was level with waist rail seal, after slackening pinch bolt (3 in bottom left image) front drop glass lowered 14mm to where pen marked line is.

Z-axis adjusters (bottom middle and right images) had not been used, pinch bolt had been slacked and glass lifted out of the regulator to achieve specification. This has a knock on effect of altering the 10mm division bar intrusion seen in previous slide as glass is loose and can be accidentally moved in X-axis.

This also creates a risk that the window will bottom out on the cant rail seals rather than the regulator bump stops meaning that the glass can raise further as the seals soften over time and affect end stop learning.

## Z-Axis height should only be adjusted by the 4mm Allen key adjusters as per ELSAPRO

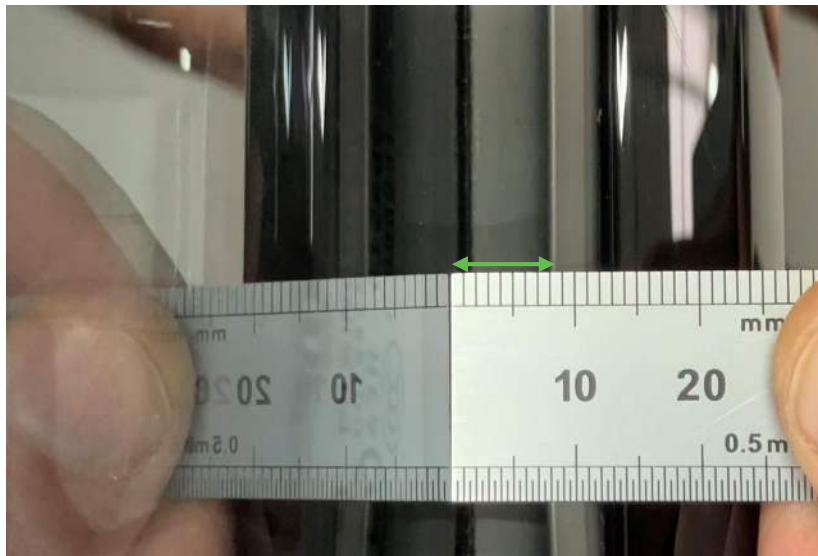
RHF window, front window closed, rear window open. Note gap

If more tension is required to resolve a wind noise or water ingress then aim for no more than 0.25mm of outboard movement.
