## Technical product information

| <b>Topic</b> | Coolant pump leaking (part number 07P 121 008C) - Low coolant warning - Engine overheating - DTC's evident |
| <b>Brand</b> | Bentley |
| <b>Transaction No.</b> | 2071239/1 |

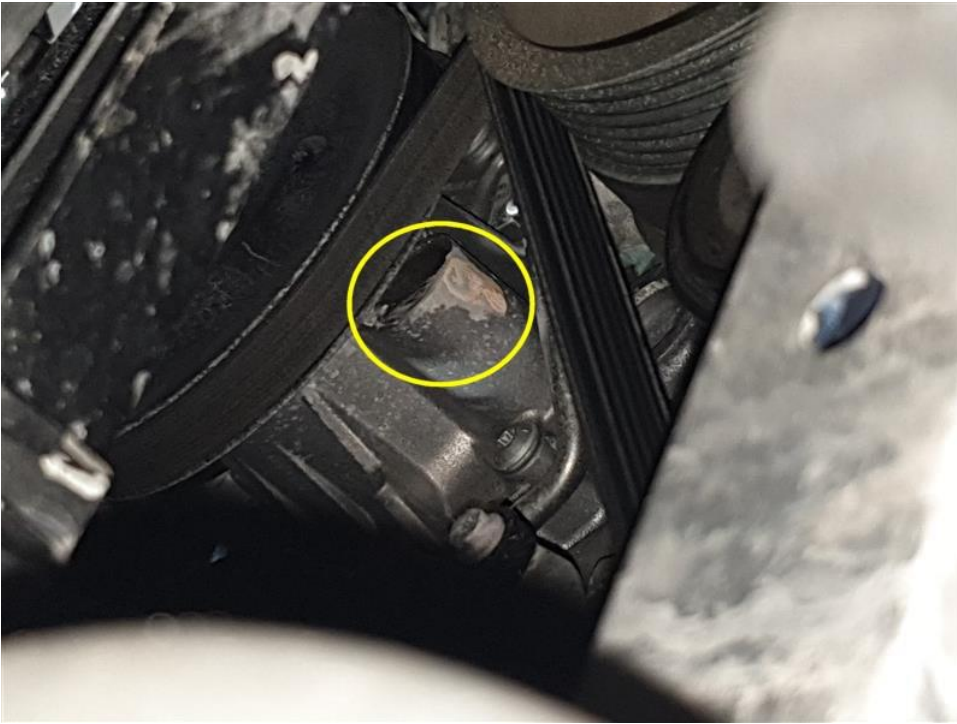
Figure 1

- Refer to the video located within the Bentley Hub reference TPI 2071238/- the video shows an example of a coolant pump with no leak although a small coolant witness mark is evident (Figure 1) in this scenario the coolant witness mark should be cleaned off (using a suitable cleaning agent) to the condition shown in Figure 2

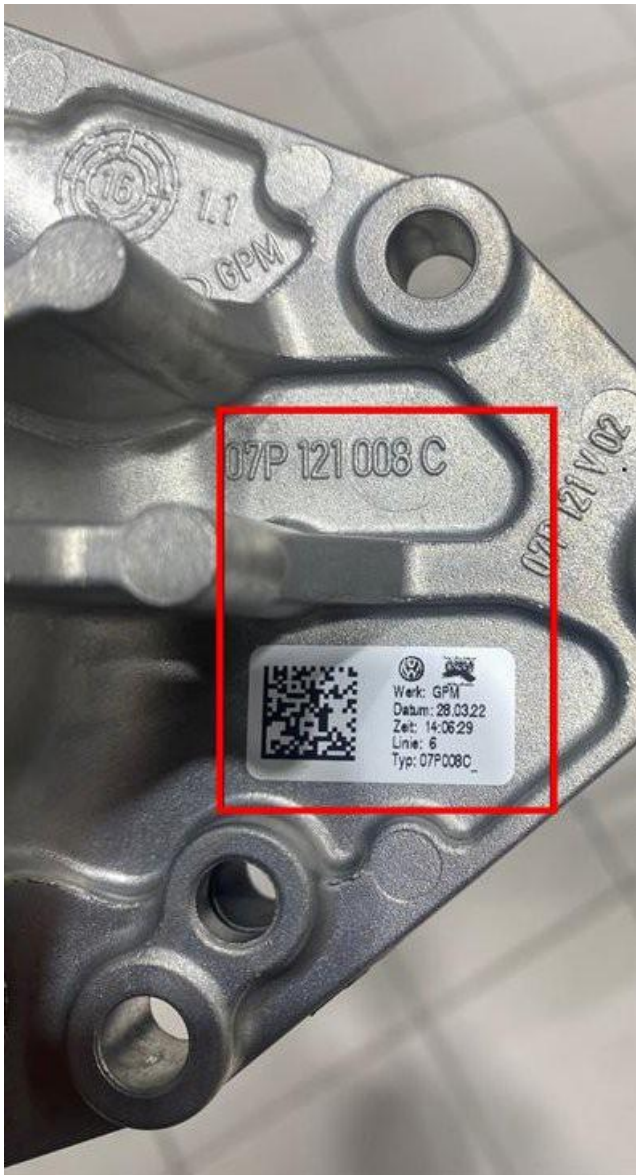
- Clear photo of the coolant level
- Clear photo of the original mechanical coolant pump part number **07P 121 008C** (Figure 4)
- Video of the coolant leak whilst carrying out the pressure test
- Current ODIS log
- Await feedback via DISS before replacing any parts

*NOTE: The photo shown in Figure 4 is a C level coolant pump (shown removed from the vehicle for photographic purposes) a borescope may have to be used for photographs of the coolant pump when fitted*

6) Once permission has been given via the technical DISS query, replace the following

- Mechanical coolant pump - Rep.Gr 19
- Solenoid for coolant circuit N492 assembly - Rep.Gr 19
