# Service Bulletin

Bulletin No.: 23-NA-030

**Subject:** Airbag Light On - DTCs B0014 / B0021 SIAB Harness Connector Contacting Seat Back Foam (New Seat Back Foam), Intermittent Service Airbag System Message, DTCs B0014, B0021

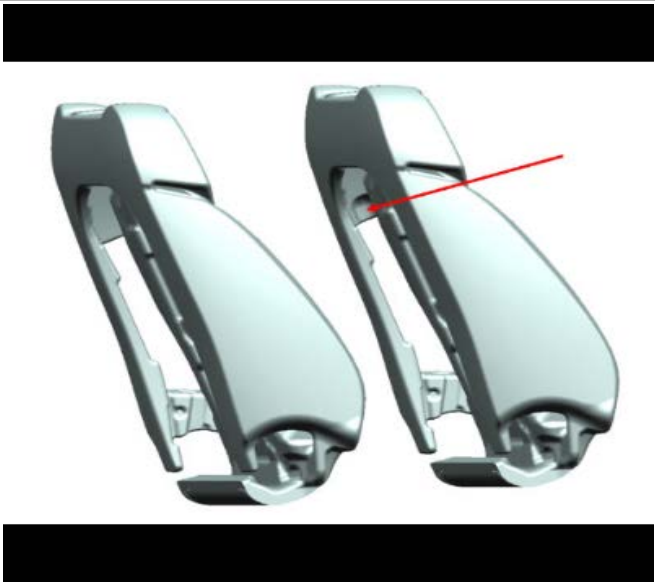
6325181

| Cause | The condition may be caused by an interference between the front seat back pad assembly and the side impact airbag wiring harness assembly. |

| Correction | <br>Replace the front seat back pad assembly with a new part number that includes a larger clearance zone for the side impact airbag wiring harness assembly. |
