# Service Bulletin

Bulletin No.: 20-NA-100

Subject: Engine Control Module Calibration for T1 L3B Engine with DTC P26BB Set

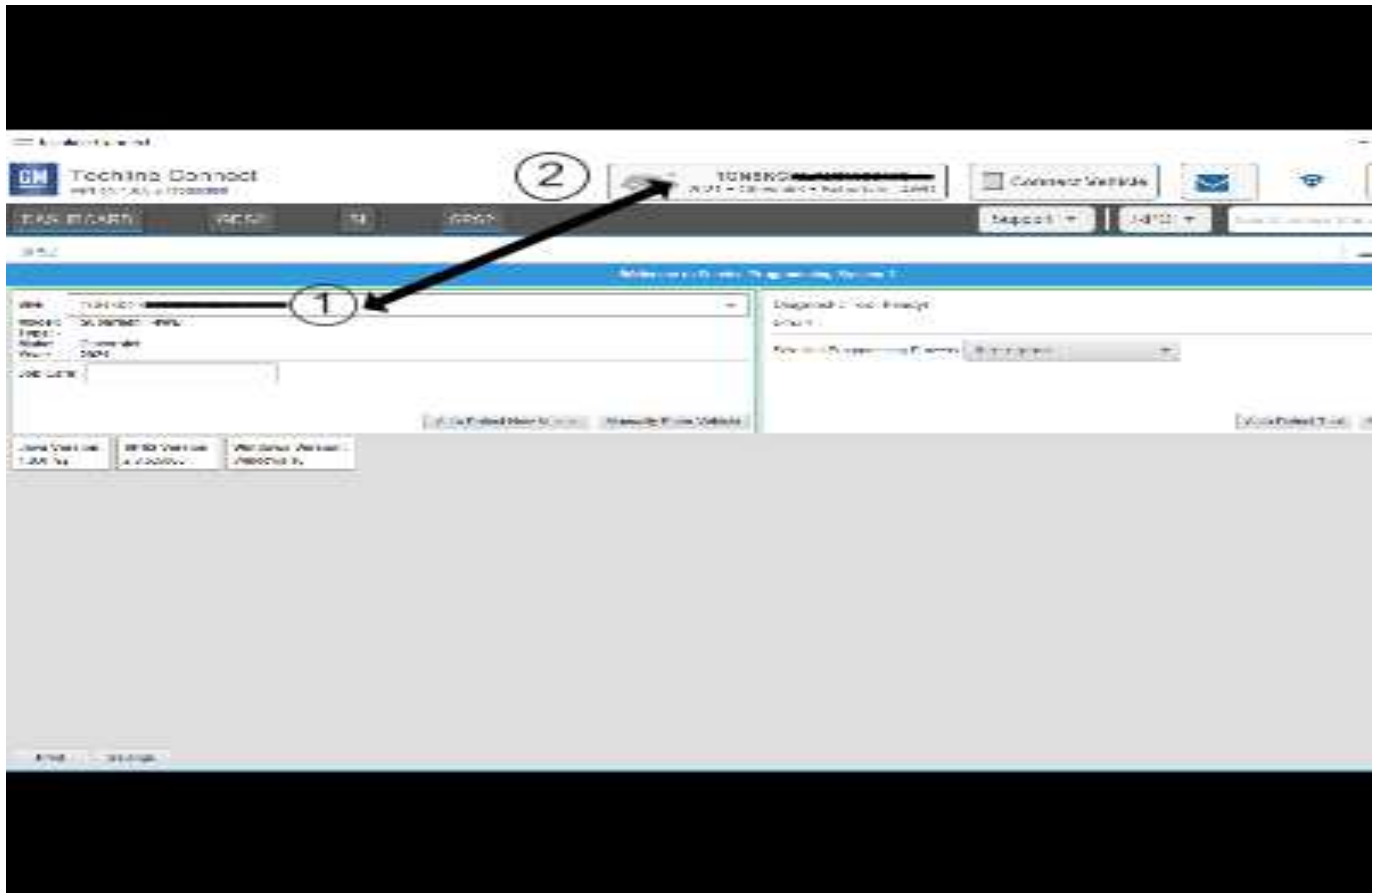
Caution: Be sure the VIN selected in the drop down menu (1) is the same as the vehicle connected (2) before beginning programming.

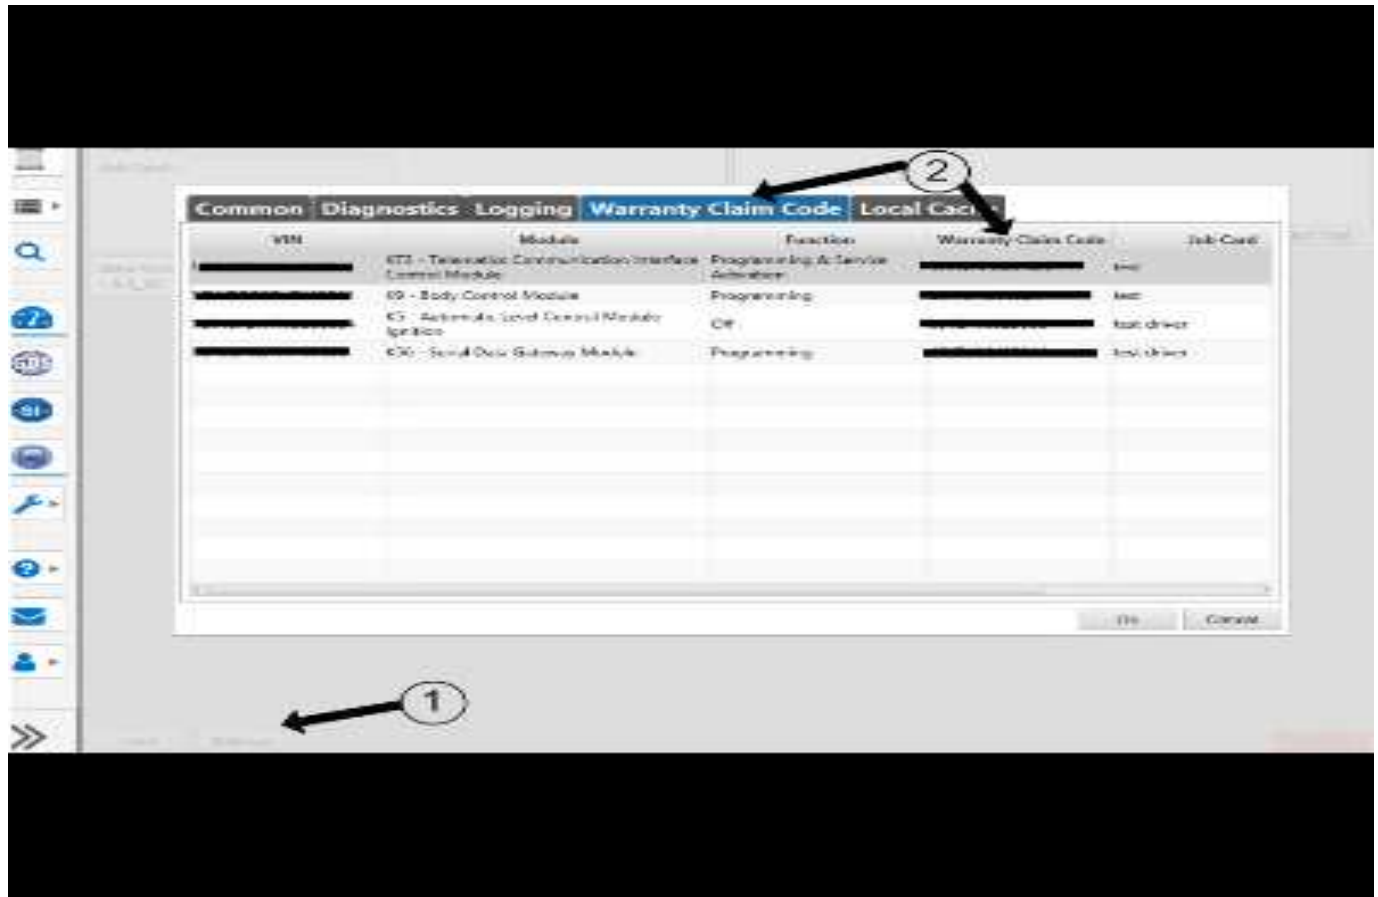
6125774

If the SPS Warranty Claim Code was not recorded on the Job Card, the code can be retrieved in the SPS system as follows:

1. Open TIS on the computer used to program the vehicle.
2. Select and start SPS.
3. Select Settings.
4. Select the Warranty Claim Code tab.
