## Technical Service Bulletin (TSB)

### Fuel Filler Cap Tether Too Long

| REFERENCE: | TSB: 14-004-23<br>GROUP 14 - Fuel System | Date: | July 1, 2023 | REVISION: | 14-010-21 |
| VEHICLES AFFECTED: | 2021 – **2023** (JL) Jeep Wrangler<br>**This bulletin applies to vehicles built on or before March 15, 2023 (MDH 0523XX) equipped with a 2.0L I4 DOHC DI Turbo PHEV Engine (Sales Code ECX).** | | | MARKET APPLICABILITY:<br><div><input checked="" type="checkbox"/> NA<input checked="" type="checkbox"/> MEA<br/><input type="checkbox"/> SA<input checked="" type="checkbox"/> IAP<br/><input checked="" type="checkbox"/> EE<input type="checkbox"/> CH</div> | |

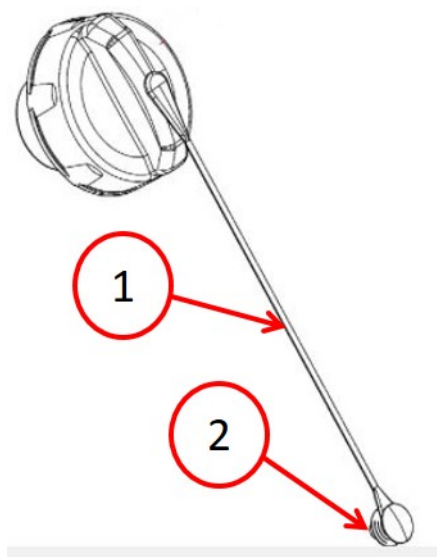
**Fig. 1**  
**Fuel Filler Cap Fastener And Tether**

| CAUSE: | There is an air leak through the fuel filler cap to fuel filler neck seal because the fuel filler cap tether gets caught between them. | | | | |

1. Open the fuel filler door.
2. Using a trim stick tool, remove the fuel filler cap tether fastener (Fig. 1) from the vehicle.

3. Remove the fuel filler cap (Fig. 1) from the filler tube.
4. \*\*Cut the existing tether near the base that is mounted in the back of housing and discard cap/tether (Fig. 1) .
5. Replace the tappet base on the fuel door with the new part.

6. Install tether onto the new mounting provision on the new tappet base.\*\*
7. Install the new fuel filler cap tether (Fig. 1) on the fuel filler cap.
8. Install the fuel filler cap (Fig. 1) on the filler tube.
9. Close the fuel filler door and verify there is no binding with the tether.
10. Clear any DTCs that may have been set.
