## Technical Service Bulletin (TSB)

### HVAC temperature door stuck (HVAC)

| REFERENCE: | TSB: 24-007-23<br>GROUP 24 - Heating and Air Conditioning | Date: | July 7, 2023 | REVISION: | – |
| VEHICLES AFFECTED: | 2022 - 2023 (WS) Wagoneer / Grand Wagoneer<br>This bulletin applies to vehicles built on and after September 01, 2022 (MDH 0901XX) and on and before March 31, 2023 (MDH 0331XX). | | | MARKET APPLICABILITY:<br><input checked="" type="checkbox"/> NA<br><input type="checkbox"/> SA<br><input type="checkbox"/> EE<br><input type="checkbox"/> MEA<br><input type="checkbox"/> IAP<br><input type="checkbox"/> CH | |

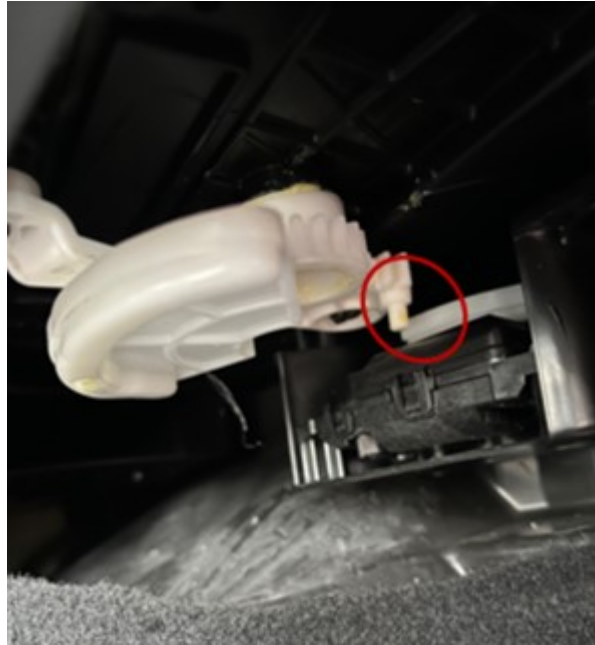
**Fig. 1**

| CAUSE: | Possible HVAC actuator cam gear disengaged at driver temp door actuator (Fig. 1) . | | | | |

**NOTE:** Door can be moved by hand in the up and down direction.

**Pin Outside Of Actuator Cam Gear**

This bulletin involves installing a three millimeter foam washer under the blend door cam gear.

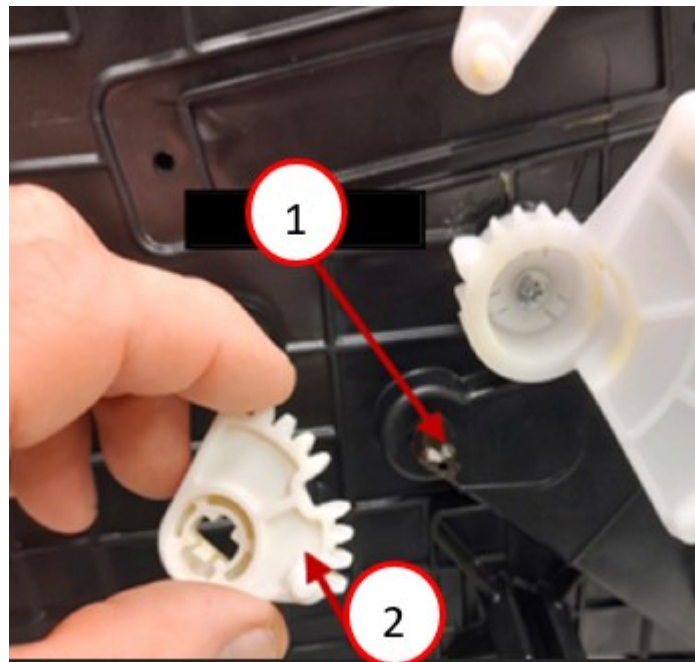
**Fig. 5**  
**Blend Door Gear Linkage Removed**

1 - Blend Door  
2 - Blend Door Linkage

1. Remove blend door gear linkage (Fig. 4) , (Fig. 5) .

3. Reinstall blend door linkage (Fig. 5) .
