## Technical Service Bulletin (TSB)

### Flash: Electric Power Steering (EPS) Module Updates

| REFERENCE: | TSB: 08-163-23<br>GROUP 08 - Electrical | Date: | July 11, 2023 | REVISION: | – |
| VEHICLES AFFECTED: | 2024 (GC) Alfa Romeo Tonale<br>This bulletin applies to vehicles built on or before June 20, 2023 (MDH 0620XX). | | | MARKET APPLICABILITY:<br><input checked="" type="checkbox"/> NA<br><input type="checkbox"/> SA<br><input type="checkbox"/> EE<br><input type="checkbox"/> MEA<br><input type="checkbox"/> IAP<br><input type="checkbox"/> CH | |

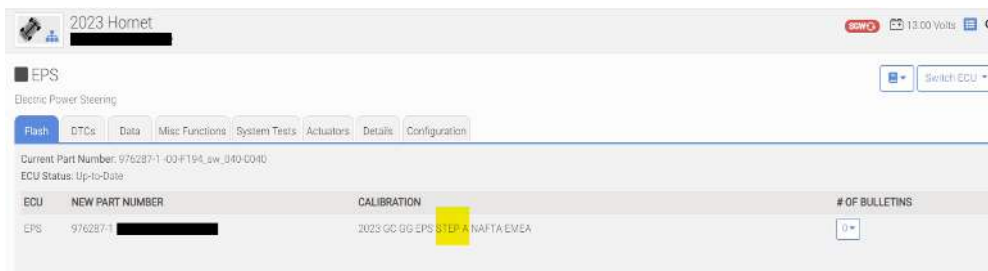
**Fig. 1**  
**Example of wiTECH Step Flashes**

**CAUTION! Multiple step flashes up to three may be necessary and are required to completely update this EPS these must be performed in order starting with STEP A or B and ending with Step C, be sure to follow wiTECH accordingly (Fig. 1) .**

3. **Select the appropriate software per wiTECH (Step A, B or C) either Step A or B must be done first in order and end with Step C when finished.**
4. Reprogram the EPS module with the latest software. Detailed instructions for flashing control modules using the wiTECH Diagnostic Application are available by selecting the application's "HELP" tab.
5. Wait 2 minutes after the EPS flash has been completed.
6. To perform an EPS reset with wiTECH - Go to the Guided Diagnostics menu --> Select Reset ECU --> Select "EPS" from the list of modules --> Click "Continue" at the bottom of the page then follow the wiTECH prompts.
