## Technical Service Bulletin (TSB)

### Low Oil Pressure

| REFERENCE: | TSB: 09-006-23 REV. C<br>GROUP 09 - Engine | Date: | July 22, 2023 | REVISION: | 09-006-23 REV. B |
| VEHICLES AFFECTED: | <b>2022 - **2024** (B1) Jeep Renegade</b><br><b>2022 - **2024** (H1) Jeep Commander</b><br><b>2022 - **2024** (M1) Jeep Compass</b><br><b>This bulletin applies to vehicles equipped with a 1.3L I4 Turbo Mair DI Eng w/ESS E100 (Sales Code EYJ):</b> <ul style="list-style-type: none"><li>• M1 built on and after April 28, 2021 (MDH 0428XX) and built on and before **June 18, 2023 (MDH 0618XX)**.</li><li>• H1 built on and after December 26, 2021 (MDH 1226XX) and built on and before **June 18, 2023 (MDH 0618XX)**.</li><li>• B1 built on and after January 14, 2022 (MDH 0114XX) and built on and before **June 18, 2023 (MDH 0618XX)**.</li></ul> <b>This bulletin applies to vehicles equipped with a 1.3L I4 Turbo Mair DI Engine w/ESS (Sales Code EYF):</b> <ul style="list-style-type: none"><li>• M1 built on and after January 29, 2022 (MDH 0129XX) and built on and before **June 18, 2023 (MDH 0618XX)**.</li><li>• H1 built on and after March 25, 2022 (MDH 0325XX) and built on and before **June 18, 2023 (MDH

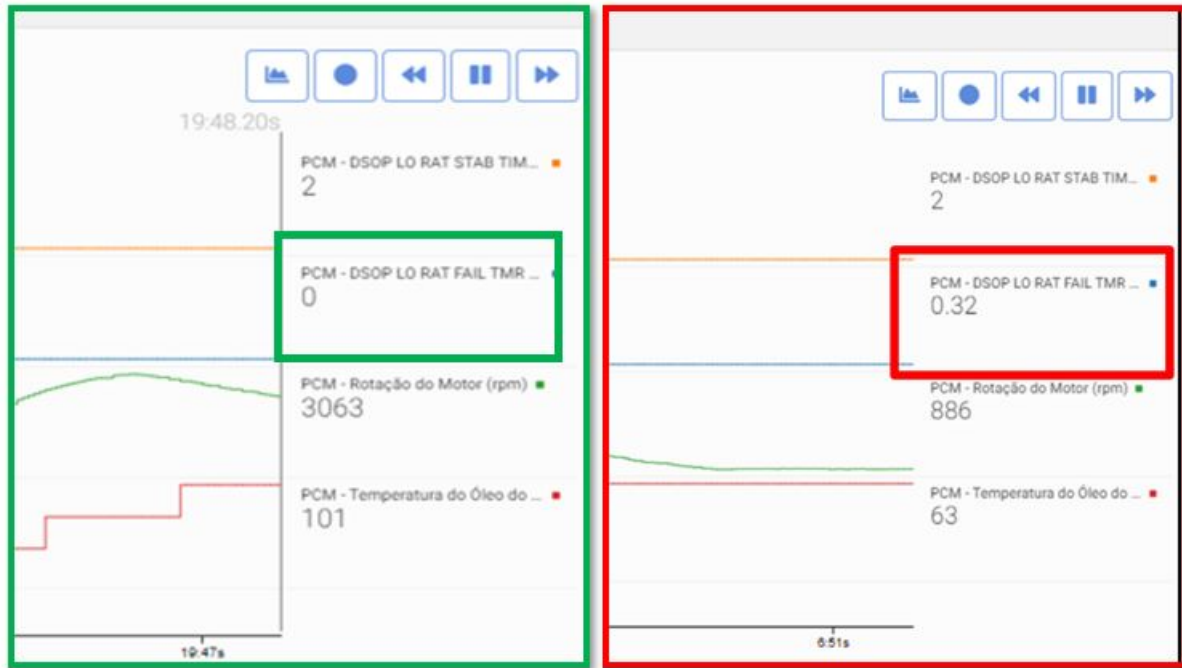
**Fig. 1**

1. Using wiTECH check if DTC P06DD is set in the Powertrain Control Module (PCM).
2. Was DTC P06DD found in the PCM?
  - YES>>> Replace the timing chain cover. Proceed to [Step 6](#).
  - NO>>> Proceed to [Step 3](#).
3. Start the engine at let it run at idle until the engine oil temperature reaches more than 85° C (185° F).
4. Create a graph of “DSOP LO RAT FAIL TMR” and review the value. **If it shows anything but “0”, the timing cover needs to be replaced (Fig. 1) .**

**NOTE:** The “DSOP LO RAT FAIL TMR” value can change in less than 20 seconds, then the oil pump (timing chain) is faulty and will need to be replaced.

**Graph Showing Correct And Not Correct Values**

5. Did the “DSOP LO RAT FAIL TMR” value read anything but “0”?
  - YES>>> Create a screen shot of the graph showing values other than “0” and attach it to the work order. Proceed to [Step 6](#).
  - NO>>> If the value always shows “0” and DTC P06DD was not found, this bulletin has been completed. Use Inspection LOP (09-65-01-74) to close the active RSU.
6. Replace the timing chain cover. Refer to the detailed service procedures available in DealerCONNECT/ Service Library under: 09 - Engine, 1.3L I4 16V Multi Air Turbo / Valve Timing / Cover(s), Engine Timing / Removal and Installation.
7. Using wiTECH clear any DTCs that may have been set.
