# TECHNICAL SERVICE BULLETIN

## Equipped With Hybrid Engines - Illuminated Powertrain Malfunction Indicator Lamp With DTC P0A1E In The PCM

**23-2279**31 August  
2023**Model:**

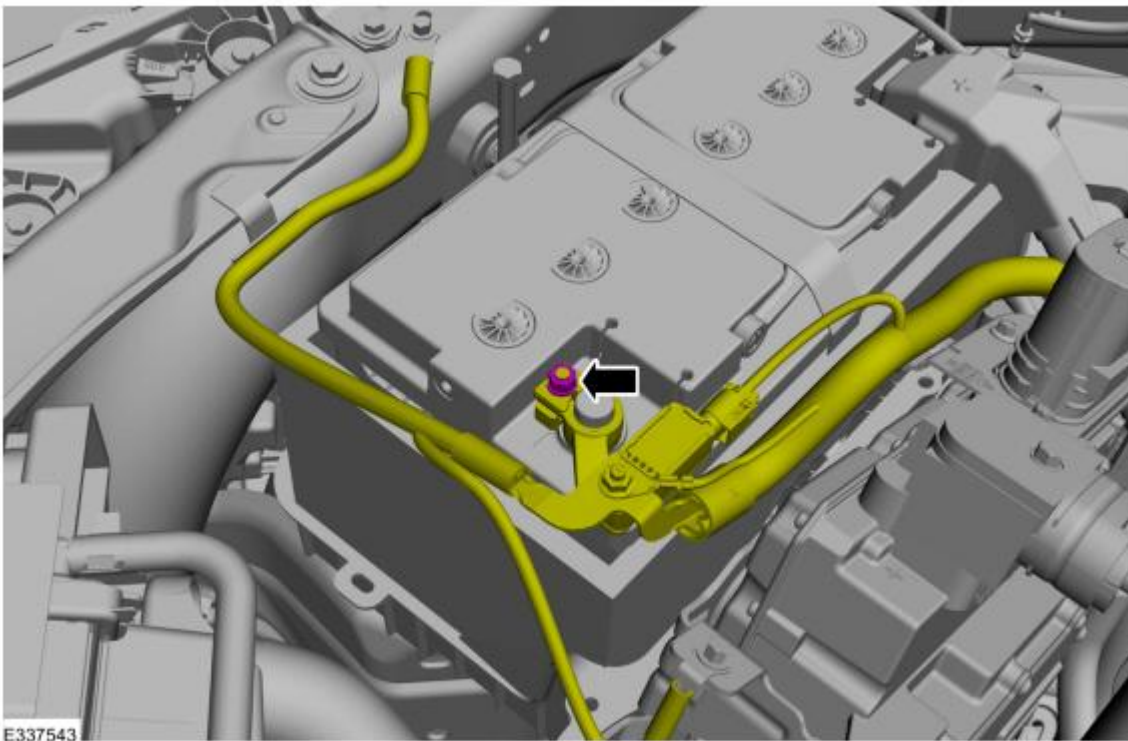
Figure 1 - F-150

- (1). Yes - repair is complete.
  - (2). No - proceed to Step 5.
5. At the 12V battery negative post, inspect the nut securing the battery monitoring sensor to the negative battery post. (Figures 1-2) If it is loose, tighten the nut to the specified tightening value. Refer to WSM, Section 414-01 Battery, Mounting and Cables, General Procedures, Battery Disconnect and Connect.

- For F-150 vehicles with a 3.5L hybrid engine, tighten to 55 lb.in (6.2 Nm).
  - For Explorer/Aviator vehicles equipped with a hybrid engine, tighten to 48 lb.in (5.4 Nm).

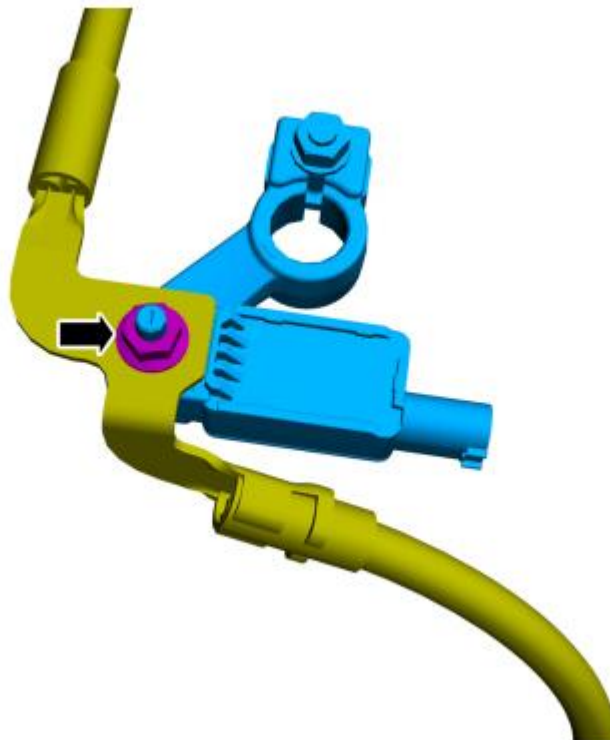
Figure 3

6. At the battery monitoring sensor, inspect the nut attaching the sensor to the ground cable. (Figure 3) If it is loose, tighten the nut to the specified tightening value. Refer to WSM, Section 414-01 Battery, Mounting and Cables, Removal and Installation, Battery Monitoring Sensor.

- For F-150 vehicles with a 3.5L hybrid engine, tighten to 97 lb.in (11 Nm).
- For Explorer/Aviator vehicles equipped with a hybrid engine, tighten to 80 lb.in (9 Nm).

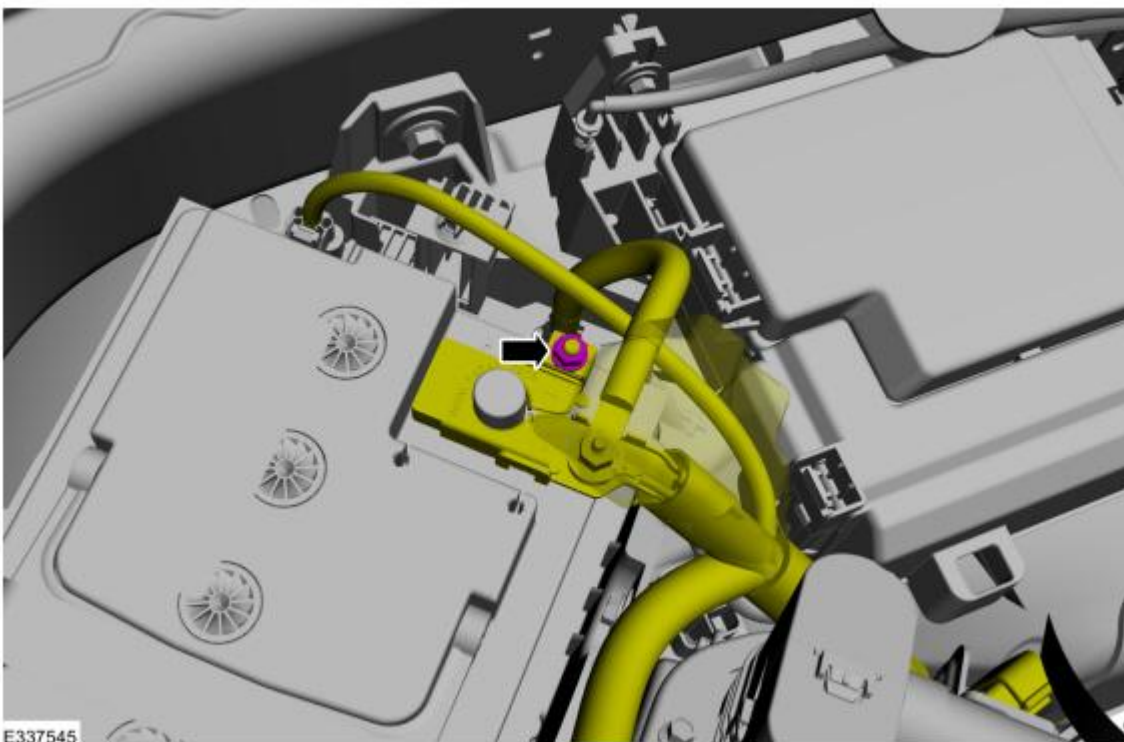
Figure 4 - F-150

7. At the 12V battery positive post, inspect the nut securing the positive battery cable to the post. (Figures 4-5) If it is loose, tighten the nut to the specified tightening value. Refer to WSM, Section 414-01 Battery, Mounting and Cables, General Procedures, Battery Disconnect and Connect.

- For F-150 vehicles with a 3.5L hybrid engine, tighten to 55 lb.in (6.2 Nm).

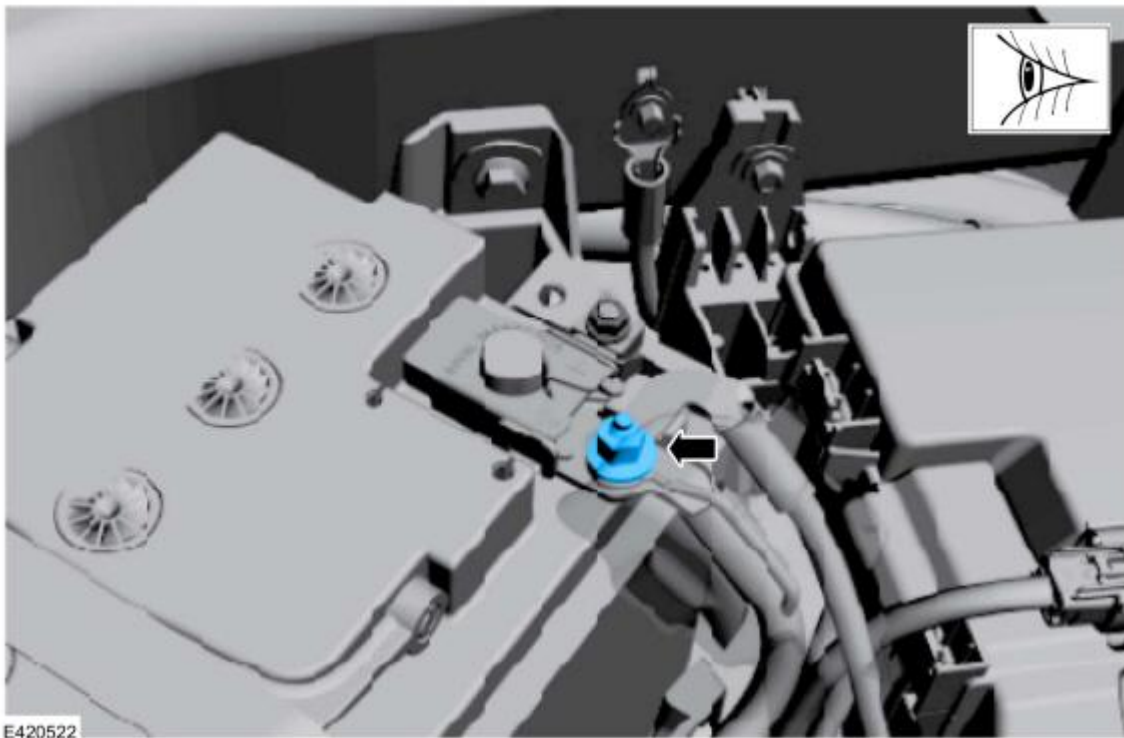
Figure 6 - F-150

**8.** At the 12V battery positive post, inspect the nut securing the positive cable eyelet lug. (Figures 6-7) If it is loose, tighten the nut to the specified tightening value. Refer to 414-01, Battery, Mounting and Mounting Cables, Removal and Installation.

- For F-150 vehicles with a 3.5L hybrid engine, tighten to 80 lb.in (9 Nm).
- For Explorer/Aviator vehicles equipped with a hybrid engine: 80 lb.in (9 Nm).

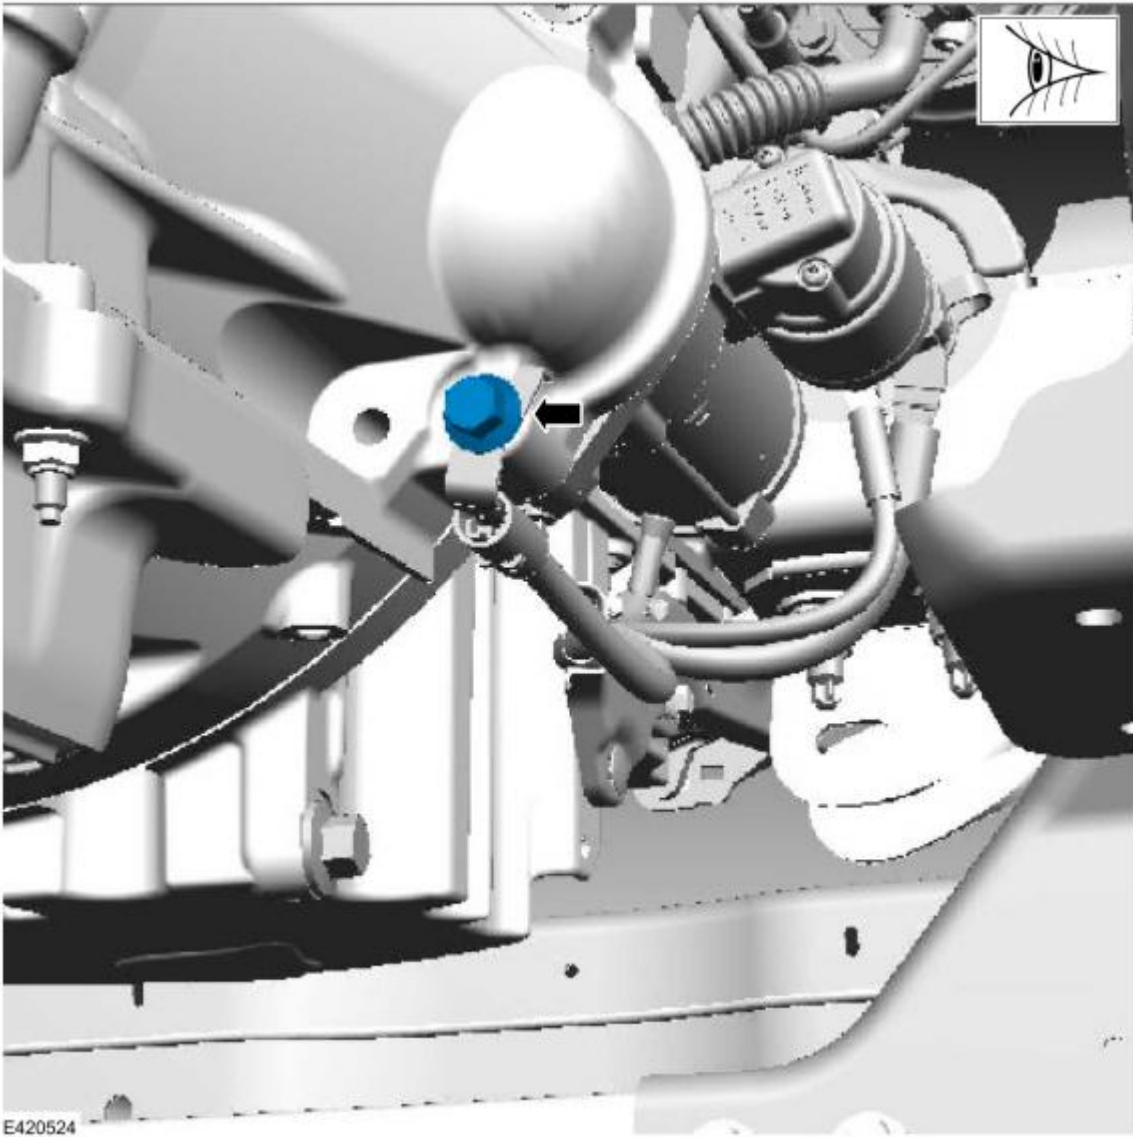
Figure 8 - F-150

9. Inspect engine ground G105. (Figures 8-10) Refer to Wiring Diagram, Cell 010, G105. If it is loose, tighten the bolt to the specified tightening value.

- For F-150 vehicles with a 3.5L hybrid engine, tighten to 35 lb.ft (48 Nm).
- For Explorer/Aviator vehicles equipped with a hybrid engine, tighten to 106 lb.in (12 Nm).
