# Technical Service Bulletin

## 01 MIL on, Whistling noise, leaking air Bank 2 - DTC P2ADF00, Engine Crankcase breather

01 23 78 2071318/2 September 20, 2023. Supersedes Technical Service Bulletin Group 01 number 23-72 dated August 23, 2023 for reasons listed below.

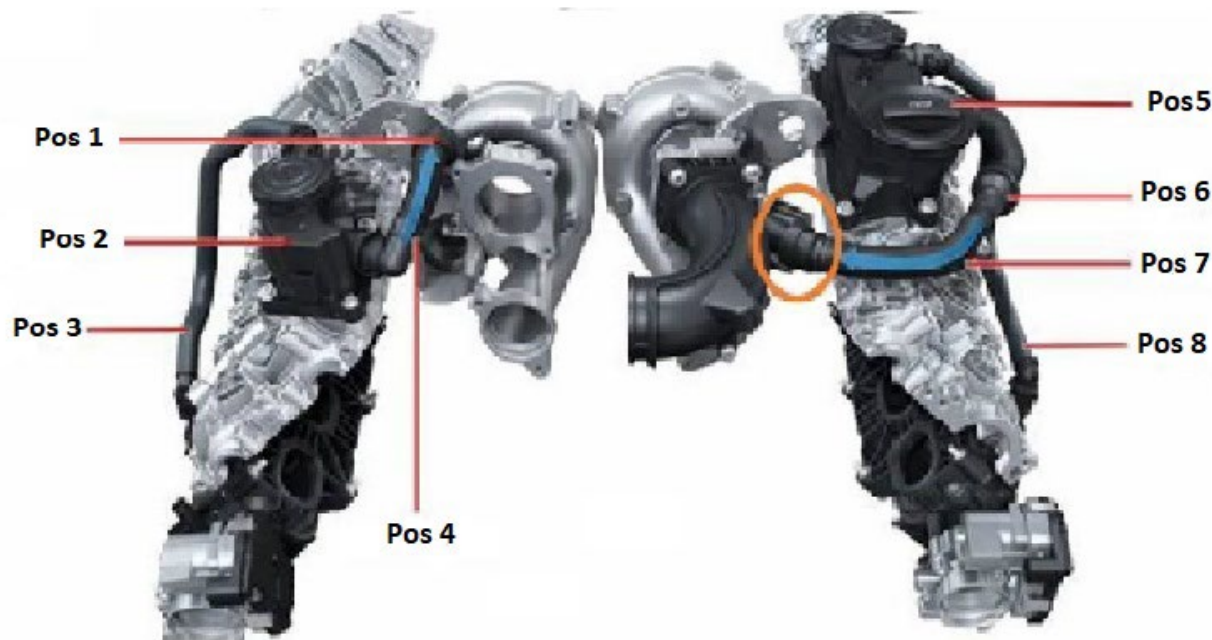
1. Do not replace the oil separator for bank 1 or bank 2 or the part load breather lines.
  - a. Please refer to image of the crankcase from the Self Study Program 920493 as a guide.

- Item 1: Non-return valve
- Item 2: Oil separator for bank 1
- Item 3 Part load breather line for bank 1
- Item 4: Full load breather line for bank 1
- Item 5: Oil separator for bank 2
- Item 6: Non-return valve
- **Item 7: Full load breather line for bank 2**
- Item 8: Part load breather line

In this case, replace the full load breather line for cylinder bank 2.
