**2021-2023MY**  
**Multiple Models**

**108****September 2023**

SUBJECT: **4WD COUPLING ACTUATOR ASSEMBLY REPLACEMENT**

This bulletin provides information to replace the AWD coupling actuator assembly on some 2021-2023MY Kia AWD models listed on page 4. The affected vehicles may exhibit an inoperative AWD system (also referred to as 4WD) capability concern which may be caused by abnormal wear of the motor brushes inside the actuator assembly. This condition will cause the warning lamps on the instrument cluster to illuminate with stored DTC(s) P195800 and/or P19600. Follow the procedure outlined in this publication to inspect and, if necessary, replace the AWD coupling actuator assembly on the applicable vehicles.

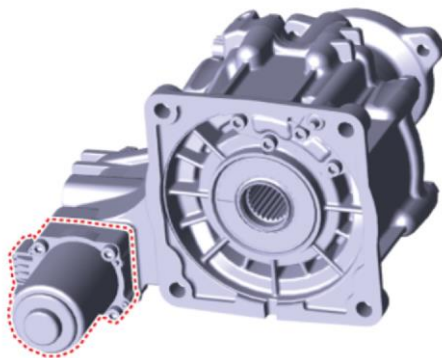
P195800 - 4WD Torque Error

P196000 - 4WD Bleeding Pressure Error
