## STAR ONLINE PUBLICATION

**Case Number:** S2008000132 Rev. E

**Symptom/Vehicle Issue:** Malfunction Indicator Lamp Illuminated. U11E9 Lost Communication With AGS. Ambient Air Temp Incorrectly Displayed. P0070 And P0073 Set for Ambient Air Temp Sensor

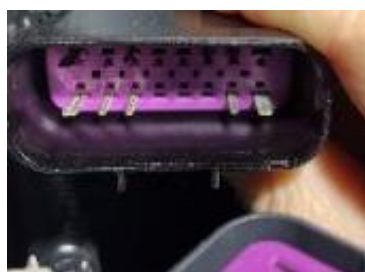
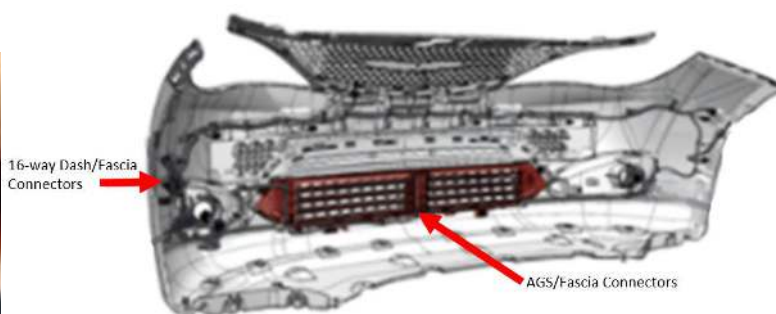
1. Inspect the wiring near the 16-way XY101A Dash to Fascia Connector for nicks and cuts. Disconnect the connector, remove the purple terminal retainer (dash side only), inspect for corrosion and terminal pushout on both sides (fascia/dash).

1. If corrosion, damage, or terminal pushout is present at the XY101A connector. Use connector kit 68497543AB to repair the 16-way Dash side connector and replace the Fascia side harness. A connector repair kit 68500834AA for the fascia side connector is also available. But due to the various possible issues described, fascia harness replacement is recommended.

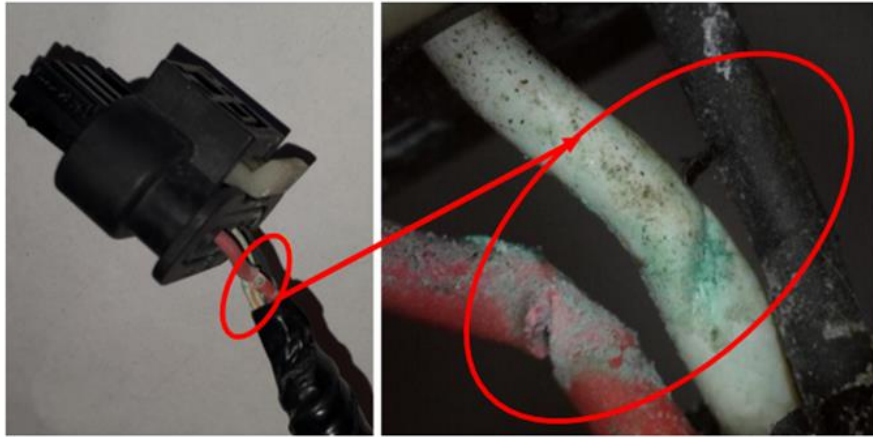
3. Disconnect the AGS to fascia/dash connectors and inspect for damage and corrosion.

### Active Grill Shutter Connection Damage/Corrosion

2. If the G917 ground is corroded and high resistance is measured. The ground circuit cavity H dash connector should be repaired using kit 68497543AB. Repair the wiring with best practices (use solder, splice Band and heat shrink).
3. If corrosion is present in the AGS connector, replace the AGS. **Do not add dielectric grease to the AGS/fascia connectors.** If corrosion is present in the fascia connector, repair it using connector kit 68396618AB or replace the harness as necessary.
4. If water intrusion is found in either of the Fog or Front Side Marker Lamp housings, replace the Fog and/or Side Marker assemblies. If water intrusion is found in any of the connectors. Use wiring diagrams or Mopar connector repair website to locate the correct connector repair kit (varies by model year).

**Note:** If the corrosion or damage is found on the wiring harness, do not replace the mating connector on the AGS side. Repair wiring and retest. Do not add dielectric grease to the fascia or Dash connectors.
